Profile/Photo Observation Report

Street:	FOXCROFT STREET	Flow Control:	Not Controlled
City:	Hobart, IN	Year Renewed:	
Location:	Yard	Tape/Media #:	
Purpose:	Routine Assessment	Dia/Height:	8"
Use:	Sanitary	Material:	PVC
Drain Area:	NA	Lining:	
Category:	NA		
Comment:	Flow direction is wrong.

Location Details:		Direction of Survey:	Upstream
US MH:	M-607-036	DS MH:	M-607-035
		Total Length Surveyed (ft):	170.0

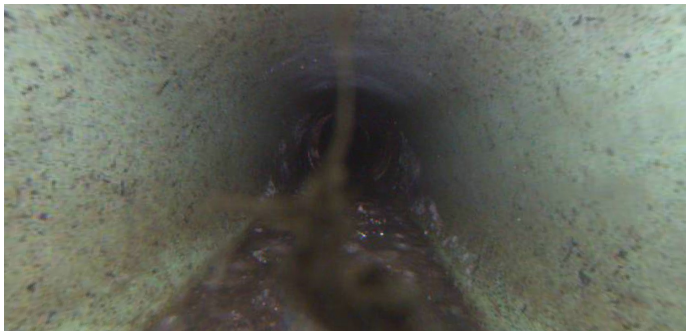
Code: **AMH**
Description: **Manhole**

Distance (ft): **.0**
Structural Grade: **0**
O&M Grade: **0**
Clock Start/From:
Clock To:
1st Value:
2nd Value:
Value Percent:
Continuous Index:
Within 8" of Joint: **NO**
Remarks: **M-607-035**

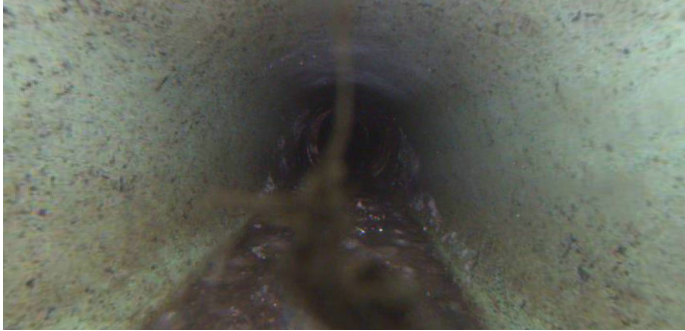
Code:	MWL
Description:	Water Level

Distance (ft):	.0
Structural Grade:	0
O&M Grade:	0
Clock Start/From:	
Clock To:	
1st Value:	
2nd Value:	
Value Percent:	10.000
Continuous Index:	
Within 8" of Joint:	NO
Remarks:

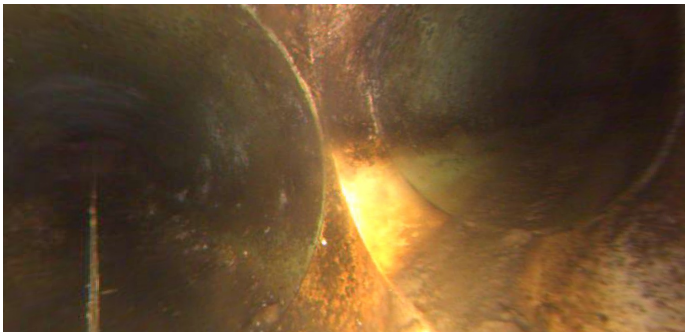
Code:	TF
Description:	Tap Factory

Distance (ft):	4.0
Structural Grade:	0
O&M Grade:	0
Clock Start/From:	9
Clock To:	
1st Value:	4.000
2nd Value:	
Value Percent:	
Continuous Index:	
Within 8" of Joint:	
Remarks:

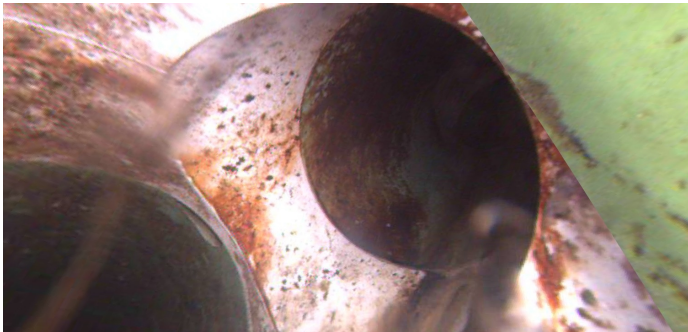
Code: **TF**
Description: **Tap Factory**

Distance (ft): **156.0**
Structural Grade: **0**
O&M Grade: **0**
Clock Start/From: **2**
Clock To:
1st Value: **4.000**
2nd Value:
Value Percent:
Continuous Index:
Within 8" of Joint:
Remarks:
