## Profile/Photo Observation Report

Street:	<b>W 14TH ST &amp; MEDLEE DR</b>	Flow Control:	<b>Not Controlled</b>
City:	<b>Hobart, IN</b>	Year Renewed:	
Location:	<b>Yard</b>	Tape/Media #:	
Purpose:	<b>Routine Assessment</b>	Dia/Height:	<b>8"</b>
Use:	<b>Sanitary</b>	Material:	<b>PVC</b>
Drain Area:	<b>NA</b>	Lining:	
Category:	<b>NA</b>		
Comment:

Location Details:		Direction of Survey:	<b>Downstream</b>
US MH:	<b>M-607-037</b>	DS MH:	<b>M-607-034</b>
		Total Length Surveyed (ft):	<b>159.4</b>

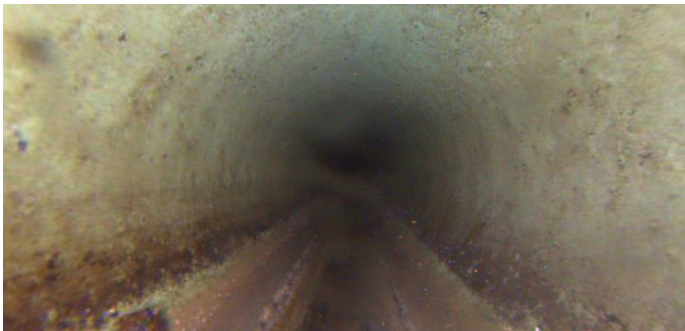
Code: **AMH**  
Description: **Manhole**

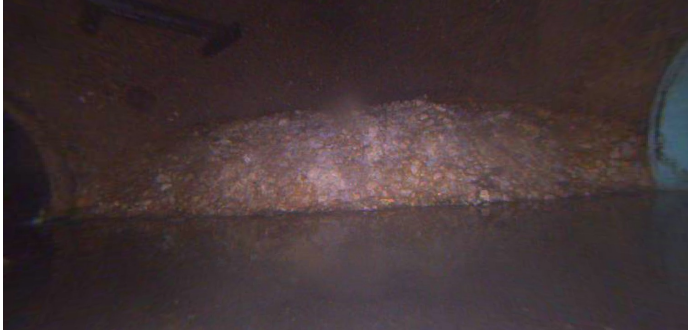
Code:	AMH
Description:	Manhole
Distance (ft):	159.4
Structural Grade:	0
O&M Grade:	0
Clock Start/From:	
Clock To:	
1st Value:	
2nd Value:	
Value Percent:	
Continuous Index:	
Within 8" of Joint:	NO
Remarks:	M-607-034
