## Profile/Photo Observation Report

Street:	<b>FOXCROFT STREET</b>	Flow Control:	<b>Not Controlled</b>
City:	<b>Hobart, IN</b>	Year Renewed:	
Location:	<b>Yard</b>	Tape/Media #:	
Purpose:	<b>Routine Assessment</b>	Dia/Height:	<b>8"</b>
Use:	<b>Sanitary</b>	Material:	<b>PVC</b>
Drain Area:	<b>NA</b>	Lining:	
Category:	<b>NA</b>		
Comment:

Location Details:		Direction of Survey:	<b>Downstream</b>
US MH:	<b>M-607-037</b>	DS MH:	<b>M-607-034</b>
		Total Length Surveyed (ft):	<b>159.4</b>

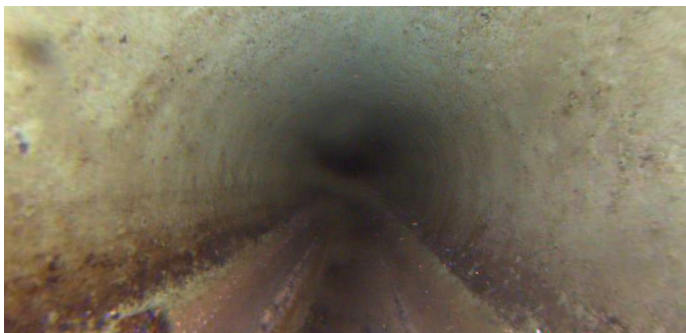
Code: **AMH**  
Description: **Manhole**

Distance (ft): **.0**  
Structural Grade: **0**  
O&M Grade: **0**  
Clock Start/From:  
Clock To:  
1st Value:  
2nd Value:  
Value Percent:  
Continuous Index:  
Within 8" of Joint: **NO**  
Remarks: **M-607-037**

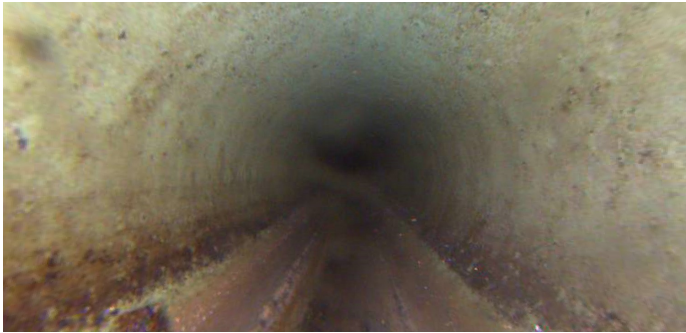
Code:	<b>MWL</b>
Description:	<b>Water Level</b>

Distance (ft):	<b>.0</b>
Structural Grade:	<b>0</b>
O&M Grade:	<b>0</b>
Clock Start/From:	
Clock To:	
1st Value:	
2nd Value:	
Value Percent:	<b>5.000</b>
Continuous Index:	
Within 8" of Joint:	<b>NO</b>
Remarks:

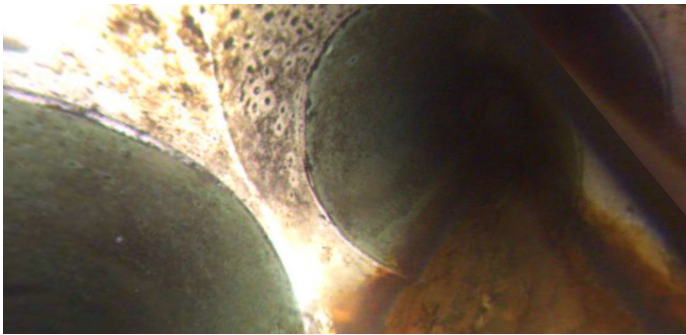
Code:	<b>TFA</b>
Description:	<b>Tap Factory Active</b>

Distance (ft):	<b>16.8</b>
Structural Grade:	<b>0</b>
O&M Grade:	<b>0</b>
Clock Start/From:	<b>10</b>
Clock To:	
1st Value:	<b>4.000</b>
2nd Value:	
Value Percent:	
Continuous Index:	
Within 8" of Joint:	
Remarks:

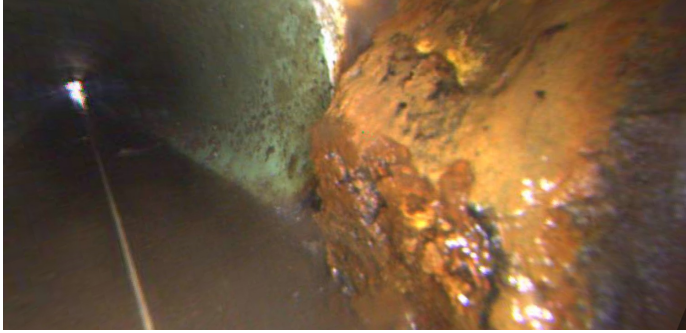
Code: **DAE**  
Description: **Deposits Attached Encrustation**

Distance (ft): **16.8**  
Structural Grade: **0**  
O&M Grade: **2**  
Clock Start/From: **7**  
Clock To: **9**  
1st Value:  
2nd Value:  
Value Percent: **10.000**  
Continuous Index:  
Within 8" of Joint: **NO**  
Remarks:

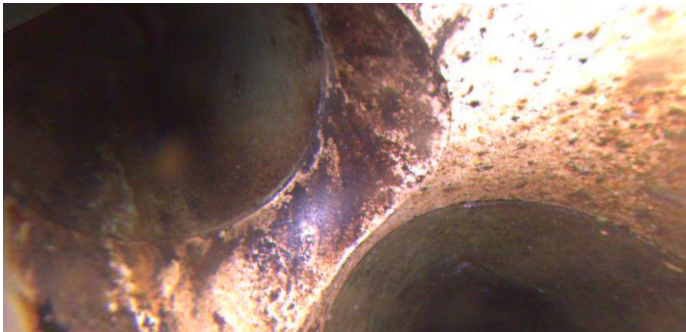
Code: **TF**  
Description: **Tap Factory**

Distance (ft): **71.0**  
Structural Grade: **0**  
O&M Grade: **0**  
Clock Start/From: **11**  
Clock To:  
1st Value: **4.000**  
2nd Value:  
Value Percent:  
Continuous Index:  
Within 8" of Joint:  
Remarks:

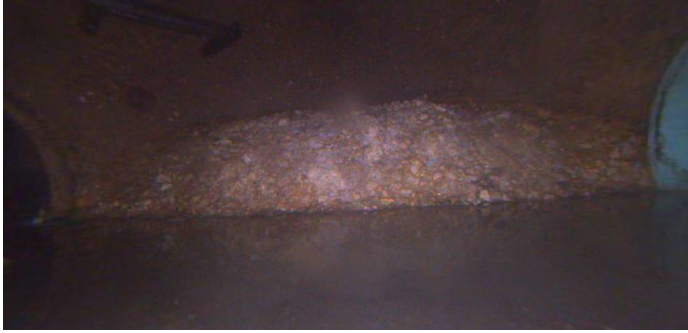
Code:	AMH
Description:	Manhole
Distance (ft):	159.4
Structural Grade:	0
O&M Grade:	0
Clock Start/From:	
Clock To:	
1st Value:	
2nd Value:	
Value Percent:	
Continuous Index:	
Within 8" of Joint:	NO
Remarks:	M-607-034
