Profile/Photo Observation Report

Street:	DIANE CT & MEDLEE DR	Flow Control:	Not Controlled
City:	Hobart, IN	Year Renewed:	
Location:	Yard	Tape/Media #:	
Purpose:	Routine Assessment	Dia/Height:	8"
Use:	Sanitary	Material:	PVC
Drain Area:	NA	Lining:	
Category:	NA		
Comment:

Location Details:		Direction of Survey:	Downstream
US MH:	M-607-037	DS MH:	M-607-036
		Total Length Surveyed (ft):	217.6

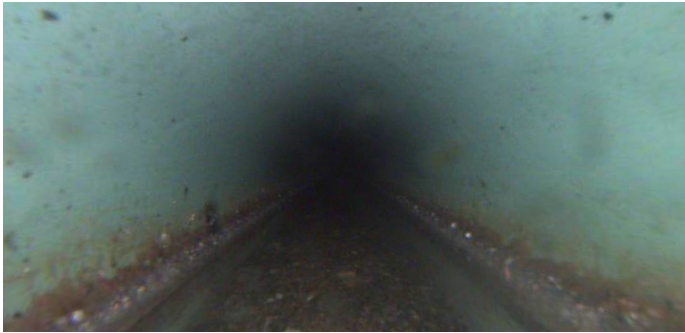
Code:	MWL
Description:	Water Level

Distance (ft):	.0
Structural Grade:	0
O&M Grade:	0
Clock Start/From:	
Clock To:	
1st Value:	
2nd Value:	
Value Percent:	10.000
Continuous Index:	
Within 8" of Joint:	NO
Remarks:

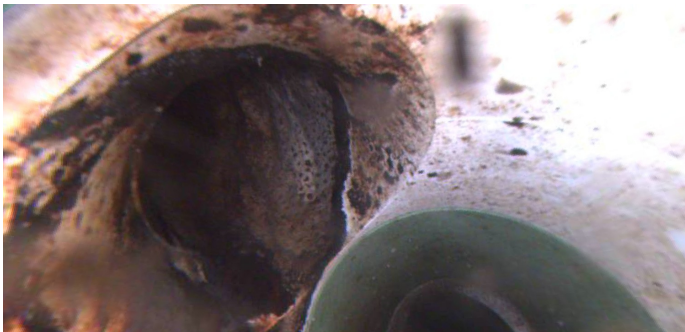
Code:	TFA
Description:	Tap Factory Active

Distance (ft):	72.7
Structural Grade:	0
O&M Grade:	0
Clock Start/From:	10
Clock To:	
1st Value:	4.000
2nd Value:	
Value Percent:	
Continuous Index:	
Within 8" of Joint:	
Remarks:

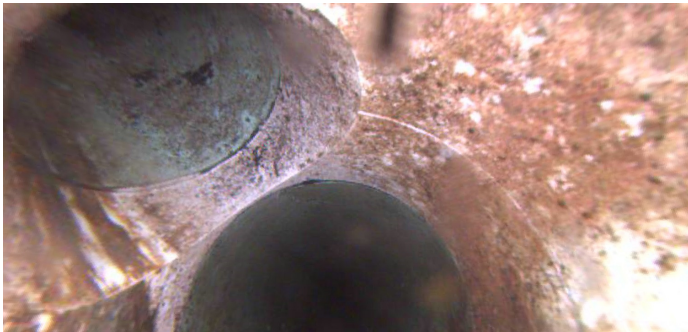
Code: **TF**
Description: **Tap Factory**

Distance (ft): **144.7**
Structural Grade: **0**
O&M Grade: **0**
Clock Start/From: **10**
Clock To:
1st Value: **4.000**
2nd Value:
Value Percent:
Continuous Index:
Within 8" of Joint:
Remarks:

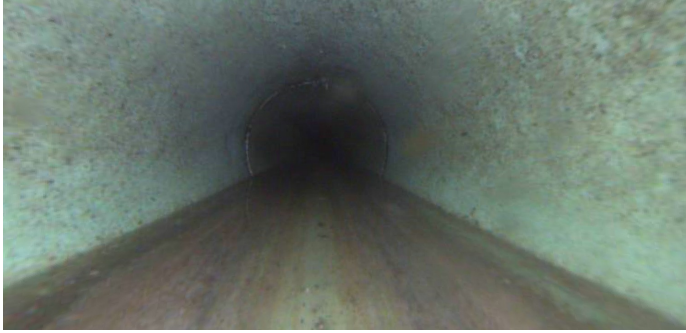
Code: **MWL**
Description: **Water Level**

Distance (ft): **164.4**
Structural Grade: **0**
O&M Grade: **0**
Clock Start/From:
Clock To:
1st Value:
2nd Value:
Value Percent: **30.000**
Continuous Index:
Within 8" of Joint: **NO**
Remarks:

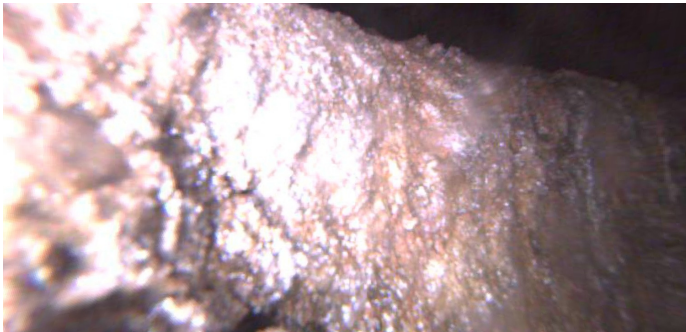
Code: **AMH**
Description: **Manhole**

Distance (ft): **217.6**
Structural Grade: **0**
O&M Grade: **0**
Clock Start/From:
Clock To:
1st Value:
2nd Value:
Value Percent:
Continuous Index:
Within 8" of Joint: **NO**
Remarks: **M-607-036**
