Profile/Photo Observation Report

Street:	FOXCROFT STREET	Flow Control:	Not Controlled
City:	Hobart, IN	Year Renewed:	
Location:	Yard	Tape/Media #:	
Purpose:	Routine Assessment	Dia/Height:	8"
Use:	Sanitary	Material:	PVC
Drain Area:	NA	Lining:	
Category:	NA		
Comment:

Location Details:		Direction of Survey:	Downstream
US MH:	M-607-037	DS MH:	M-607-036
		Total Length Surveyed (ft):	217.6

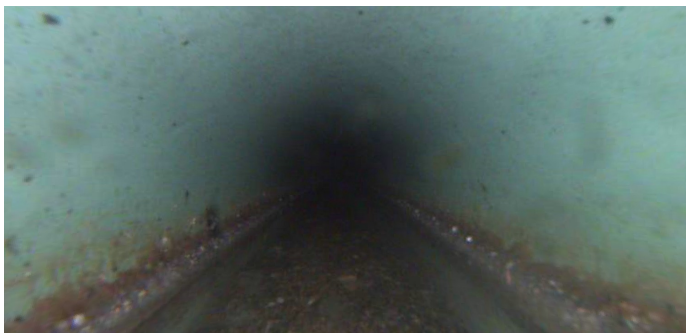
Code: **AMH**
Description: **Manhole**

Distance (ft): **.0**
Structural Grade: **0**
O&M Grade: **0**
Clock Start/From:
Clock To:
1st Value:
2nd Value:
Value Percent:
Continuous Index:
Within 8" of Joint: **NO**
Remarks: **M-607-037**

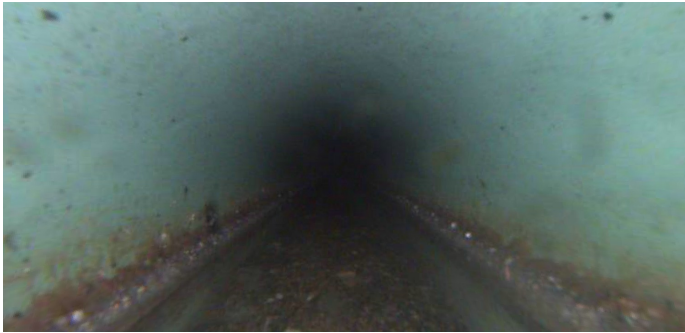
Code:	MWL
Description:	Water Level

Distance (ft):	.0
Structural Grade:	0
O&M Grade:	0
Clock Start/From:	
Clock To:	
1st Value:	
2nd Value:	
Value Percent:	10.000
Continuous Index:	
Within 8" of Joint:	NO
Remarks:

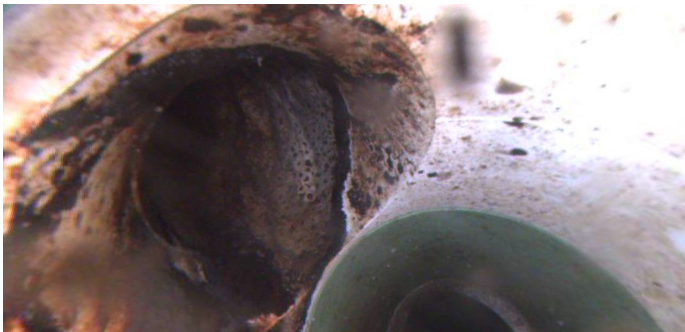
Code:	TFA
Description:	Tap Factory Active

Distance (ft):	72.7
Structural Grade:	0
O&M Grade:	0
Clock Start/From:	10
Clock To:	
1st Value:	4.000
2nd Value:	
Value Percent:	
Continuous Index:	
Within 8" of Joint:	
Remarks:

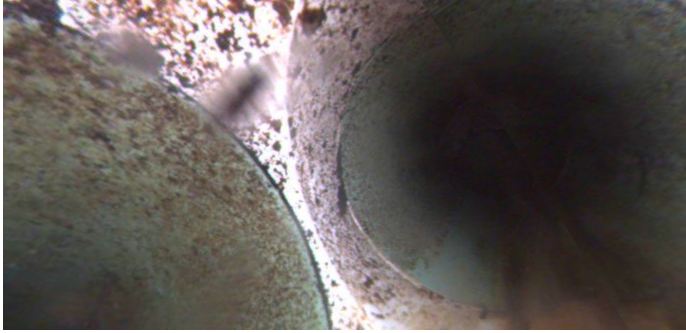
Code: **TF**
Description: **Tap Factory**

Distance (ft): **74.6**
Structural Grade: **0**
O&M Grade: **0**
Clock Start/From: **2**
Clock To:
1st Value: **4.000**
2nd Value:
Value Percent:
Continuous Index:
Within 8" of Joint:
Remarks:

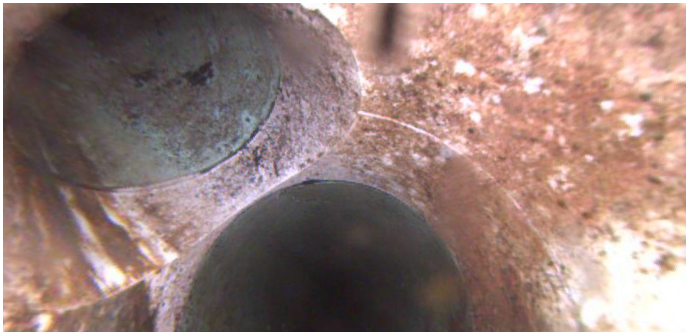
Code: **TF**
Description: **Tap Factory**

Distance (ft): **144.7**
Structural Grade: **0**
O&M Grade: **0**
Clock Start/From: **10**
Clock To:
1st Value: **4.000**
2nd Value:
Value Percent:
Continuous Index:
Within 8" of Joint:
Remarks:

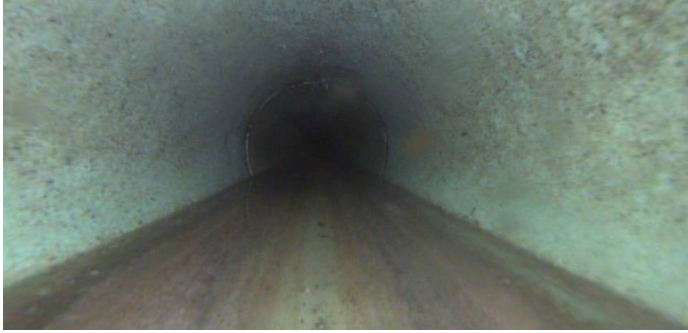
Code:	MWL
Description:	Water Level
Distance (ft):	164.4
Structural Grade:	0
O&M Grade:	0
Clock Start/From:	
Clock To:	
1st Value:	
2nd Value:	
Value Percent:	30.000
Continuous Index:	
Within 8" of Joint:	NO
Remarks:

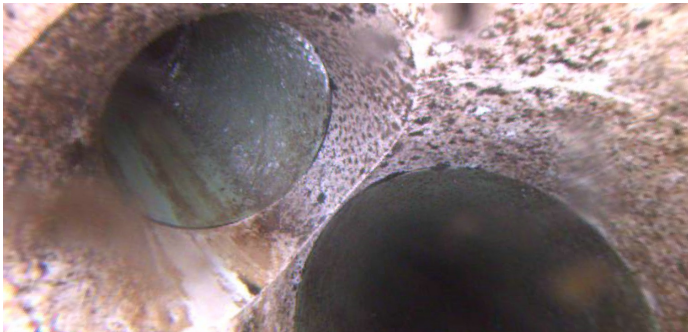
Code:	TF
Description:	Tap Factory
Distance (ft):	190.2
Structural Grade:	0
O&M Grade:	0
Clock Start/From:	11
Clock To:	
1st Value:	4.000
2nd Value:	
Value Percent:	
Continuous Index:	
Within 8" of Joint:	
Remarks:

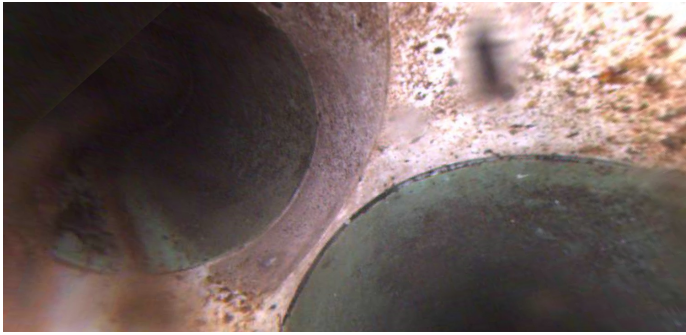
Code: **TF**
Description: **Tap Factory**

Distance (ft): **211.1**
Structural Grade: **0**
O&M Grade: **0**
Clock Start/From: **11**
Clock To:
1st Value: **4.000**
2nd Value:
Value Percent:
Continuous Index:
Within 8" of Joint:
Remarks:

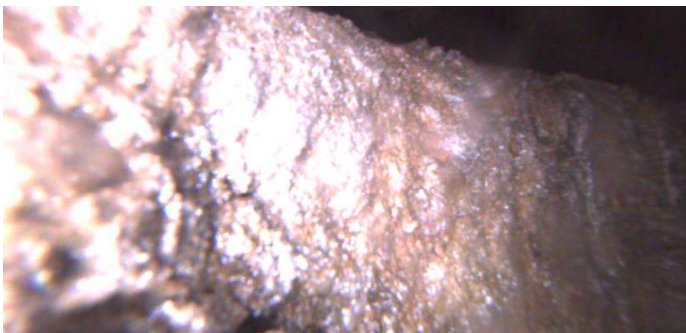
Code: **AMH**
Description: **Manhole**

Distance (ft): **217.6**
Structural Grade: **0**
O&M Grade: **0**
Clock Start/From:
Clock To:
1st Value:
2nd Value:
Value Percent:
Continuous Index:
Within 8" of Joint: **NO**
Remarks: **M-607-036**
