## Profile/Photo Observation Report

Date:	<b>04/03/2018</b>	Weather:		Coding:	<b>PACP 6.0</b>
Pipe Length (ft):	<b>210.7</b>	Owner:	<b>NA</b>	Pre Clean:	<b>No Pre-Cleaning</b>
P.O.#:		Surveyor:	<b>Jen Costello</b>	PSR:	<b>P-607-038-037</b>
Customer:		Clean Date:	<b>01/01/1900</b>	Shape:	<b>C</b>

Street:	<b>MEDLEE DR</b>	Flow Control:	<b>Not Controlled</b>
City:	<b>Hobart, IN</b>	Year Renewed:	
Location:	<b>Yard</b>	Tape/Media #:	
Purpose:	<b>Routine Assessment</b>	Dia/Height:	<b>8"</b>
Use:	<b>Sanitary</b>	Material:	<b>PVC</b>
Drain Area:	<b>NA</b>	Lining:	
Category:	<b>NA</b>		
Comment:			
Location Details:		Direction of Survey:	<b>Upstream</b>
US MH:	<b>M-607-038</b>	DS MH:	<b>M-607-037</b>
		Total Length Surveyed (ft):	<b>204.2</b>

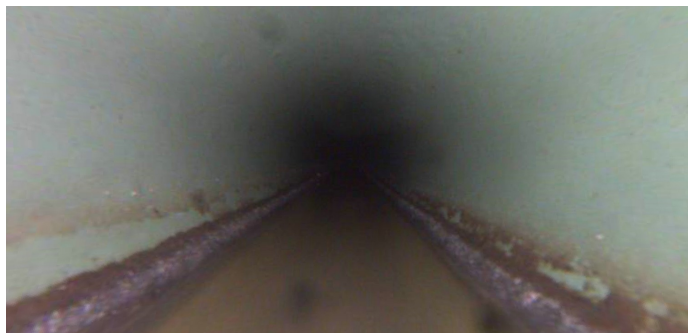
Code: **AMH**  
Description: **Manhole**

Distance (ft): **.0**  
Structural Grade: **0**  
O&M Grade: **0**  
Clock Start/From:  
Clock To:  
1st Value:  
2nd Value:  
Value Percent:  
Continuous Index:  
Within 8" of Joint: **NO**  
Remarks: **M-607-037**

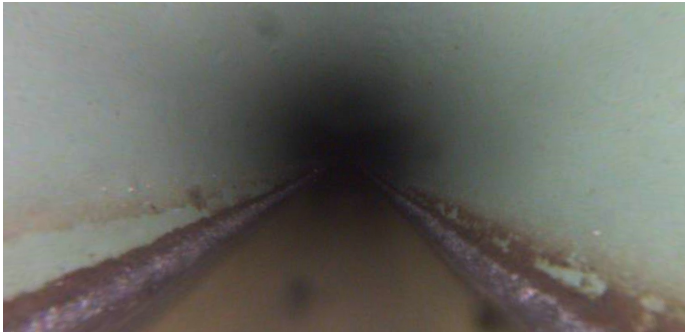
Code:	<b>MWL</b>
Description:	<b>Water Level</b>

Distance (ft):	<b>.0</b>
Structural Grade:	<b>0</b>
O&M Grade:	<b>0</b>
Clock Start/From:	
Clock To:	
1st Value:	
2nd Value:	
Value Percent:	<b>20.000</b>
Continuous Index:	
Within 8" of Joint:	<b>NO</b>
Remarks:

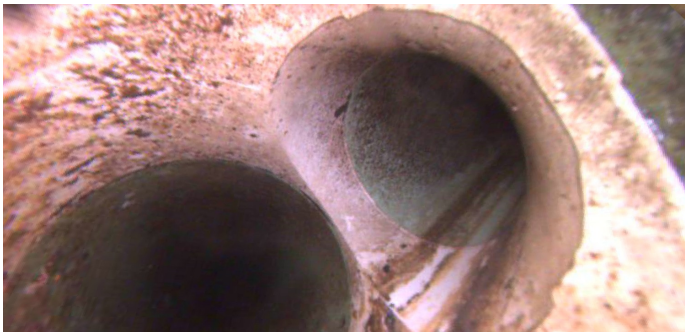
Code:	<b>TF</b>
Description:	<b>Tap Factory</b>

Distance (ft):	<b>108.0</b>
Structural Grade:	<b>0</b>
O&M Grade:	<b>0</b>
Clock Start/From:	<b>2</b>
Clock To:	
1st Value:	<b>4.000</b>
2nd Value:	
Value Percent:	
Continuous Index:	
Within 8" of Joint:	
Remarks:

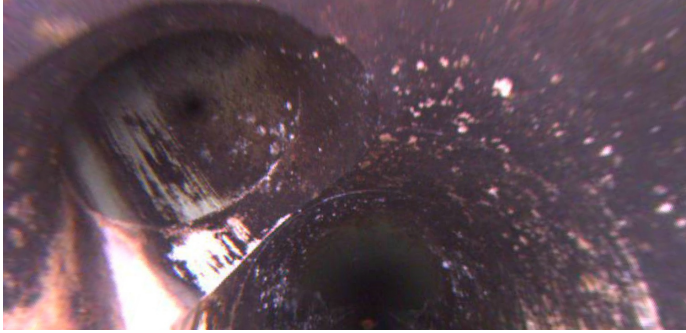
Code: **TF**  
Description: **Tap Factory**

Distance (ft): **157.3**  
Structural Grade: **0**  
O&M Grade: **0**  
Clock Start/From: **10**  
Clock To:  
1st Value: **4.000**  
2nd Value:  
Value Percent:  
Continuous Index:  
Within 8" of Joint:  
Remarks:

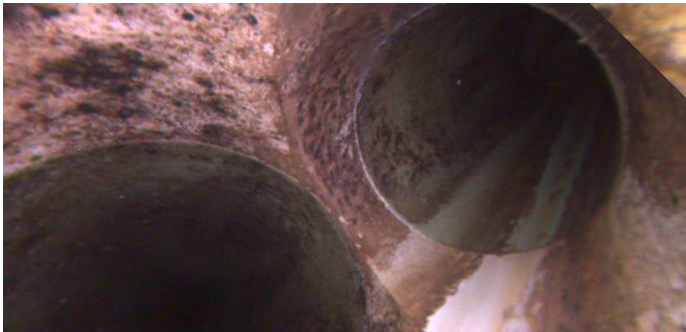
Code: **TF**  
Description: **Tap Factory**

Distance (ft): **168.7**  
Structural Grade: **0**  
O&M Grade: **0**  
Clock Start/From: **2**  
Clock To:  
1st Value: **4.000**  
2nd Value:  
Value Percent:  
Continuous Index:  
Within 8" of Joint:  
Remarks:

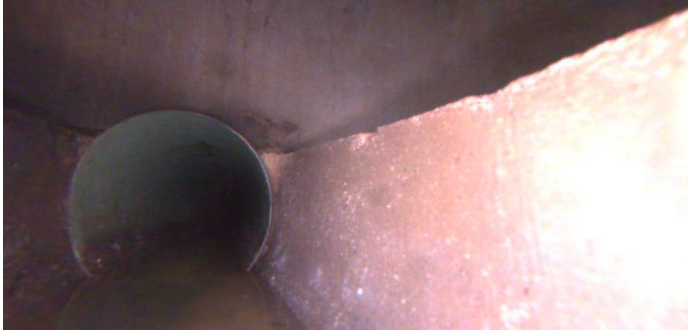
Code:	AMH
Description:	Manhole
Distance (ft):	204.2
Structural Grade:	0
O&M Grade:	0
Clock Start/From:	
Clock To:	
1st Value:	
2nd Value:	
Value Percent:	
Continuous Index:	
Within 8" of Joint:	NO
Remarks:	M-607-038
