Profile/Photo Observation Report

Street:	FOXCROFT STREET	Flow Control:	Not Controlled
City:	Hobart, IN	Year Renewed:	
Location:	Yard	Tape/Media #:	
Purpose:	Routine Assessment	Dia/Height:	8"
Use:	Sanitary	Material:	PVC
Drain Area:	NA	Lining:	
Category:	NA		
Comment:

Location Details:		Direction of Survey:	Upstream
US MH:	M-607-038	DS MH:	M-607-037
		Total Length Surveyed (ft):	204.2

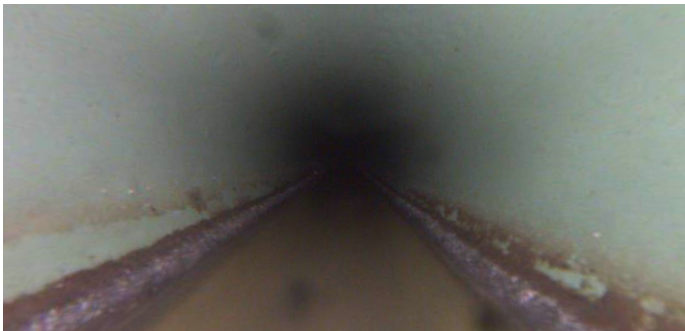
Code: **AMH**
Description: **Manhole**

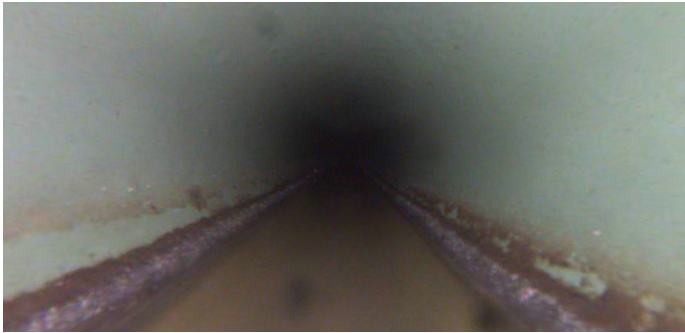
Code:	MWL
Description:	Water Level

Distance (ft):	.0
Structural Grade:	0
O&M Grade:	0
Clock Start/From:	
Clock To:	
1st Value:	
2nd Value:	
Value Percent:	20.000
Continuous Index:	
Within 8" of Joint:	NO
Remarks:

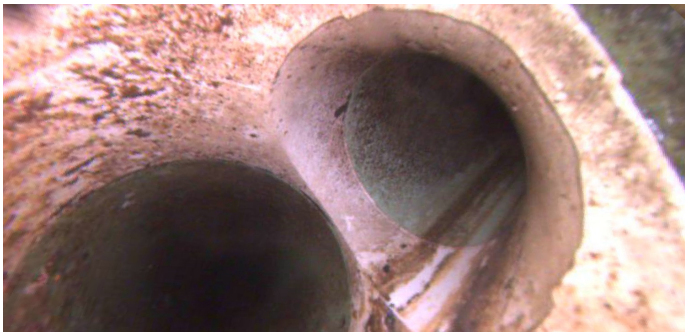
Code:	TF
Description:	Tap Factory

Distance (ft):	108.0
Structural Grade:	0
O&M Grade:	0
Clock Start/From:	2
Clock To:	
1st Value:	4.000
2nd Value:	
Value Percent:	
Continuous Index:	
Within 8" of Joint:	
Remarks:

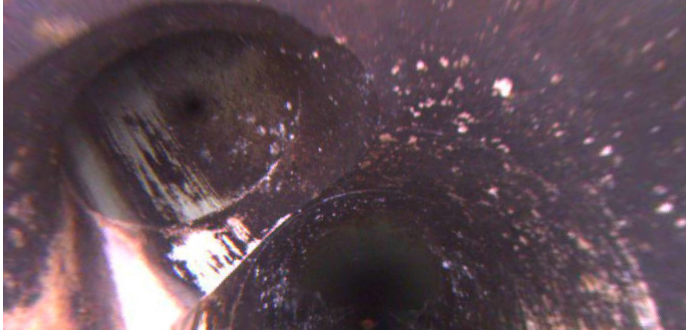
Code: **TF**
Description: **Tap Factory**

Distance (ft): **157.3**
Structural Grade: **0**
O&M Grade: **0**
Clock Start/From: **10**
Clock To:
1st Value: **4.000**
2nd Value:
Value Percent:
Continuous Index:
Within 8" of Joint:
Remarks:

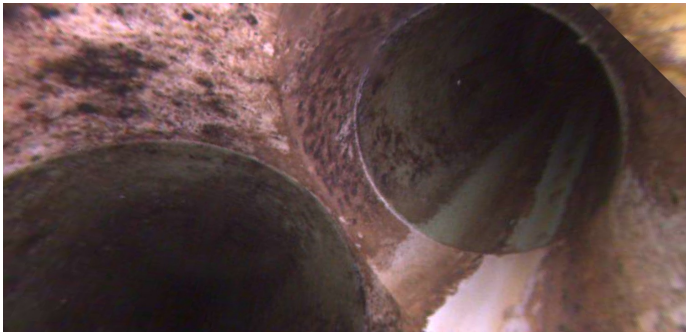
Code: **TF**
Description: **Tap Factory**

Distance (ft): **168.7**
Structural Grade: **0**
O&M Grade: **0**
Clock Start/From: **2**
Clock To:
1st Value: **4.000**
2nd Value:
Value Percent:
Continuous Index:
Within 8" of Joint:
Remarks:

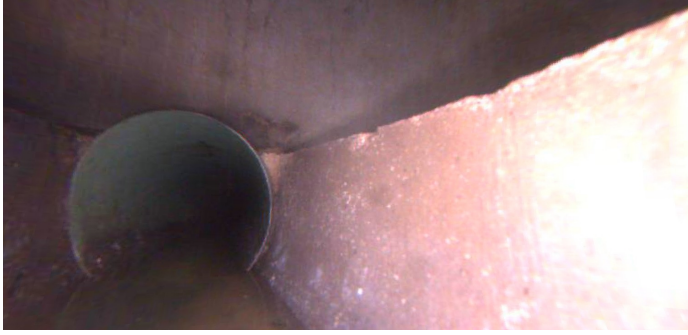
Code:	AMH
Description:	Manhole
Distance (ft):	204.2
Structural Grade:	0
O&M Grade:	0
Clock Start/From:	
Clock To:	
1st Value:	
2nd Value:	
Value Percent:	
Continuous Index:	
Within 8" of Joint:	NO
Remarks:	M-607-038
