Profile/Photo Observation Report

Street:	FOXCROFT STREET	Flow Control:	Not Controlled
City:	Hobart, IN	Year Renewed:	
Location:	Yard	Tape/Media #:	
Purpose:	Routine Assessment	Dia/Height:	8"
Use:	Sanitary	Material:	PVC
Drain Area:	NA	Lining:	
Category:	NA		
Comment:

Location Details:		Direction of Survey:	Upstream
US MH:	M-607-039	DS MH:	M-607-069
		Total Length Surveyed (ft):	22.9

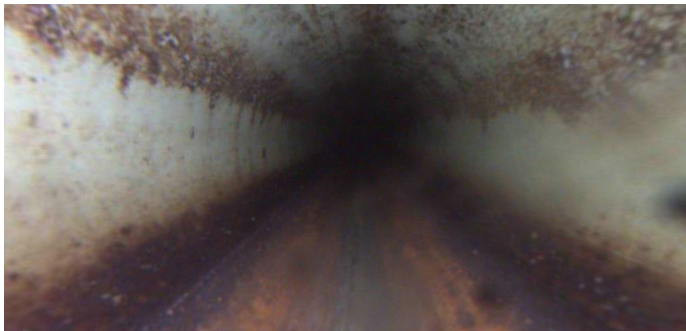
Code: **AMH**
Description: **Manhole**

Distance (ft): **.0**
Structural Grade: **0**
O&M Grade: **0**
Clock Start/From:
Clock To:
1st Value:
2nd Value:
Value Percent:
Continuous Index:
Within 8" of Joint: **NO**
Remarks: **M-607-069**

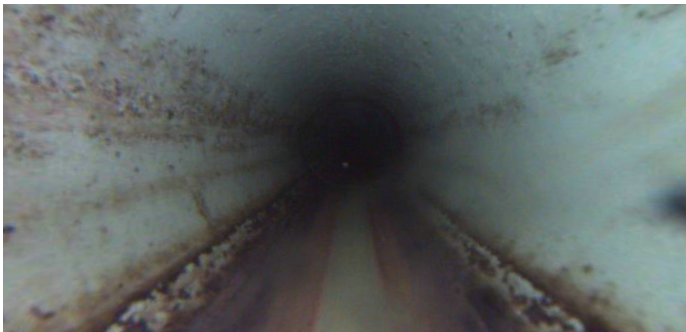
Code:	MSA
Description:	Abandoned Survey

Distance (ft):	22.9
Structural Grade:	0
O&M Grade:	0
Clock Start/From:	
Clock To:	
1st Value:	
2nd Value:	
Value Percent:	
Continuous Index:	
Within 8" of Joint:	NO
Remarks:	UNKNOWN
