Profile/Photo Observation Report

Date:	04/03/2018	Weather:		Coding:	PACP 6.0
Pipe Length (ft):	158.5	Owner:	NA	Pre Clean:	No Pre-Cleaning
P.O.#:		Surveyor:	Jen Costello	PSR:	P-607-040-039
Customer:		Clean Date:	01/01/1900	Shape:	C

Street:	MEDLEE DR	Flow Control:	Not Controlled
City:	Hobart, IN	Year Renewed:	
Location:	Yard	Tape/Media #:	
Purpose:	Routine Assessment	Dia/Height:	8"
Use:	Sanitary	Material:	PVC
Drain Area:	NA	Lining:	
Category:	NA		
Comment:

Location Details:		Direction of Survey:	Downstream
US MH:	M-607-040	DS MH:	M-607-039
		Total Length Surveyed (ft):	155.5

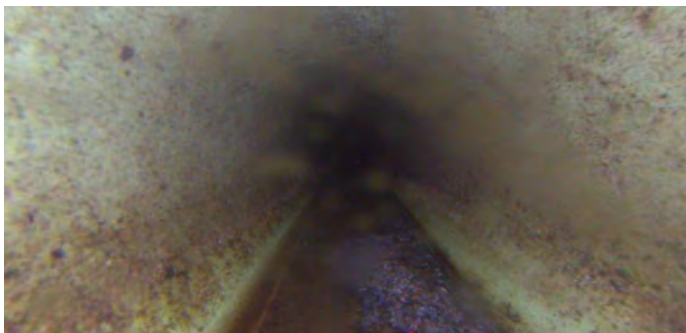
Code: **AMH**
Description: **Manhole**

Distance (ft): **.0**
Structural Grade: **0**
O&M Grade: **0**
Clock Start/From:
Clock To:
1st Value:
2nd Value:
Value Percent:
Continuous Index:
Within 8" of Joint: **NO**
Remarks: **M-607-040**

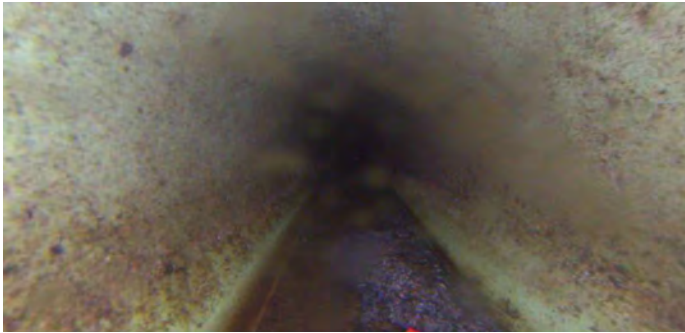
Code:	MWL
Description:	Water Level

Distance (ft):	.0
Structural Grade:	0
O&M Grade:	0
Clock Start/From:	
Clock To:	
1st Value:	
2nd Value:	
Value Percent:	5.000
Continuous Index:	
Within 8" of Joint:	NO
Remarks:

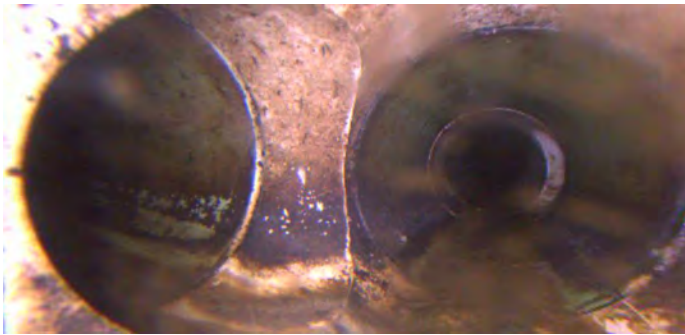
Code:	TFA
Description:	Tap Factory Active

Distance (ft):	9.3
Structural Grade:	0
O&M Grade:	0
Clock Start/From:	9
Clock To:	
1st Value:	4.000
2nd Value:	
Value Percent:	
Continuous Index:	
Within 8" of Joint:	
Remarks:

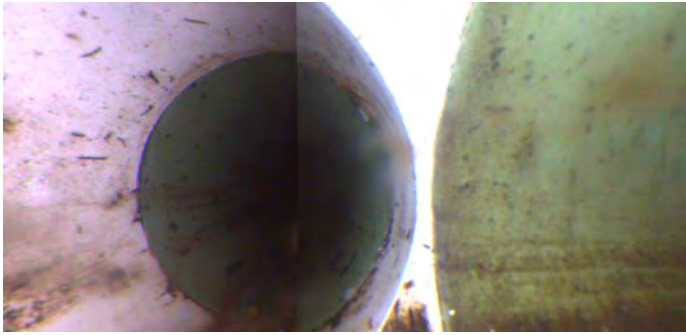
Code: **TF**
Description: **Tap Factory**

Distance (ft): **11.1**
Structural Grade: **0**
O&M Grade: **0**
Clock Start/From: **3**
Clock To:
1st Value: **4.000**
2nd Value:
Value Percent:
Continuous Index:
Within 8" of Joint:
Remarks:

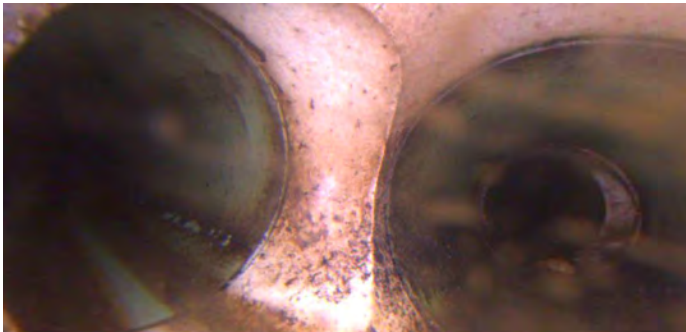
Code: **TFA**
Description: **Tap Factory Active**

Distance (ft): **75.9**
Structural Grade: **0**
O&M Grade: **0**
Clock Start/From: **9**
Clock To:
1st Value: **4.000**
2nd Value:
Value Percent:
Continuous Index:
Within 8" of Joint:
Remarks:

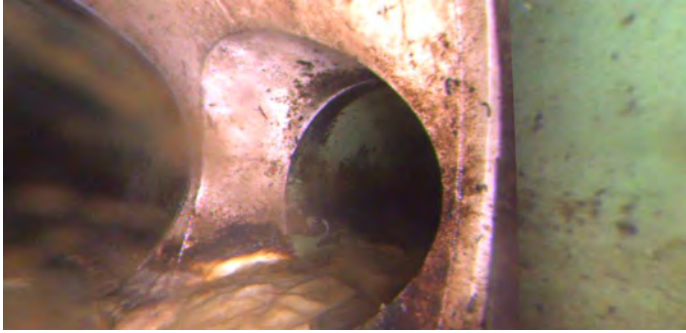
Code: **TFA**
Description: **Tap Factory Active**

Distance (ft): **77.5**
Structural Grade: **0**
O&M Grade: **0**
Clock Start/From: **3**
Clock To:
1st Value: **4.000**
2nd Value:
Value Percent:
Continuous Index:
Within 8" of Joint:
Remarks:

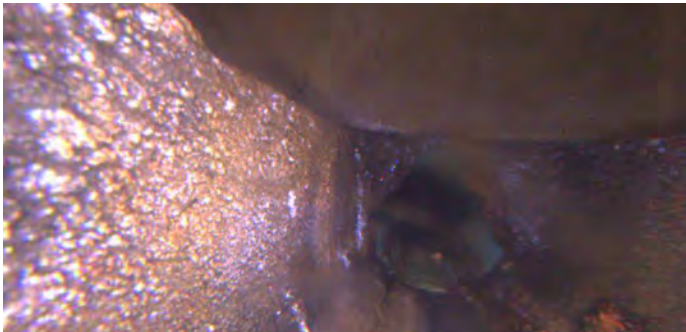
Code: **AMH**
Description: **Manhole**

Distance (ft): **155.5**
Structural Grade: **0**
O&M Grade: **0**
Clock Start/From:
Clock To:
1st Value:
2nd Value:
Value Percent:
Continuous Index:
Within 8" of Joint: **NO**
Remarks: **M-607-039**
