## Profile/Photo Observation Report

Street:	<b>FOXCROFT STREET</b>	Flow Control:	<b>Not Controlled</b>
City:	<b>Hobart, IN</b>	Year Renewed:	
Location:	<b>Yard</b>	Tape/Media #:	
Purpose:	<b>Routine Assessment</b>	Dia/Height:	<b>8"</b>
Use:	<b>Sanitary</b>	Material:	<b>PVC</b>
Drain Area:	<b>NA</b>	Lining:	
Category:	<b>NA</b>		
Comment:

Location Details:		Direction of Survey:	<b>Downstream</b>
US MH:	<b>M-607-040</b>	DS MH:	<b>M-607-039</b>
		Total Length Surveyed (ft):	<b>155.5</b>

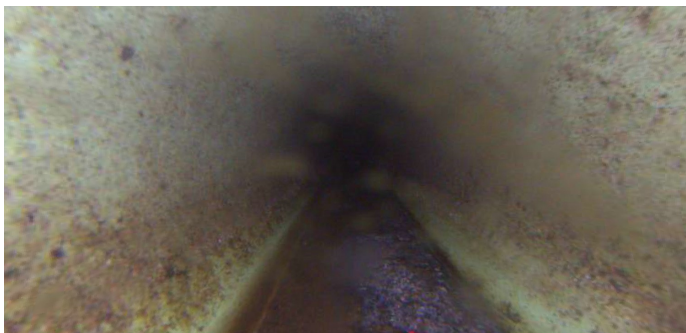
Code: **AMH**  
Description: **Manhole**

Distance (ft): **.0**  
Structural Grade: **0**  
O&M Grade: **0**  
Clock Start/From:  
Clock To:  
1st Value:  
2nd Value:  
Value Percent:  
Continuous Index:  
Within 8" of Joint: **NO**  
Remarks: **M-607-040**

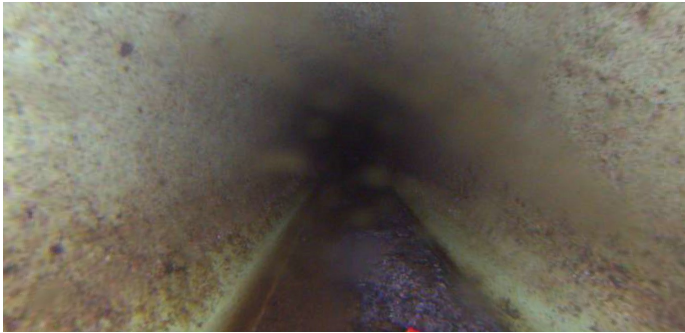
Code:	<b>MWL</b>
Description:	<b>Water Level</b>

Distance (ft):	<b>.0</b>
Structural Grade:	<b>0</b>
O&M Grade:	<b>0</b>
Clock Start/From:	
Clock To:	
1st Value:	
2nd Value:	
Value Percent:	<b>5.000</b>
Continuous Index:	
Within 8" of Joint:	<b>NO</b>
Remarks:

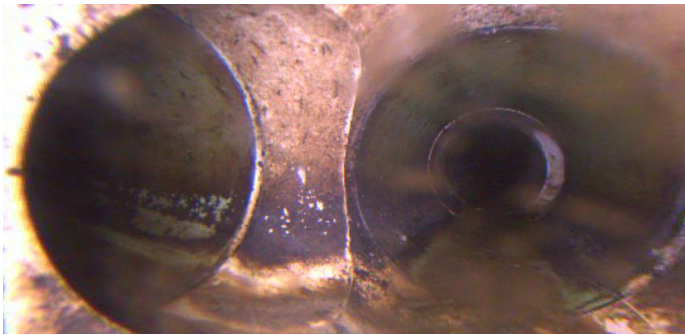
Code:	<b>TFA</b>
Description:	<b>Tap Factory Active</b>

Distance (ft):	<b>9.3</b>
Structural Grade:	<b>0</b>
O&M Grade:	<b>0</b>
Clock Start/From:	<b>9</b>
Clock To:	
1st Value:	<b>4.000</b>
2nd Value:	
Value Percent:	
Continuous Index:	
Within 8" of Joint:	
Remarks:

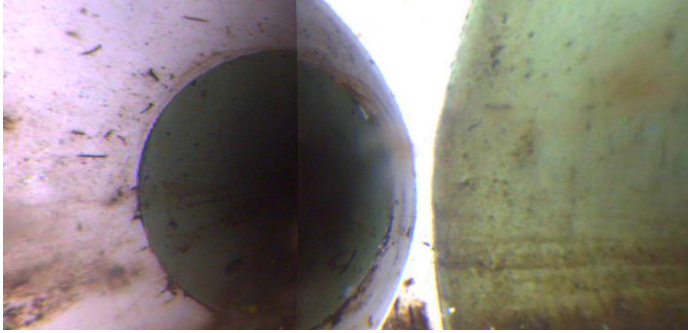
Code: **TF**  
Description: **Tap Factory**

Distance (ft): **11.1**  
Structural Grade: **0**  
O&M Grade: **0**  
Clock Start/From: **3**  
Clock To:  
1st Value: **4.000**  
2nd Value:  
Value Percent:  
Continuous Index:  
Within 8" of Joint:  
Remarks:

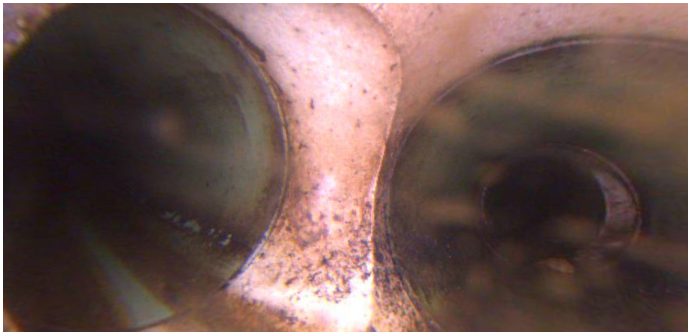
Code: **TFA**  
Description: **Tap Factory Active**

Distance (ft): **75.9**  
Structural Grade: **0**  
O&M Grade: **0**  
Clock Start/From: **9**  
Clock To:  
1st Value: **4.000**  
2nd Value:  
Value Percent:  
Continuous Index:  
Within 8" of Joint:  
Remarks:

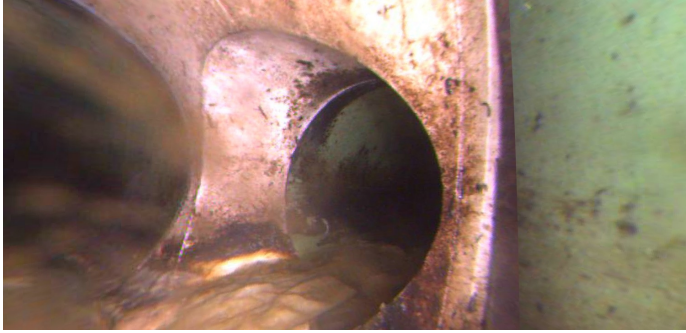
Code: **TFA**  
Description: **Tap Factory Active**

Distance (ft): **77.5**  
Structural Grade: **0**  
O&M Grade: **0**  
Clock Start/From: **3**  
Clock To:  
1st Value: **4.000**  
2nd Value:  
Value Percent:  
Continuous Index:  
Within 8" of Joint:  
Remarks:

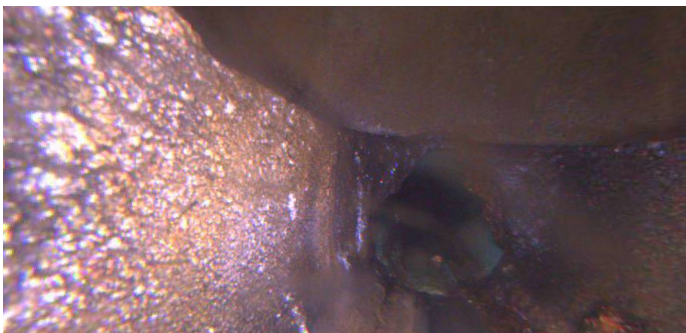
Code: **AMH**  
Description: **Manhole**

Distance (ft): **155.5**  
Structural Grade: **0**  
O&M Grade: **0**  
Clock Start/From:  
Clock To:  
1st Value:  
2nd Value:  
Value Percent:  
Continuous Index:  
Within 8" of Joint: **NO**  
Remarks: **M-607-039**
