## Profile/Photo Observation Report

Street:	<b>MEDLEE DR &amp; MEDLEE CT</b>	Flow Control:	<b>Not Controlled</b>
City:	<b>Hobart, IN</b>	Year Renewed:	
Location:	<b>Yard</b>	Tape/Media #:	
Purpose:	<b>Routine Assessment</b>	Dia/Height:	<b>8"</b>
Use:	<b>Sanitary</b>	Material:	<b>PVC</b>
Drain Area:	<b>NA</b>	Lining:	
Category:	<b>NA</b>		
Comment:	<b>Flow direction is marked wrong.</b>		
Location Details:		Direction of Survey:	<b>Upstream</b>
US MH:	<b>M-607-042</b>	DS MH:	<b>M-607-041</b>
		Total Length Surveyed (ft):	<b>221.1</b>

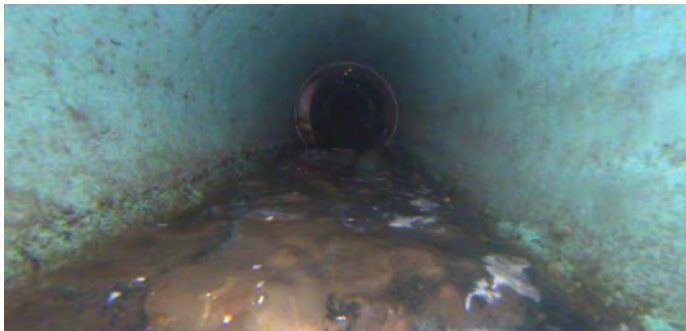
Code: **AMH**  
Description: **Manhole**

Distance (ft): **.0**  
Structural Grade: **0**  
O&M Grade: **0**  
Clock Start/From:  
Clock To:  
1st Value:  
2nd Value:  
Value Percent:  
Continuous Index:  
Within 8" of Joint: **NO**  
Remarks: **M-607-041**

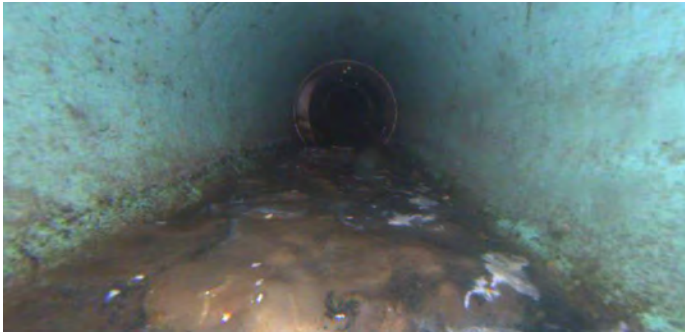
Code:	<b>MWL</b>
Description:	<b>Water Level</b>

Distance (ft):	<b>.0</b>
Structural Grade:	<b>0</b>
O&M Grade:	<b>0</b>
Clock Start/From:	
Clock To:	
1st Value:	
2nd Value:	
Value Percent:	<b>20.000</b>
Continuous Index:	
Within 8" of Joint:	<b>NO</b>
Remarks:

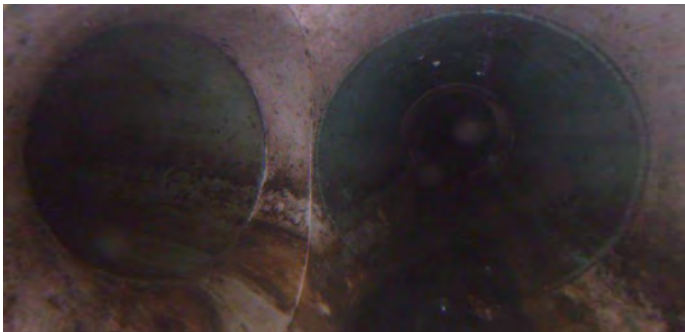
Code:	<b>TFA</b>
Description:	<b>Tap Factory Active</b>

Distance (ft):	<b>3.2</b>
Structural Grade:	<b>0</b>
O&M Grade:	<b>0</b>
Clock Start/From:	<b>9</b>
Clock To:	
1st Value:	<b>4.000</b>
2nd Value:	
Value Percent:	
Continuous Index:	
Within 8" of Joint:	
Remarks:

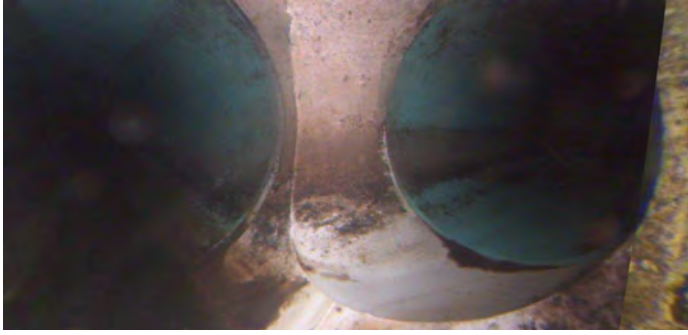
Code: **TFA**  
Description: **Tap Factory Active**

Distance (ft): **5.1**  
Structural Grade: **0**  
O&M Grade: **0**  
Clock Start/From: **2**  
Clock To:  
1st Value: **4.000**  
2nd Value:  
Value Percent:  
Continuous Index:  
Within 8" of Joint:  
Remarks:

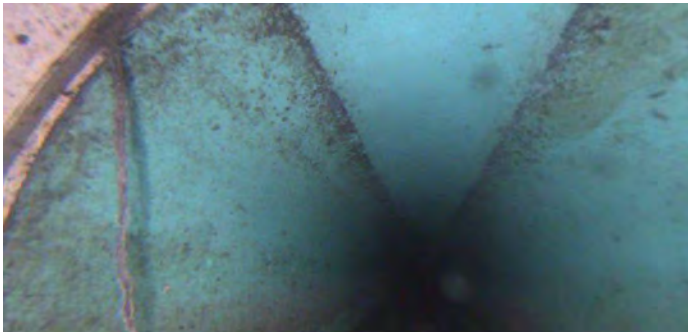
Code: **RFJ**  
Description: **Roots Fine Joint**

Distance (ft): **5.6**  
Structural Grade: **0**  
O&M Grade: **1**  
Clock Start/From: **11**  
Clock To:  
1st Value:  
2nd Value:  
Value Percent:  
Continuous Index:  
Within 8" of Joint: **YES**  
Remarks:

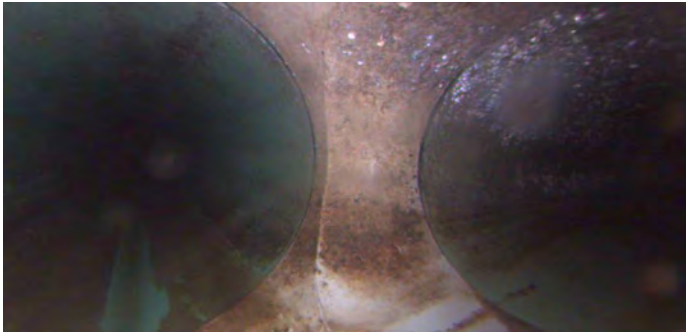
Code: **TF**  
Description: **Tap Factory**

Distance (ft): **13.1**  
Structural Grade: **0**  
O&M Grade: **0**  
Clock Start/From: **3**  
Clock To:  
1st Value: **4.000**  
2nd Value:  
Value Percent:  
Continuous Index:  
Within 8" of Joint:  
Remarks:

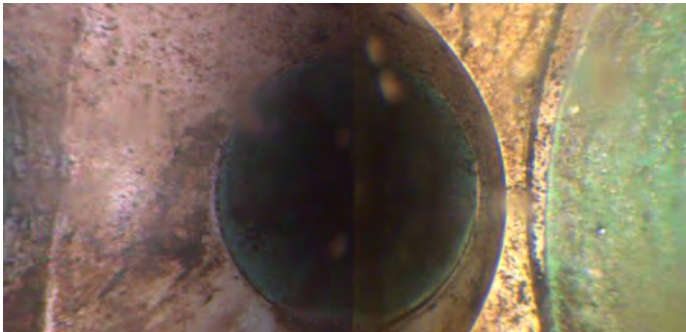
Code: **TF**  
Description: **Tap Factory**

Distance (ft): **20.7**  
Structural Grade: **0**  
O&M Grade: **0**  
Clock Start/From: **3**  
Clock To:  
1st Value: **4.000**  
2nd Value:  
Value Percent:  
Continuous Index:  
Within 8" of Joint:  
Remarks:

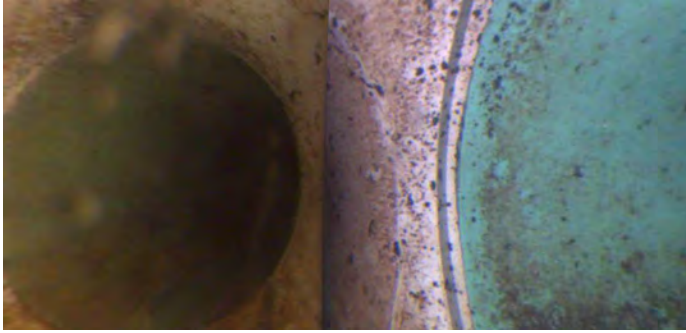
Code: **TFA**  
Description: **Tap Factory Active**

Distance (ft): **32.7**  
Structural Grade: **0**  
O&M Grade: **0**  
Clock Start/From: **9**  
Clock To:  
1st Value: **4.000**  
2nd Value:  
Value Percent:  
Continuous Index:  
Within 8" of Joint:  
Remarks:

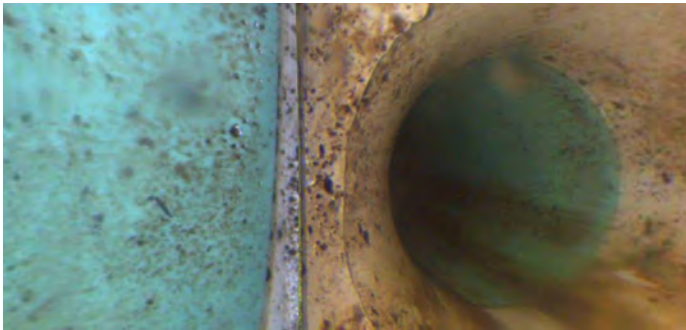
Code: **TF**  
Description: **Tap Factory**

Distance (ft): **51.5**  
Structural Grade: **0**  
O&M Grade: **0**  
Clock Start/From: **3**  
Clock To:  
1st Value: **4.000**  
2nd Value:  
Value Percent:  
Continuous Index:  
Within 8" of Joint:  
Remarks:

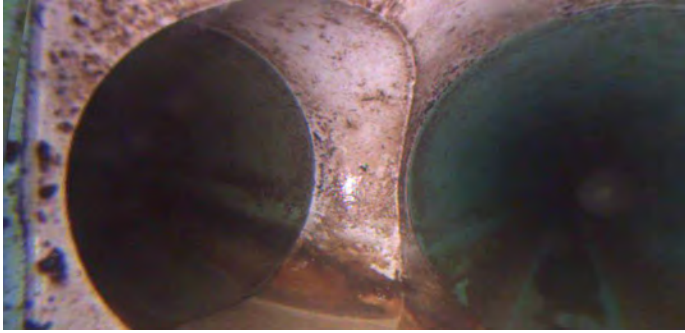
Code: **TFA**  
Description: **Tap Factory Active**

Distance (ft): **66.6**  
Structural Grade: **0**  
O&M Grade: **0**  
Clock Start/From: **9**  
Clock To:  
1st Value: **4.000**  
2nd Value:  
Value Percent:  
Continuous Index:  
Within 8" of Joint:  
Remarks:

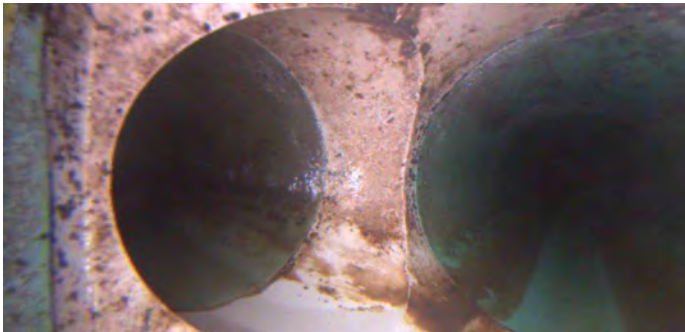
Code: **TF**  
Description: **Tap Factory**

Distance (ft): **161.4**  
Structural Grade: **0**  
O&M Grade: **0**  
Clock Start/From: **9**  
Clock To:  
1st Value: **4.000**  
2nd Value:  
Value Percent:  
Continuous Index:  
Within 8" of Joint:  
Remarks:

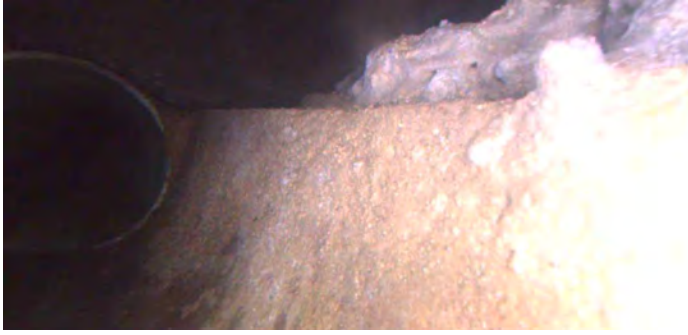
Code:	AMH
Description:	Manhole
Distance (ft):	221.1
Structural Grade:	0
O&M Grade:	0
Clock Start/From:	
Clock To:	
1st Value:	
2nd Value:	
Value Percent:	
Continuous Index:	
Within 8" of Joint:	NO
Remarks:	M-607-042
