Profile/Photo Observation Report

Street:	FOXCROFT STREET	Flow Control:	Not Controlled
City:	Hobart, IN	Year Renewed:	
Location:	Yard	Tape/Media #:	
Purpose:	Routine Assessment	Dia/Height:	8"
Use:	Sanitary	Material:	PVC
Drain Area:	NA	Lining:	
Category:	NA		
Comment:	Flow direction is marked wrong.		
Location Details:		Direction of Survey:	Upstream
US MH:	M-607-042	DS MH:	M-607-041
		Total Length Surveyed (ft):	221.1

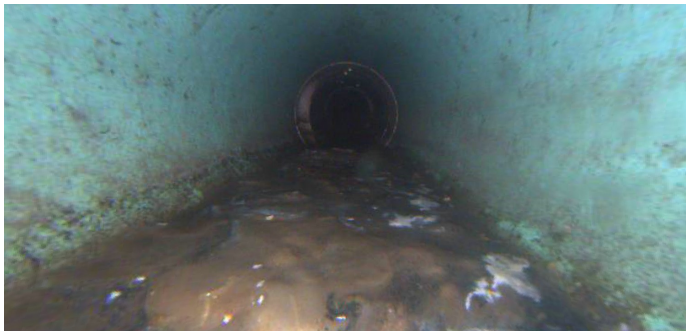
Code: **AMH**
Description: **Manhole**

Distance (ft): **.0**
Structural Grade: **0**
O&M Grade: **0**
Clock Start/From:
Clock To:
1st Value:
2nd Value:
Value Percent:
Continuous Index:
Within 8" of Joint: **NO**
Remarks: **M-607-041**

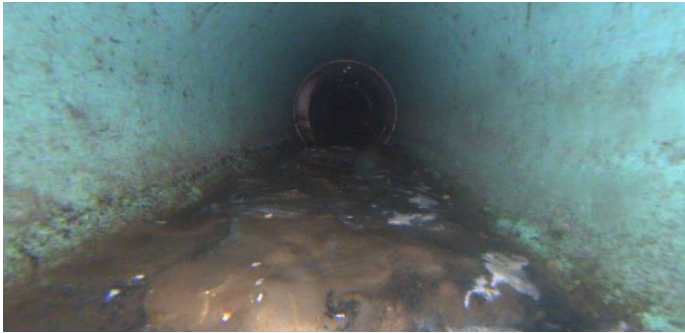
Code:	MWL
Description:	Water Level

Distance (ft):	.0
Structural Grade:	0
O&M Grade:	0
Clock Start/From:	
Clock To:	
1st Value:	
2nd Value:	
Value Percent:	20.000
Continuous Index:	
Within 8" of Joint:	NO
Remarks:

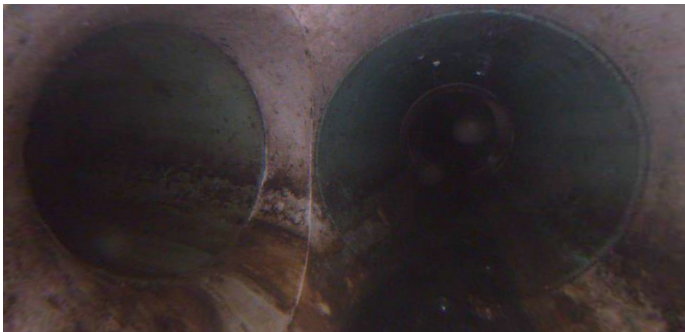
Code:	TFA
Description:	Tap Factory Active

Distance (ft):	3.2
Structural Grade:	0
O&M Grade:	0
Clock Start/From:	9
Clock To:	
1st Value:	4.000
2nd Value:	
Value Percent:	
Continuous Index:	
Within 8" of Joint:	
Remarks:

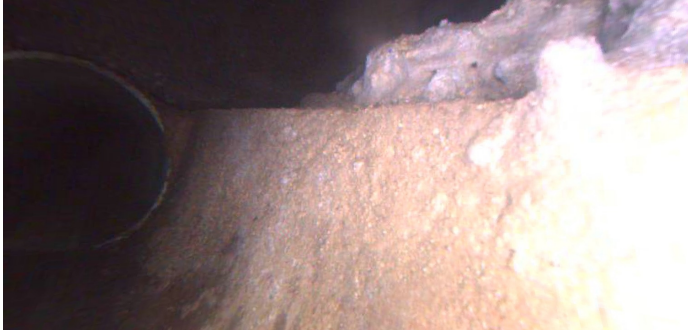
Code:	AMH
Description:	Manhole
Distance (ft):	221.1
Structural Grade:	0
O&M Grade:	0
Clock Start/From:	
Clock To:	
1st Value:	
2nd Value:	
Value Percent:	
Continuous Index:	
Within 8" of Joint:	NO
Remarks:	M-607-042
