## Profile/Photo Observation Report

Street:	<b>Medlee Drive</b>	Flow Control:	
City:	<b>Hobart, IN</b>	Year Renewed:	
Location:	<b>Light Highway</b>	Tape/Media #:	<b>1000</b>
Purpose:	<b>Routine Assessment</b>	Dia/Height:	<b>8"</b>
Use:	<b>Sanitary</b>	Material:	<b>PVC</b>
Drain Area:		Lining:	
Category:	<b>NA</b>		
Comment:

Location Details:		Direction of Survey:	<b>Upstream</b>
US MH:	<b>M-607-44</b>	DS MH:	<b>M-607-43</b>
		Total Length Surveyed (ft):	<b>96.3</b>

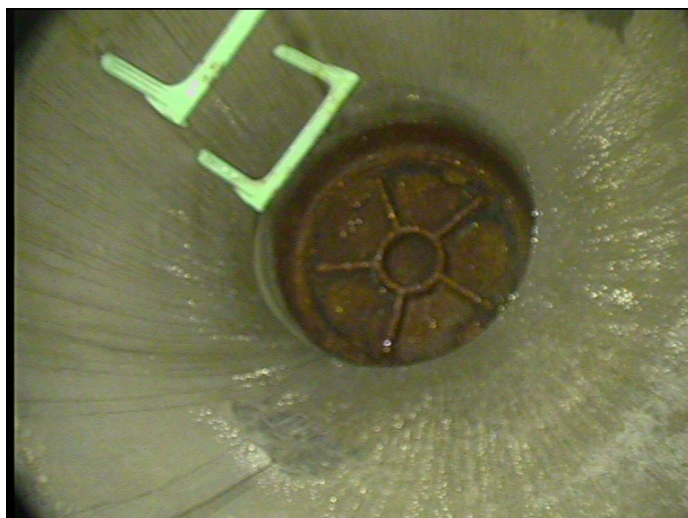
Code: **AMH**  
Description: **Manhole**

Distance (ft): **.0**  
Structural Grade: **0**  
O&M Grade: **0**  
Clock Start/From:  
Clock To:  
1st Value:  
2nd Value:  
Value Percent:  
Continuous Index:  
Within 8" of Joint: **NO**  
Remarks: **M-607-43**

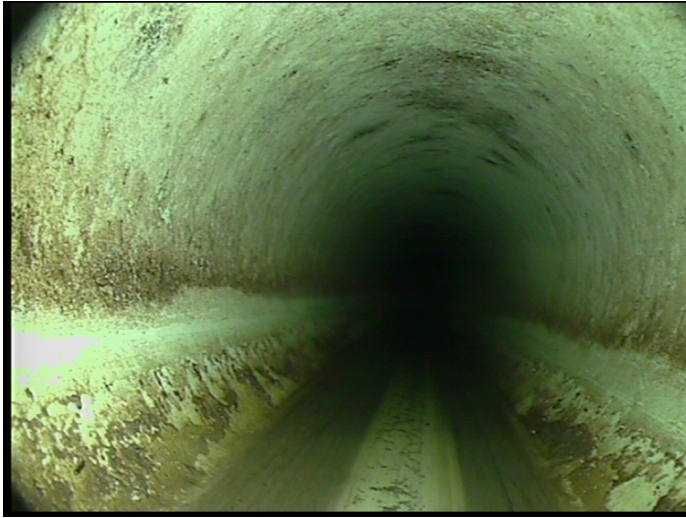
Code: **MWL**  
Description: **Water Level**

Distance (ft): **.0**  
Structural Grade: **0**  
O&M Grade: **0**  
Clock Start/From:  
Clock To:  
1st Value:  
2nd Value:  
Value Percent: **5.000**  
Continuous Index:  
Within 8" of Joint: **NO**  
Remarks:

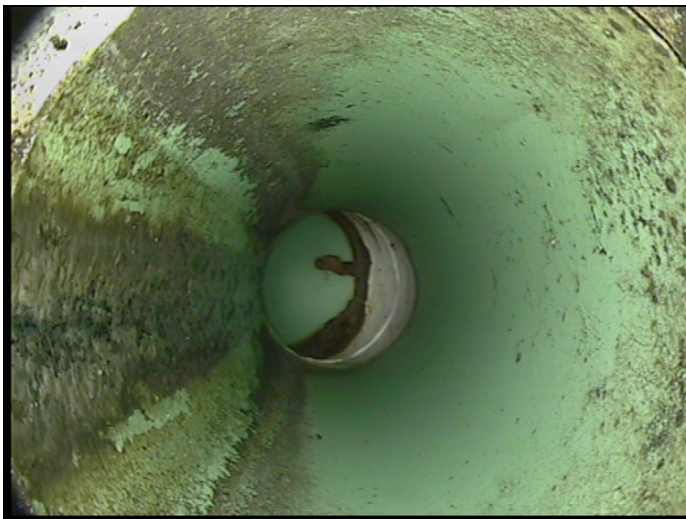
Code: **TFA**  
Description: **Tap Factory Active**

Distance (ft): **19.5**  
Structural Grade: **0**  
O&M Grade: **0**  
Clock Start/From: **10**  
Clock To:  
1st Value: **4.000**  
2nd Value:  
Value Percent:  
Continuous Index:  
Within 8" of Joint: **NO**  
Remarks:

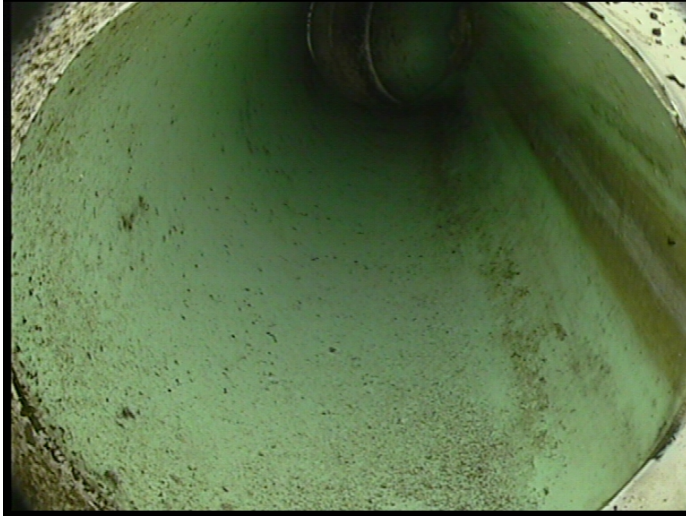
Code: **TF**  
Description: **Tap Factory**

Distance (ft): **21.3**  
Structural Grade: **0**  
O&M Grade: **0**  
Clock Start/From: **2**  
Clock To:  
1st Value: **4.000**  
2nd Value:  
Value Percent:  
Continuous Index:  
Within 8" of Joint: **NO**  
Remarks:

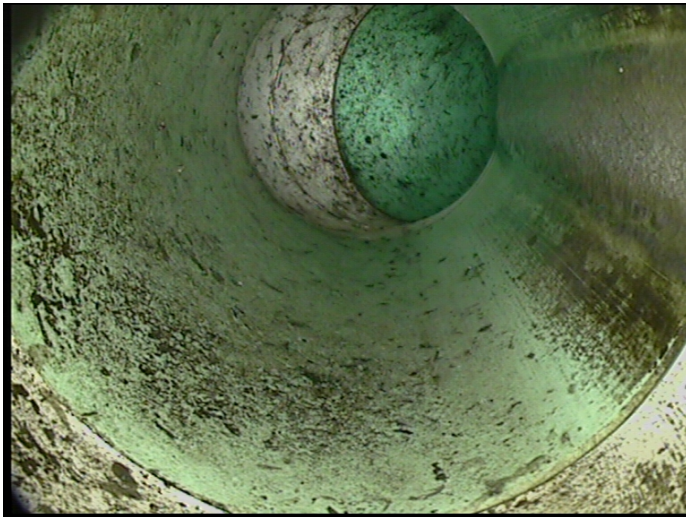
Code: **TF**  
Description: **Tap Factory**

Distance (ft): **85.8**  
Structural Grade: **0**  
O&M Grade: **0**  
Clock Start/From: **2**  
Clock To:  
1st Value: **4.000**  
2nd Value:  
Value Percent:  
Continuous Index:  
Within 8" of Joint: **NO**  
Remarks:

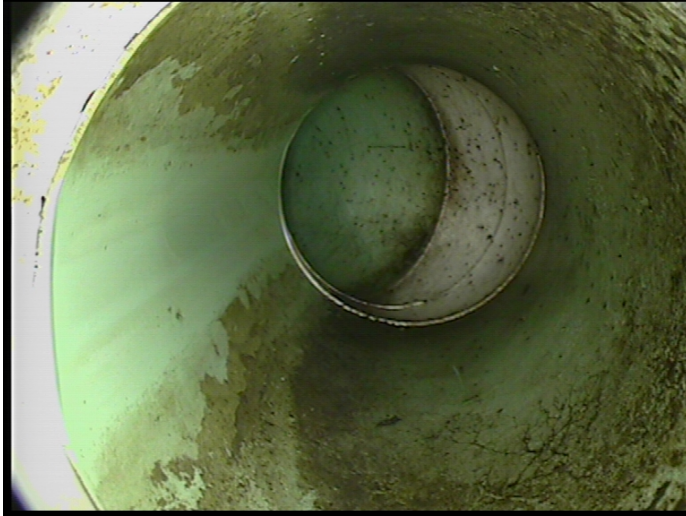
Code: **TF**  
Description: **Tap Factory**

Distance (ft): **87.4**  
Structural Grade: **0**  
O&M Grade: **0**  
Clock Start/From: **10**  
Clock To:  
1st Value: **4.000**  
2nd Value:  
Value Percent:  
Continuous Index:  
Within 8" of Joint: **NO**  
Remarks:

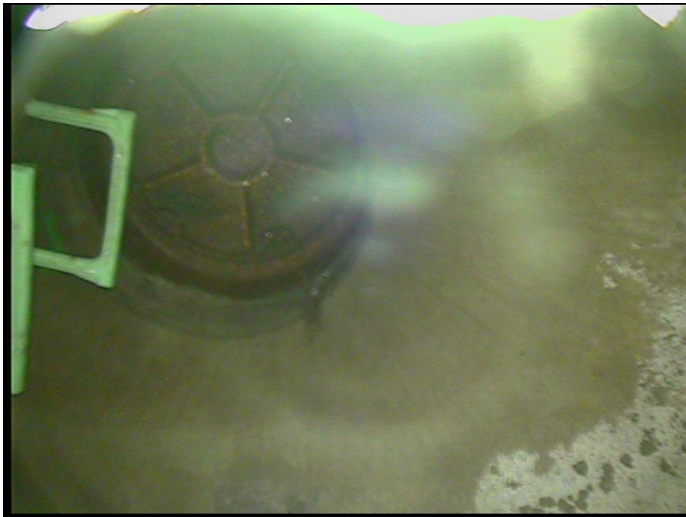
Code: **AMH**  
Description: **Manhole**

Distance (ft): **96.3**  
Structural Grade: **0**  
O&M Grade: **0**  
Clock Start/From:  
Clock To:  
1st Value:  
2nd Value:  
Value Percent:  
Continuous Index:  
Within 8" of Joint: **NO**  
Remarks: **M-607-44**
