Profile/Photo Observation Report

Street:	MEDLEE DR	Flow Control:	Not Controlled
City:	Hobart, IN	Year Renewed:	
Location:	Yard	Tape/Media #:	
Purpose:	Routine Assessment	Dia/Height:	8"
Use:	Sanitary	Material:	PVC
Drain Area:	NA	Lining:	
Category:	NA		
Comment:	Flow direction is marked wrong.

Location Details:		Direction of Survey:	Downstream
US MH:	M-607-046	DS MH:	M-607-044
		Total Length Surveyed (ft):	191.8

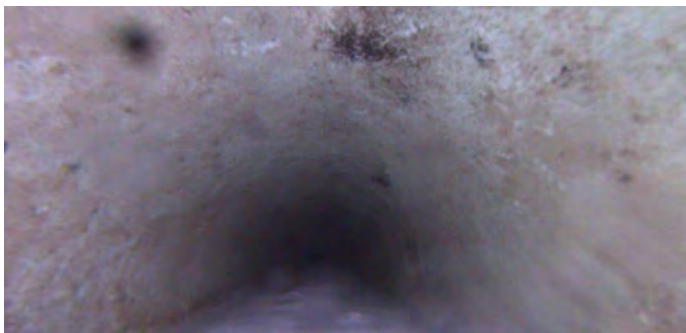
Code: **AMH**
Description: **Manhole**

Distance (ft): **.0**
Structural Grade: **0**
O&M Grade: **0**
Clock Start/From:
Clock To:
1st Value:
2nd Value:
Value Percent:
Continuous Index:
Within 8" of Joint: **NO**
Remarks: **M-607-046**

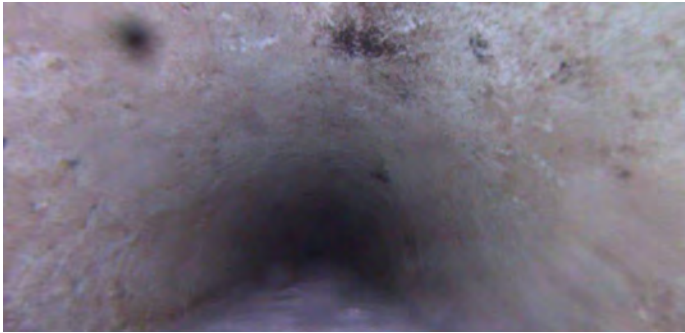
Code:	MWL
Description:	Water Level

Distance (ft):	.0
Structural Grade:	0
O&M Grade:	0
Clock Start/From:	
Clock To:	
1st Value:	
2nd Value:	
Value Percent:	20.000
Continuous Index:	
Within 8" of Joint:	NO
Remarks:

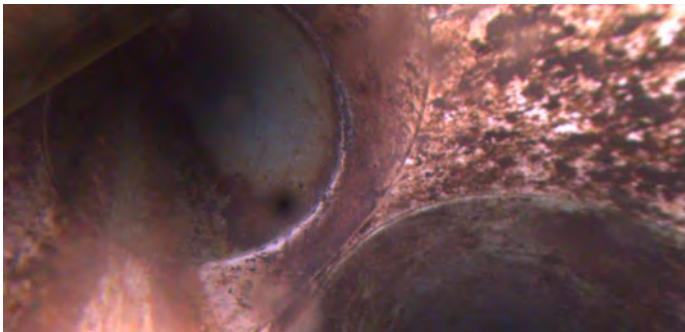
Code:	TFA
Description:	Tap Factory Active

Distance (ft):	41.3
Structural Grade:	0
O&M Grade:	0
Clock Start/From:	11
Clock To:	
1st Value:	4.000
2nd Value:	
Value Percent:	
Continuous Index:	
Within 8" of Joint:	
Remarks:

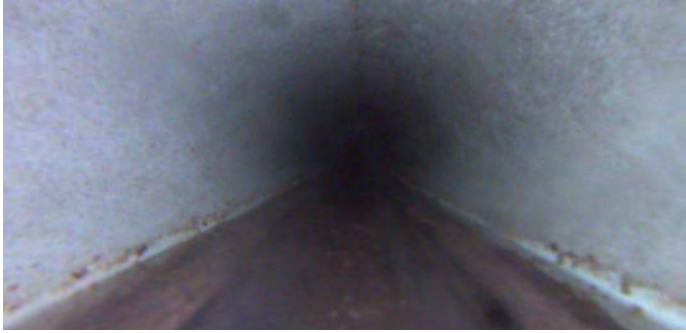
Code: **MWL**
Description: **Water Level**

Distance (ft): **81.0**
Structural Grade: **0**
O&M Grade: **0**
Clock Start/From:
Clock To:
1st Value:
2nd Value:
Value Percent: **20.000**
Continuous Index:
Within 8" of Joint: **NO**
Remarks:

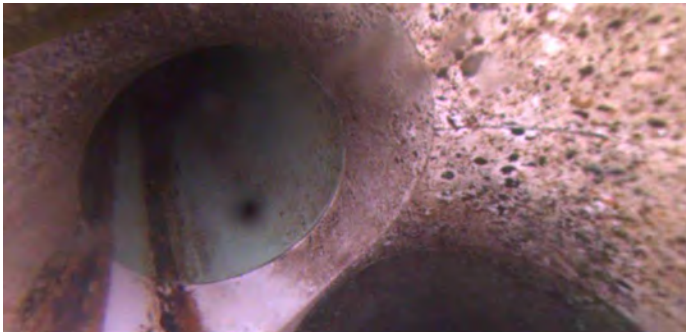
Code: **TF**
Description: **Tap Factory**

Distance (ft): **96.9**
Structural Grade: **0**
O&M Grade: **0**
Clock Start/From: **11**
Clock To:
1st Value: **4.000**
2nd Value:
Value Percent:
Continuous Index:
Within 8" of Joint:
Remarks:

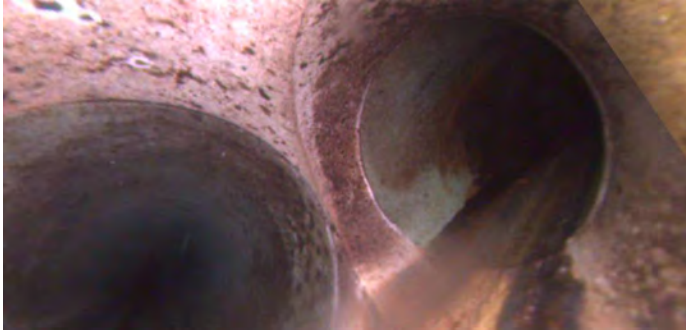
Code: **TFA**
Description: **Tap Factory Active**

Distance (ft): **136.1**
Structural Grade: **0**
O&M Grade: **0**
Clock Start/From: **2**
Clock To:
1st Value: **4.000**
2nd Value:
Value Percent:
Continuous Index:
Within 8" of Joint:
Remarks:

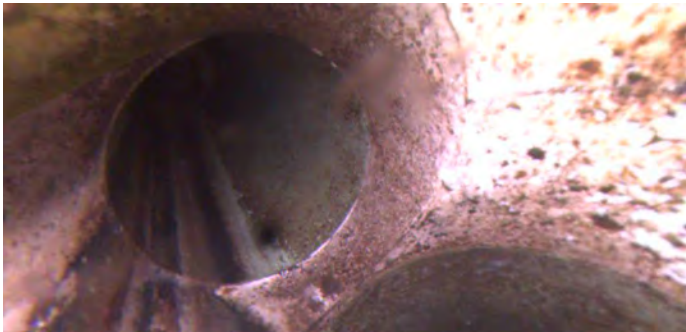
Code: **TF**
Description: **Tap Factory**

Distance (ft): **149.6**
Structural Grade: **0**
O&M Grade: **0**
Clock Start/From: **11**
Clock To:
1st Value: **4.000**
2nd Value:
Value Percent:
Continuous Index:
Within 8" of Joint:
Remarks:

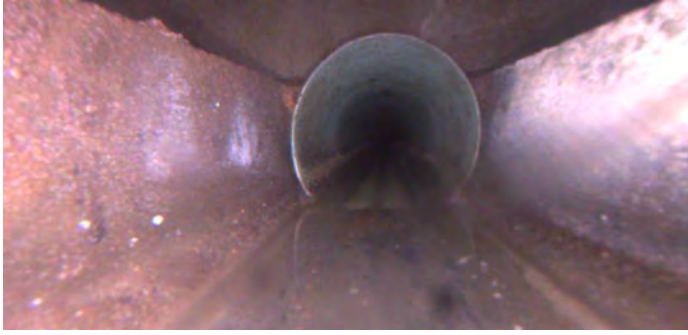
Code:	AMH
Description:	Manhole
Distance (ft):	191.8
Structural Grade:	0
O&M Grade:	0
Clock Start/From:	
Clock To:	
1st Value:	
2nd Value:	
Value Percent:	
Continuous Index:	
Within 8" of Joint:	NO
Remarks:	M-607-044
