Profile/Photo Observation Report

| Street: | FOXCROFT STREET | Flow Control: | Not Controlled |
| City: | Hobart, IN | Year Renewed: | |

| US MH: | M-607-046 | DS MH: | M-607-044 |

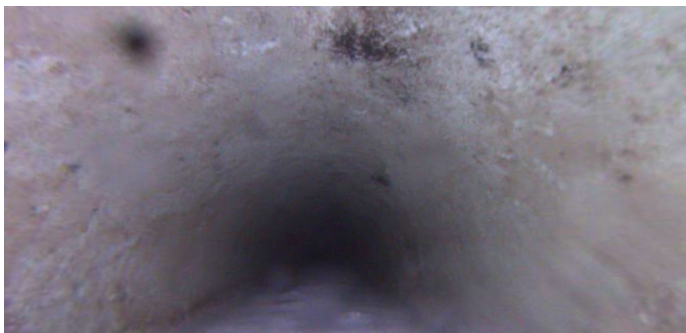
Code: **AMH**
Description: **Manhole**

Distance (ft): **.0**
Structural Grade: **0**
O&M Grade: **0**
Clock Start/From:
Clock To:
1st Value:
2nd Value:
Value Percent:
Continuous Index:
Within 8" of Joint: **NO**
Remarks: **M-607-046**

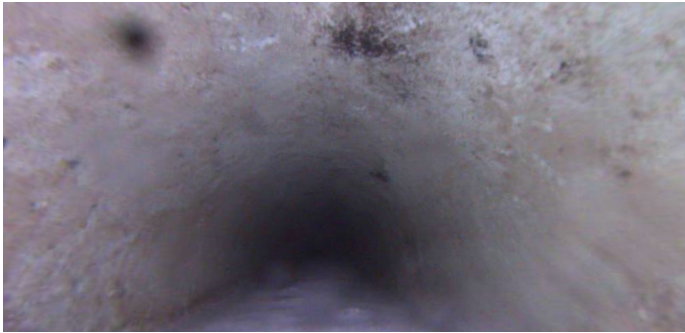
| Code: | MWL |

| Description: | Water Level |

| Distance (ft): | .0 |
| Value Percent: | 20.000 |

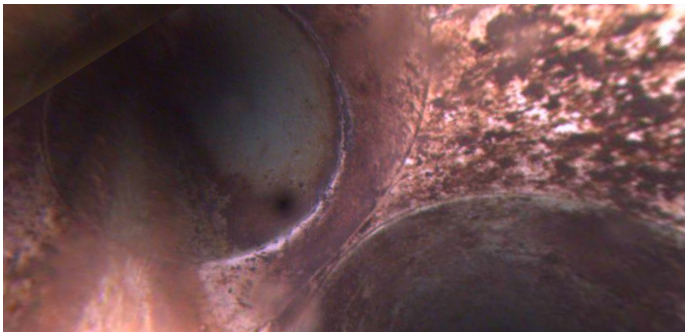
| Code: | TFA |

| Description: | Tap Factory Active |

| Distance (ft): | 41.3 |
| Clock Start/From: | 11 |
| 1st Value: | 4.000 |

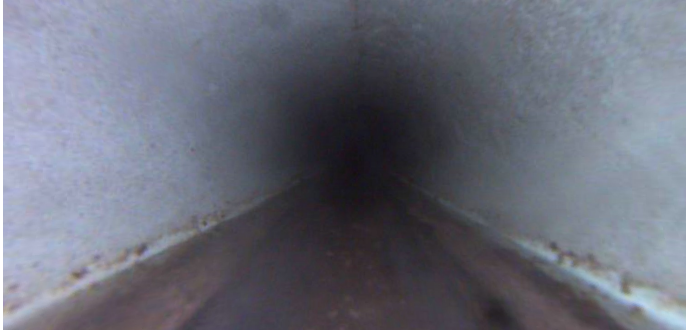
Code: **MWL**
Description: **Water Level**

Distance (ft): **81.0**
Structural Grade: **0**
O&M Grade: **0**
Clock Start/From:
Clock To:
1st Value:
2nd Value:
Value Percent: **20.000**
Continuous Index:
Within 8" of Joint: **NO**
Remarks:

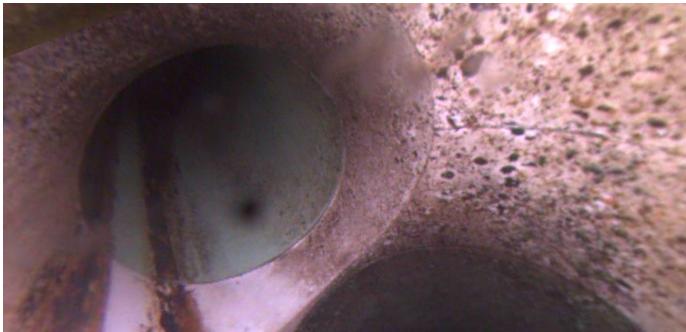
Code: **TF**
Description: **Tap Factory**

Distance (ft): **96.9**
Structural Grade: **0**
O&M Grade: **0**
Clock Start/From: **11**
Clock To:
1st Value: **4.000**
2nd Value:
Value Percent:
Continuous Index:
Within 8" of Joint:
Remarks:

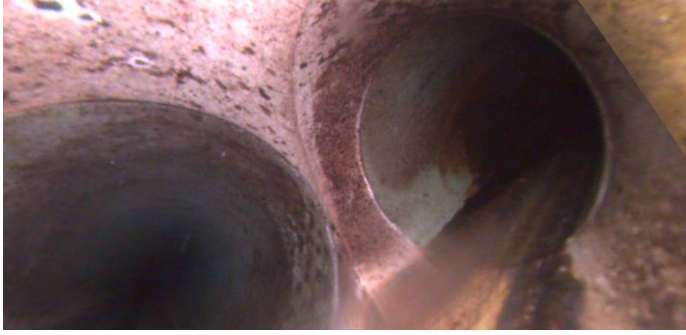
Code: **TFA**
Description: **Tap Factory Active**

Distance (ft): **136.1**
Structural Grade: **0**
O&M Grade: **0**
Clock Start/From: **2**
Clock To:
1st Value: **4.000**
2nd Value:
Value Percent:
Continuous Index:
Within 8" of Joint:
Remarks:

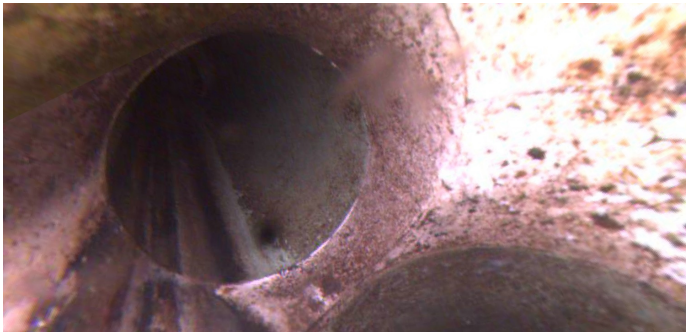
Code: **TF**
Description: **Tap Factory**

Distance (ft): **149.6**
Structural Grade: **0**
O&M Grade: **0**
Clock Start/From: **11**
Clock To:
1st Value: **4.000**
2nd Value:
Value Percent:
Continuous Index:
Within 8" of Joint:
Remarks:

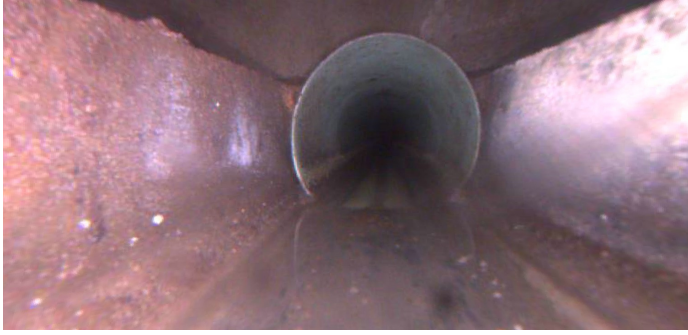
| Code: | AMH |

| Description: | Manhole |
| Distance (ft): | 191.8 |
| Remarks: | M-607-044 |
