Profile/Photo Observation Report

Street:	MEDLEE DR & FATIMA LN	Flow Control:	Not Controlled
City:	Hobart, IN	Year Renewed:	
Location:	Yard	Tape/Media #:	
Purpose:	Routine Assessment	Dia/Height:	8"
Use:	Sanitary	Material:	PVC
Drain Area:	NA	Lining:	
Category:	NA		
Comment:	Flow direction is marked wrong.

Location Details:		Direction of Survey:	Downstream
US MH:	M-607-046	DS MH:	M-607-045
		Total Length Surveyed (ft):	331.8

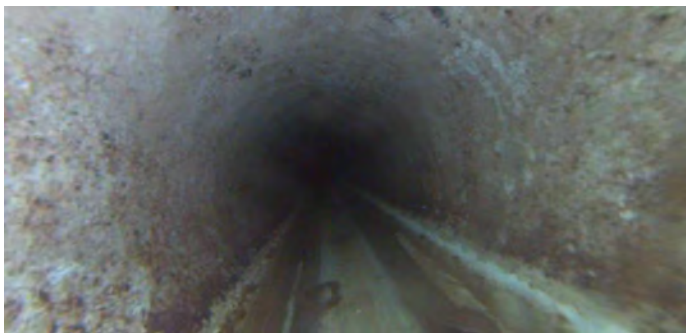
Code: **AMH**
Description: **Manhole**

Distance (ft): **.0**
Structural Grade: **0**
O&M Grade: **0**
Clock Start/From:
Clock To:
1st Value:
2nd Value:
Value Percent:
Continuous Index:
Within 8" of Joint: **NO**
Remarks: **M-607-046**

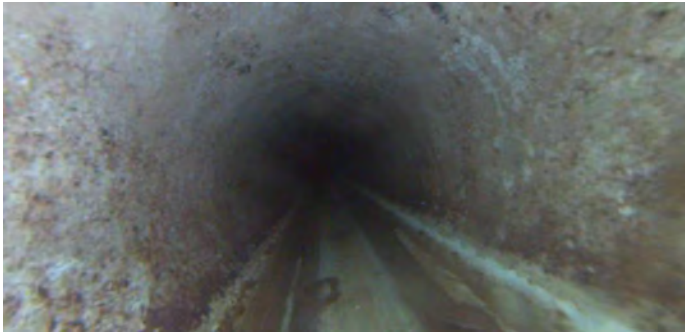
Code:	MWL
Description:	Water Level

Distance (ft):	.0
Structural Grade:	0
O&M Grade:	0
Clock Start/From:	
Clock To:	
1st Value:	
2nd Value:	
Value Percent:	5.000
Continuous Index:	
Within 8" of Joint:	NO
Remarks:

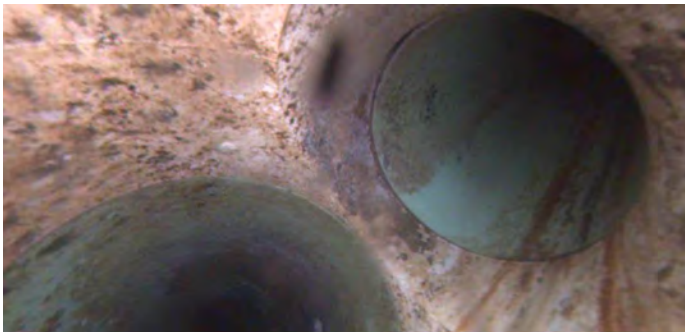
Code:	TF
Description:	Tap Factory

Distance (ft):	96.2
Structural Grade:	0
O&M Grade:	0
Clock Start/From:	2
Clock To:	
1st Value:	4.000
2nd Value:	
Value Percent:	
Continuous Index:	
Within 8" of Joint:	
Remarks:

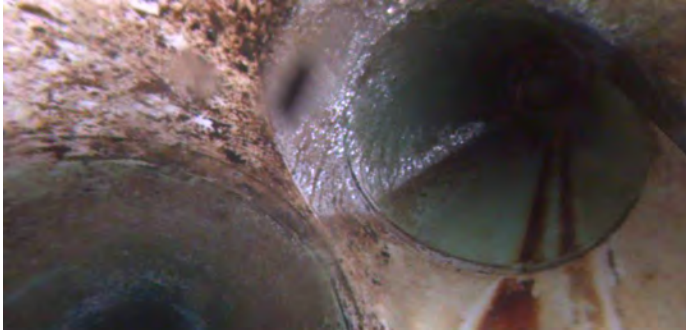
Code: **TF**
Description: **Tap Factory**

Distance (ft): **164.8**
Structural Grade: **0**
O&M Grade: **0**
Clock Start/From: **2**
Clock To:
1st Value: **4.000**
2nd Value:
Value Percent:
Continuous Index:
Within 8" of Joint:
Remarks:

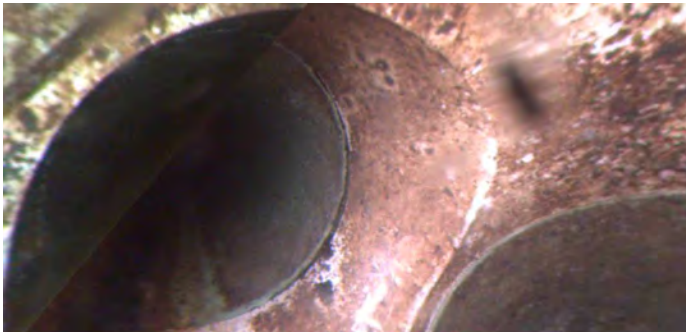
Code: **TF**
Description: **Tap Factory**

Distance (ft): **188.5**
Structural Grade: **0**
O&M Grade: **0**
Clock Start/From: **10**
Clock To:
1st Value: **4.000**
2nd Value:
Value Percent:
Continuous Index:
Within 8" of Joint:
Remarks:

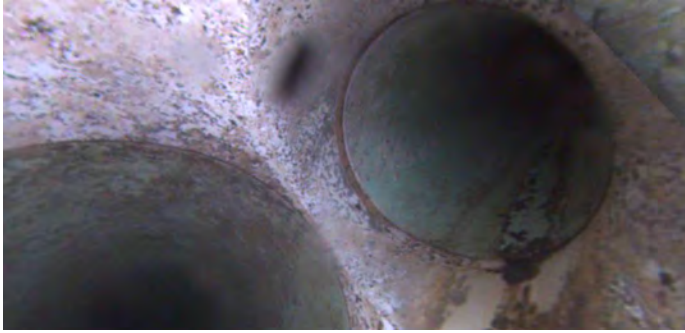
Code: **TF**
Description: **Tap Factory**

Distance (ft): **222.8**
Structural Grade: **0**
O&M Grade: **0**
Clock Start/From: **2**
Clock To:
1st Value: **4.000**
2nd Value:
Value Percent:
Continuous Index:
Within 8" of Joint:
Remarks:

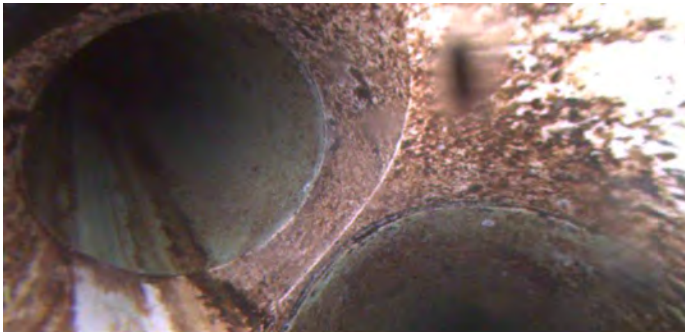
Code: **TF**
Description: **Tap Factory**

Distance (ft): **241.8**
Structural Grade: **0**
O&M Grade: **0**
Clock Start/From: **11**
Clock To:
1st Value: **4.000**
2nd Value:
Value Percent:
Continuous Index:
Within 8" of Joint:
Remarks:

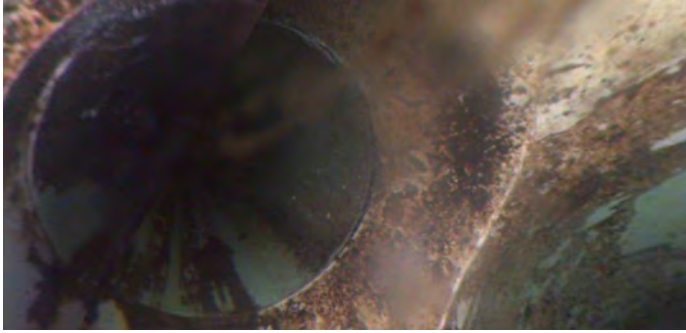
Code: **TF**
Description: **Tap Factory**

Distance (ft): **282.5**
Structural Grade: **0**
O&M Grade: **0**
Clock Start/From: **2**
Clock To:
1st Value: **4.000**
2nd Value:
Value Percent:
Continuous Index:
Within 8" of Joint:
Remarks:

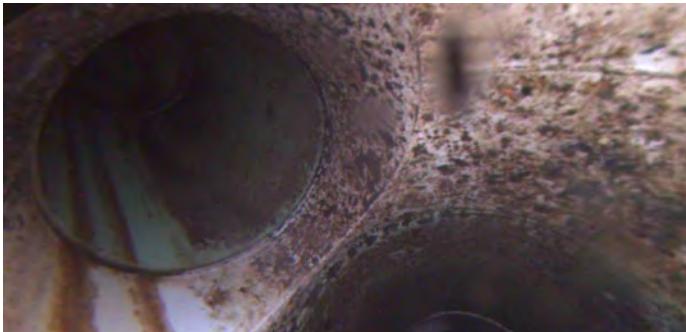
Code: **TF**
Description: **Tap Factory**

Distance (ft): **292.7**
Structural Grade: **0**
O&M Grade: **0**
Clock Start/From: **10**
Clock To:
1st Value: **4.000**
2nd Value:
Value Percent:
Continuous Index:
Within 8" of Joint:
Remarks:

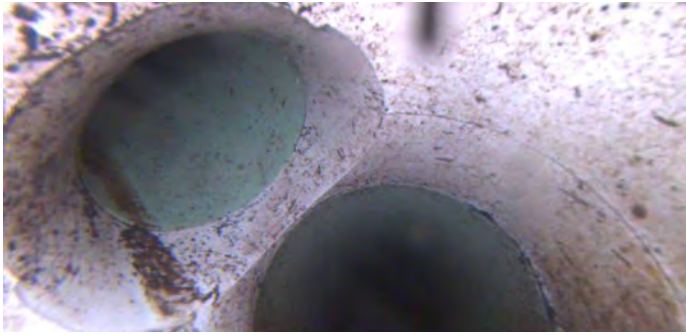
Code: **TF**
Description: **Tap Factory**

Distance (ft): **294.1**
Structural Grade: **0**
O&M Grade: **0**
Clock Start/From: **10**
Clock To:
1st Value: **4.000**
2nd Value:
Value Percent:
Continuous Index:
Within 8" of Joint:
Remarks:

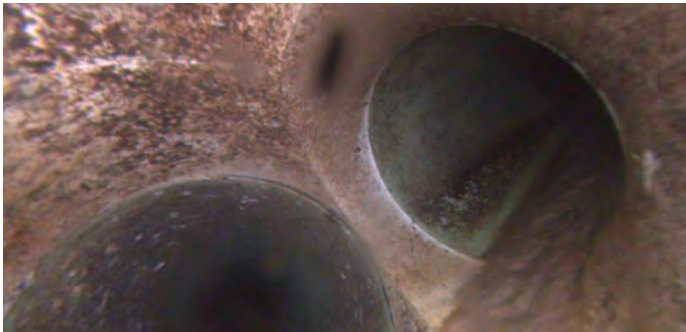
Code: **TFA**
Description: **Tap Factory Active**

Distance (ft): **324.1**
Structural Grade: **0**
O&M Grade: **0**
Clock Start/From: **2**
Clock To:
1st Value: **4.000**
2nd Value:
Value Percent:
Continuous Index:
Within 8" of Joint:
Remarks:

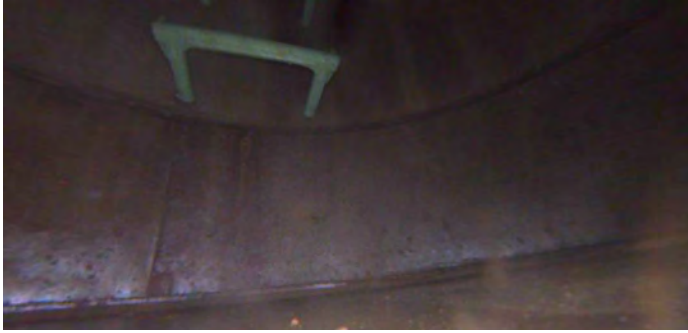
Code:	AMH
Description:	Manhole
Distance (ft):	331.8
Structural Grade:	0
O&M Grade:	0
Clock Start/From:	
Clock To:	
1st Value:	
2nd Value:	
Value Percent:	
Continuous Index:	
Within 8" of Joint:	NO
Remarks:	M-607-045
