## Profile/Photo Observation Report

Date:	<b>04/03/2018</b>	Weather:		Coding:	<b>PACP 6.0</b>
Pipe Length (ft):	<b>340.7</b>	Owner:	<b>NA</b>	Pre Clean:	<b>No Pre-Cleaning</b>
P.O.#:		Surveyor:	<b>Jen Costello</b>	PSR:	<b>P-607-045-046</b>
Customer:		Clean Date:	<b>01/01/1900</b>	Shape:	<b>C</b>

Street:	<b>FOXCROFT STREET</b>	Flow Control:	<b>Not Controlled</b>
City:	<b>Hobart, IN</b>	Year Renewed:	
Location:	<b>Yard</b>	Tape/Media #:	
Purpose:	<b>Routine Assessment</b>	Dia/Height:	<b>8"</b>
Use:	<b>Sanitary</b>	Material:	<b>PVC</b>
Drain Area:	<b>NA</b>	Lining:	
Category:	<b>NA</b>		
Comment:	<b>Flow direction is marked wrong.</b>

Location Details:		Direction of Survey:	<b>Downstream</b>
US MH:	<b>M-607-046</b>	DS MH:	<b>M-607-045</b>
		Total Length Surveyed (ft):	<b>331.8</b>

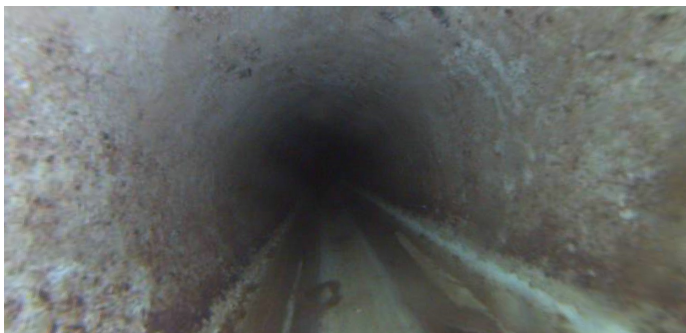
Code: **AMH**  
Description: **Manhole**

Distance (ft): **.0**  
Structural Grade: **0**  
O&M Grade: **0**  
Clock Start/From:  
Clock To:  
1st Value:  
2nd Value:  
Value Percent:  
Continuous Index:  
Within 8" of Joint: **NO**  
Remarks: **M-607-046**

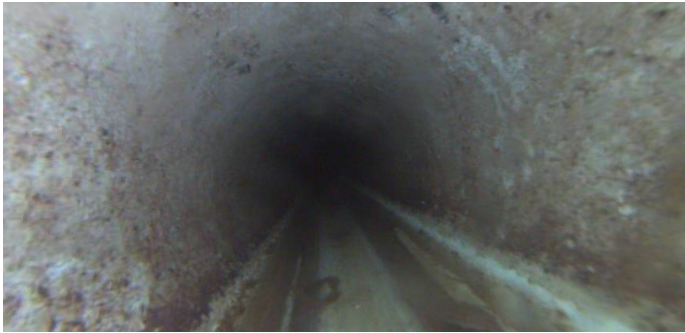
Code:	<b>MWL</b>
Description:	<b>Water Level</b>

Distance (ft):	<b>.0</b>
Structural Grade:	<b>0</b>
O&M Grade:	<b>0</b>
Clock Start/From:	
Clock To:	
1st Value:	
2nd Value:	
Value Percent:	<b>5.000</b>
Continuous Index:	
Within 8" of Joint:	<b>NO</b>
Remarks:

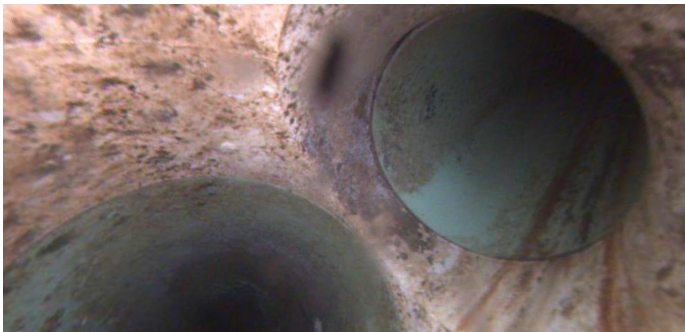
Code:	<b>TF</b>
Description:	<b>Tap Factory</b>

Distance (ft):	<b>96.2</b>
Structural Grade:	<b>0</b>
O&M Grade:	<b>0</b>
Clock Start/From:	<b>2</b>
Clock To:	
1st Value:	<b>4.000</b>
2nd Value:	
Value Percent:	
Continuous Index:	
Within 8" of Joint:	
Remarks:

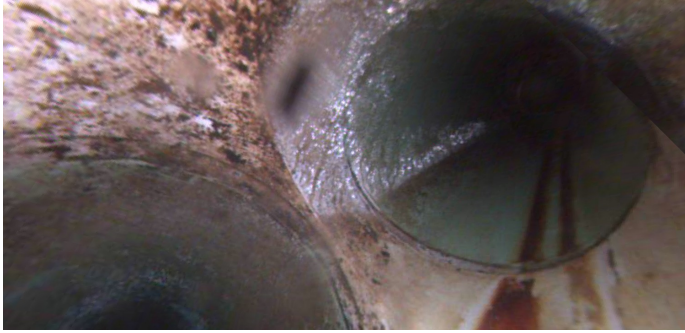
Code: **TF**  
Description: **Tap Factory**

Distance (ft): **164.8**  
Structural Grade: **0**  
O&M Grade: **0**  
Clock Start/From: **2**  
Clock To:  
1st Value: **4.000**  
2nd Value:  
Value Percent:  
Continuous Index:  
Within 8" of Joint:  
Remarks:

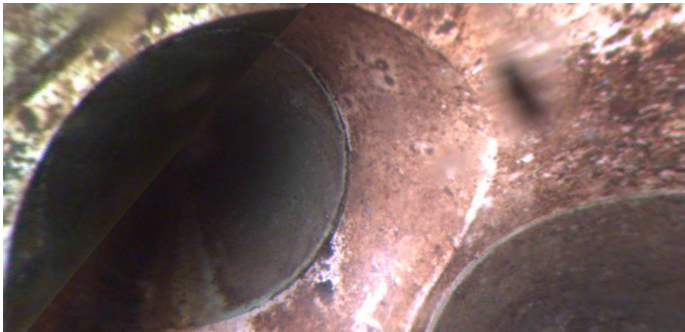
Code: **TF**  
Description: **Tap Factory**

Distance (ft): **188.5**  
Structural Grade: **0**  
O&M Grade: **0**  
Clock Start/From: **10**  
Clock To:  
1st Value: **4.000**  
2nd Value:  
Value Percent:  
Continuous Index:  
Within 8" of Joint:  
Remarks:

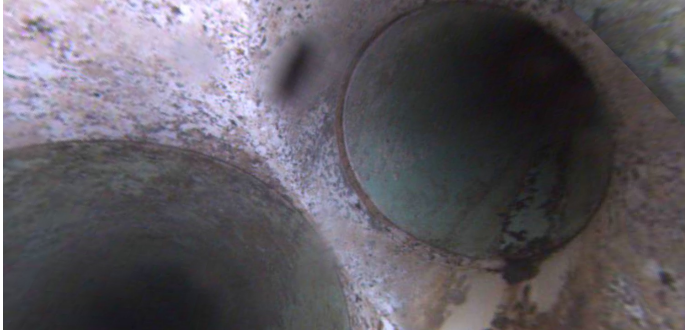
Code: **TF**  
Description: **Tap Factory**

Distance (ft): **222.8**  
Structural Grade: **0**  
O&M Grade: **0**  
Clock Start/From: **2**  
Clock To:  
1st Value: **4.000**  
2nd Value:  
Value Percent:  
Continuous Index:  
Within 8" of Joint:  
Remarks:

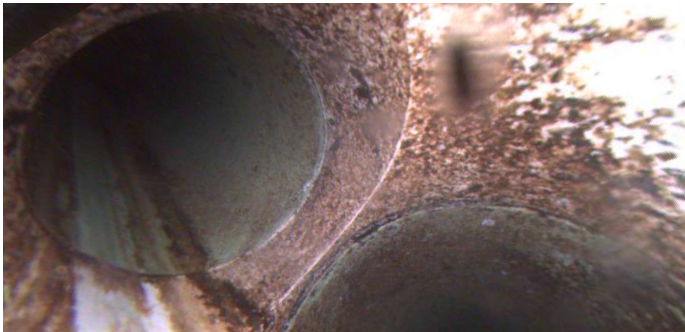
Code: **TF**  
Description: **Tap Factory**

Distance (ft): **241.8**  
Structural Grade: **0**  
O&M Grade: **0**  
Clock Start/From: **11**  
Clock To:  
1st Value: **4.000**  
2nd Value:  
Value Percent:  
Continuous Index:  
Within 8" of Joint:  
Remarks:

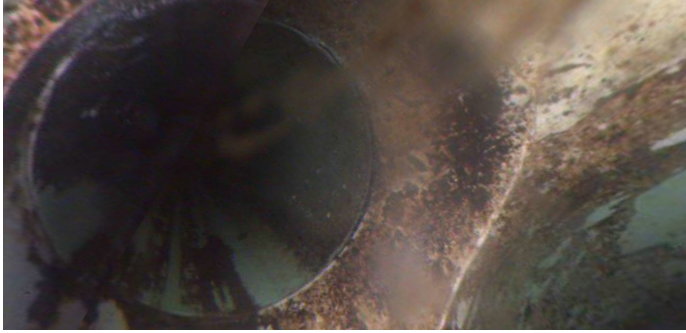
Code: **TF**  
Description: **Tap Factory**

Distance (ft): **282.5**  
Structural Grade: **0**  
O&M Grade: **0**  
Clock Start/From: **2**  
Clock To:  
1st Value: **4.000**  
2nd Value:  
Value Percent:  
Continuous Index:  
Within 8" of Joint:  
Remarks:

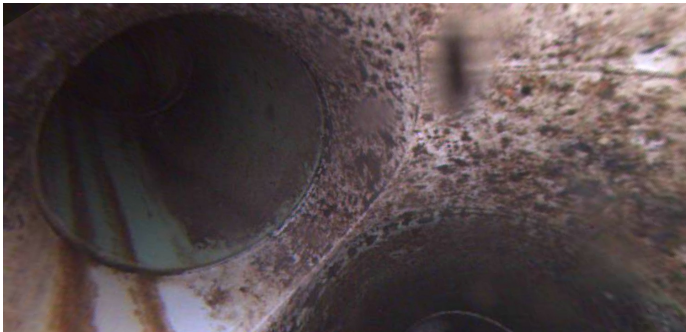
Code: **TF**  
Description: **Tap Factory**

Distance (ft): **292.7**  
Structural Grade: **0**  
O&M Grade: **0**  
Clock Start/From: **10**  
Clock To:  
1st Value: **4.000**  
2nd Value:  
Value Percent:  
Continuous Index:  
Within 8" of Joint:  
Remarks:

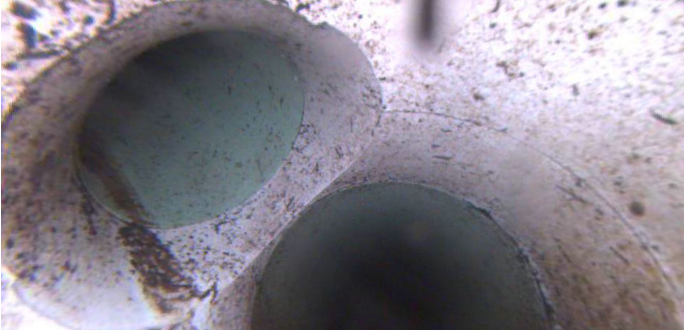
Code: **TF**  
Description: **Tap Factory**

Distance (ft): **294.1**  
Structural Grade: **0**  
O&M Grade: **0**  
Clock Start/From: **10**  
Clock To:  
1st Value: **4.000**  
2nd Value:  
Value Percent:  
Continuous Index:  
Within 8" of Joint:  
Remarks:

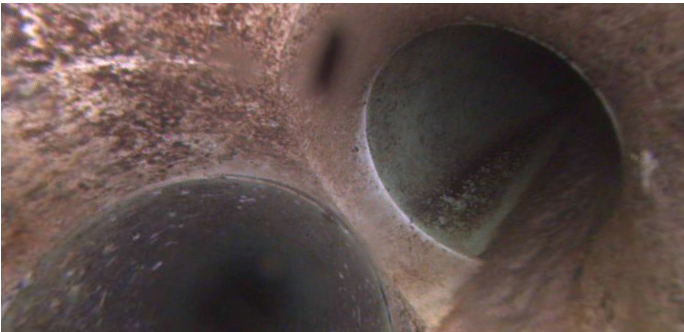
Code: **TFA**  
Description: **Tap Factory Active**

Distance (ft): **324.1**  
Structural Grade: **0**  
O&M Grade: **0**  
Clock Start/From: **2**  
Clock To:  
1st Value: **4.000**  
2nd Value:  
Value Percent:  
Continuous Index:  
Within 8" of Joint:  
Remarks:

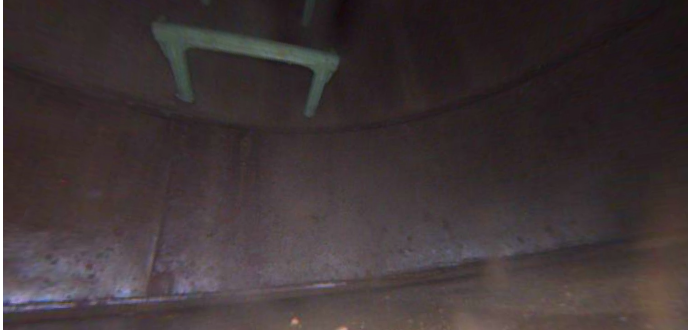
Code:	AMH
Description:	Manhole
Distance (ft):	331.8
Structural Grade:	0
O&M Grade:	0
Clock Start/From:	
Clock To:	
1st Value:	
2nd Value:	
Value Percent:	
Continuous Index:	
Within 8" of Joint:	NO
Remarks:	M-607-045
