## Profile/Photo Observation Report

Street:	<b>MEDLEE DR</b>	Flow Control:	<b>Not Controlled</b>
City:	<b>Hobart, IN</b>	Year Renewed:	
Location:	<b>Yard</b>	Tape/Media #:	
Purpose:	<b>Routine Assessment</b>	Dia/Height:	<b>8"</b>
Use:	<b>Sanitary</b>	Material:	<b>PVC</b>
Drain Area:	<b>NA</b>	Lining:	
Category:	<b>NA</b>		
Comment:	<b>Flow direction is marked wrong.</b>

Location Details:		Direction of Survey:	<b>Upstream</b>
US MH:	<b>M-607-047</b>	DS MH:	<b>M-607-046</b>
		Total Length Surveyed (ft):	<b>163.7</b>

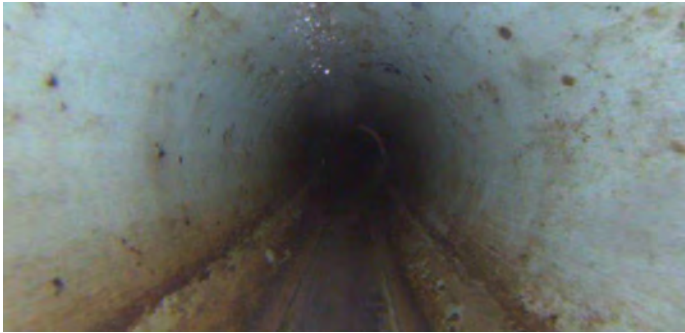
Code:	<b>MWL</b>
Description:	<b>Water Level</b>

Distance (ft):	<b>.0</b>
Structural Grade:	<b>0</b>
O&M Grade:	<b>0</b>
Clock Start/From:	
Clock To:	
1st Value:	
2nd Value:	
Value Percent:	<b>5.000</b>
Continuous Index:	
Within 8" of Joint:	<b>NO</b>
Remarks:

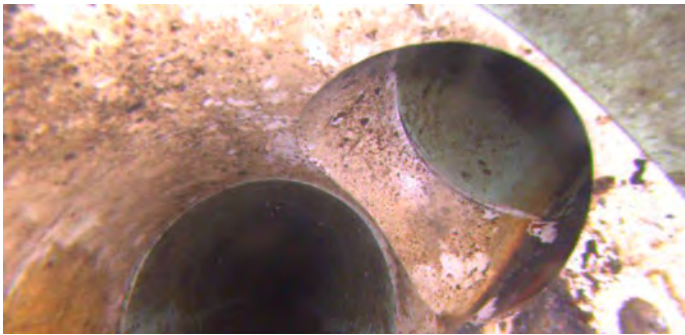
Code:	<b>TF</b>
Description:	<b>Tap Factory</b>

Distance (ft):	<b>3.7</b>
Structural Grade:	<b>0</b>
O&M Grade:	<b>0</b>
Clock Start/From:	<b>2</b>
Clock To:	
1st Value:	<b>4.000</b>
2nd Value:	
Value Percent:	
Continuous Index:	
Within 8" of Joint:	
Remarks:

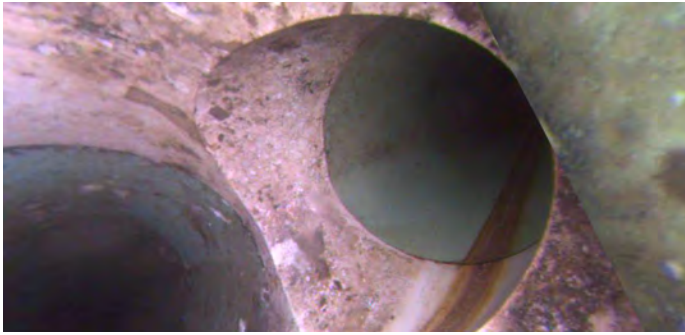
Code: **TF**  
Description: **Tap Factory**

Distance (ft): **68.9**  
Structural Grade: **0**  
O&M Grade: **0**  
Clock Start/From: **2**  
Clock To:  
1st Value: **4.000**  
2nd Value:  
Value Percent:  
Continuous Index:  
Within 8" of Joint:  
Remarks:

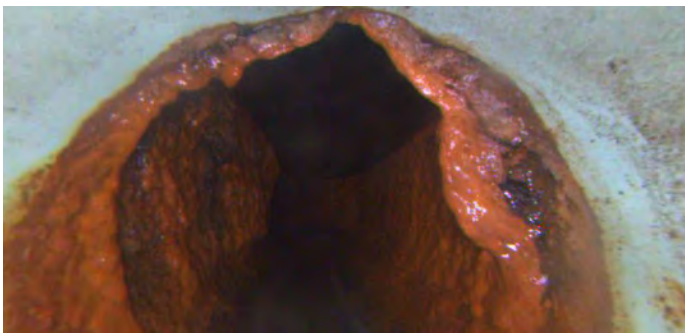
Code: **DAE**  
Description: **Deposits Attached Encrustation**

Distance (ft): **161.4**  
Structural Grade: **0**  
O&M Grade: **2**  
Clock Start/From: **8**  
Clock To: **4**  
1st Value:  
2nd Value:  
Value Percent: **10.000**  
Continuous Index:  
Within 8" of Joint: **NO**  
Remarks: **FROM MH**

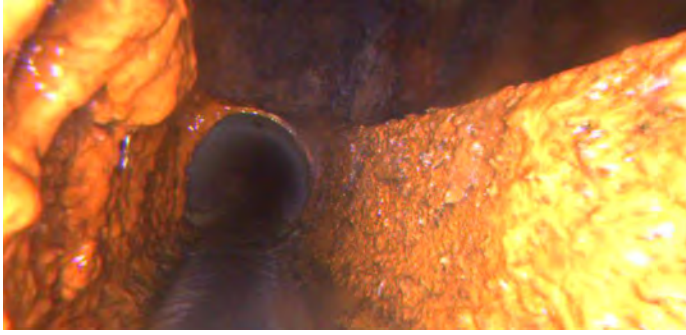
Code:	AMH
Description:	Manhole
Distance (ft):	163.7
Structural Grade:	0
O&M Grade:	0
Clock Start/From:	
Clock To:	
1st Value:	
2nd Value:	
Value Percent:	
Continuous Index:	
Within 8" of Joint:	NO
Remarks:	M-607-047
