Profile/Photo Observation Report

Street:	FOXCROFT STREET	Flow Control:	Not Controlled
City:	Hobart, IN	Year Renewed:	
Location:	Yard	Tape/Media #:	
Purpose:	Routine Assessment	Dia/Height:	8"
Use:	Sanitary	Material:	PVC
Drain Area:	NA	Lining:	
Category:	NA		
Comment:	Flow direction is marked wrong.

Location Details:		Direction of Survey:	Upstream
US MH:	M-607-047	DS MH:	M-607-046
		Total Length Surveyed (ft):	163.7

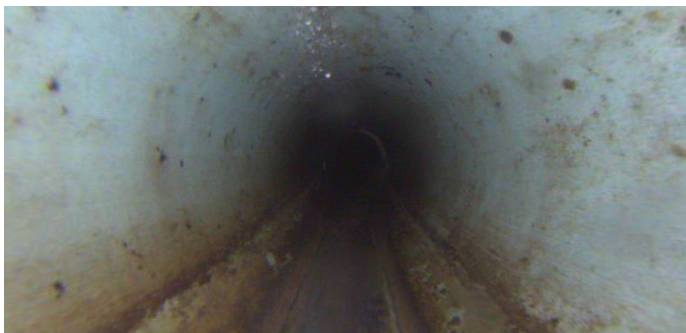
Code: **AMH**
Description: **Manhole**

Distance (ft): **.0**
Structural Grade: **0**
O&M Grade: **0**
Clock Start/From:
Clock To:
1st Value:
2nd Value:
Value Percent:
Continuous Index:
Within 8" of Joint: **NO**
Remarks: **M-607-046**

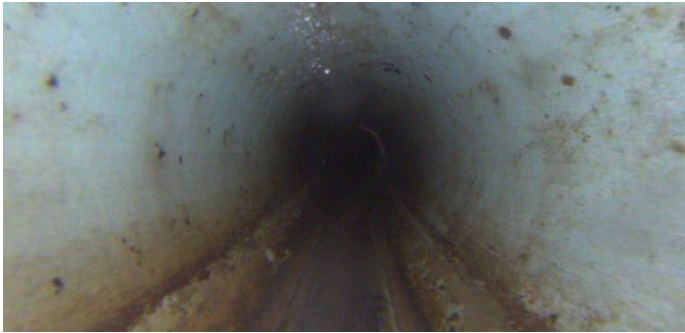
Code:	MWL
Description:	Water Level

Distance (ft):	.0
Structural Grade:	0
O&M Grade:	0
Clock Start/From:	
Clock To:	
1st Value:	
2nd Value:	
Value Percent:	5.000
Continuous Index:	
Within 8" of Joint:	NO
Remarks:

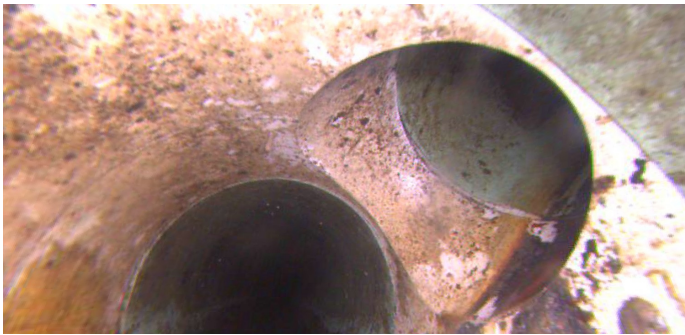
Code:	TF
Description:	Tap Factory

Distance (ft):	3.7
Structural Grade:	0
O&M Grade:	0
Clock Start/From:	2
Clock To:	
1st Value:	4.000
2nd Value:	
Value Percent:	
Continuous Index:	
Within 8" of Joint:	
Remarks:

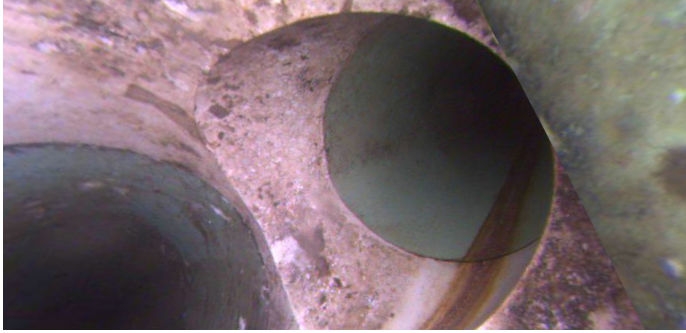
Code: **TF**
Description: **Tap Factory**

Distance (ft): **68.9**
Structural Grade: **0**
O&M Grade: **0**
Clock Start/From: **2**
Clock To:
1st Value: **4.000**
2nd Value:
Value Percent:
Continuous Index:
Within 8" of Joint:
Remarks:

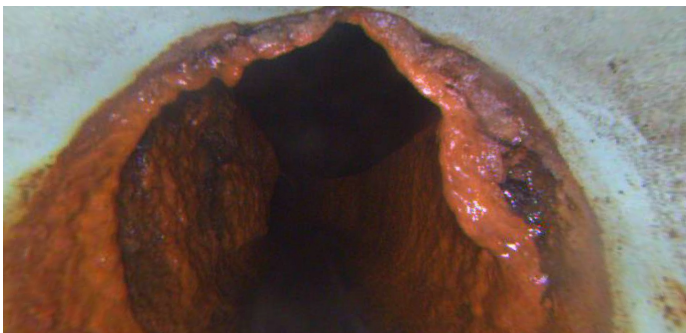
Code: **DAE**
Description: **Deposits Attached Encrustation**

Distance (ft): **161.4**
Structural Grade: **0**
O&M Grade: **2**
Clock Start/From: **8**
Clock To: **4**
1st Value:
2nd Value:
Value Percent: **10.000**
Continuous Index:
Within 8" of Joint: **NO**
Remarks: **FROM MH**

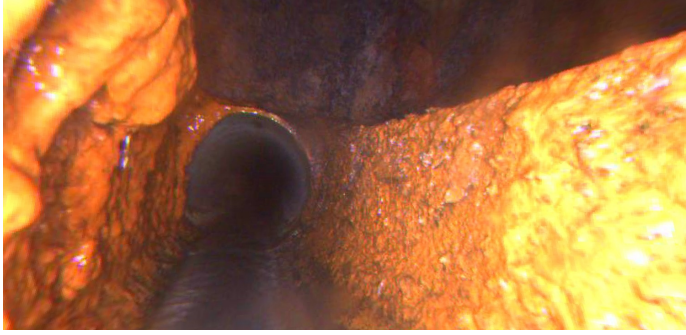
Code:	AMH
Description:	Manhole
Distance (ft):	163.7
Structural Grade:	0
O&M Grade:	0
Clock Start/From:	
Clock To:	
1st Value:	
2nd Value:	
Value Percent:	
Continuous Index:	
Within 8" of Joint:	NO
Remarks:	M-607-047
