Profile/Photo Observation Report

Street:	FOXCROFT STREET	Flow Control:	Not Controlled
City:	Hobart, IN	Year Renewed:	
Location:	Yard	Tape/Media #:	
Purpose:	Routine Assessment	Dia/Height:	8"
Use:	Sanitary	Material:	PVC
Drain Area:	NA	Lining:	
Category:	NA		
Comment:	Flow direction is marked wrong.

Location Details:		Direction of Survey:	Downstream
US MH:	M-607-048	DS MH:	M-607-047
		Total Length Surveyed (ft):	115.7

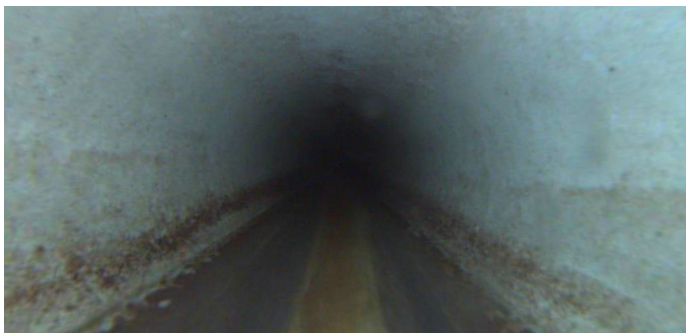
Code: **AMH**
Description: **Manhole**

Distance (ft): **.0**
Structural Grade: **0**
O&M Grade: **0**
Clock Start/From:
Clock To:
1st Value:
2nd Value:
Value Percent:
Continuous Index:
Within 8" of Joint: **NO**
Remarks: **M-607-048**

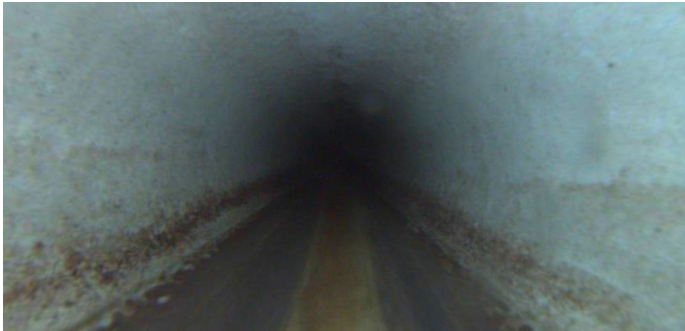
Code:	MWL
Description:	Water Level

Distance (ft):	.0
Structural Grade:	0
O&M Grade:	0
Clock Start/From:	
Clock To:	
1st Value:	
2nd Value:	
Value Percent:	5.000
Continuous Index:	
Within 8" of Joint:	NO
Remarks:

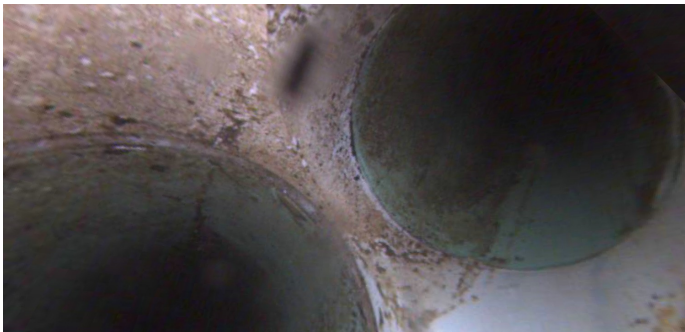
Code:	TF
Description:	Tap Factory

Distance (ft):	12.4
Structural Grade:	0
O&M Grade:	0
Clock Start/From:	2
Clock To:	
1st Value:	4.000
2nd Value:	
Value Percent:	
Continuous Index:	
Within 8" of Joint:	
Remarks:

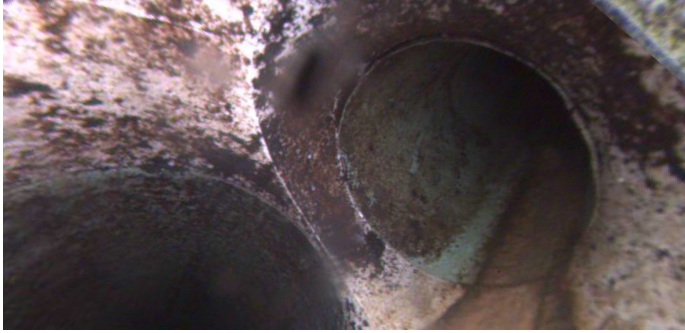
Code: **TFA**
Description: **Tap Factory Active**

Distance (ft): **93.0**
Structural Grade: **0**
O&M Grade: **0**
Clock Start/From: **2**
Clock To:
1st Value: **4.000**
2nd Value:
Value Percent:
Continuous Index:
Within 8" of Joint:
Remarks:

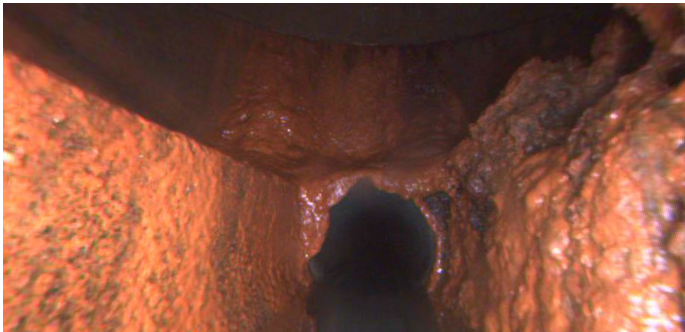
Code: **AMH**
Description: **Manhole**

Distance (ft): **115.7**
Structural Grade: **0**
O&M Grade: **0**
Clock Start/From:
Clock To:
1st Value:
2nd Value:
Value Percent:
Continuous Index:
Within 8" of Joint: **NO**
Remarks: **M-607-047**
