Profile/Photo Observation Report

Street:	MEDLEE DR	Flow Control:	Not Controlled
City:	Hobart, IN	Year Renewed:	
Location:	Yard	Tape/Media #:	
Purpose:	Routine Assessment	Dia/Height:	8"
Use:	Sanitary	Material:	PVC
Drain Area:	NA	Lining:	
Category:	NA		
Comment:	Flow direction is marked wrong.

Location Details:		Direction of Survey:	Upstream
US MH:	M-607-049	DS MH:	M-607-048
		Total Length Surveyed (ft):	269.0

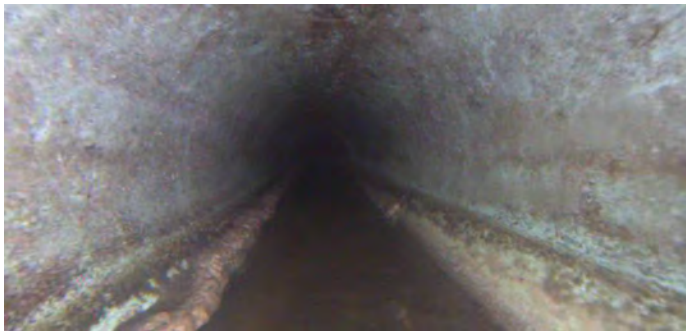
Code: **AMH**
Description: **Manhole**

Distance (ft): **.0**
Structural Grade: **0**
O&M Grade: **0**
Clock Start/From:
Clock To:
1st Value:
2nd Value:
Value Percent:
Continuous Index:
Within 8" of Joint: **NO**
Remarks: **M-607-048**

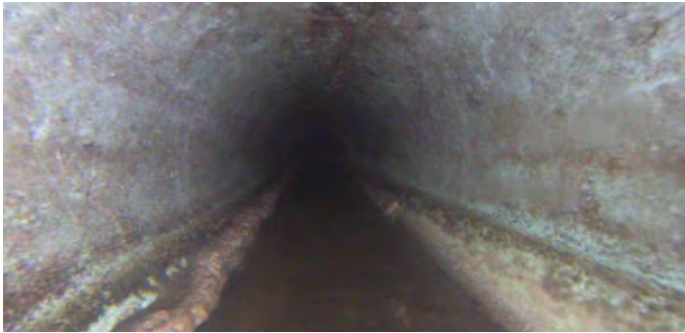
Code:	MWL
Description:	Water Level

Distance (ft):	.0
Structural Grade:	0
O&M Grade:	0
Clock Start/From:	
Clock To:	
1st Value:	
2nd Value:	
Value Percent:	10.000
Continuous Index:	
Within 8" of Joint:	NO
Remarks:

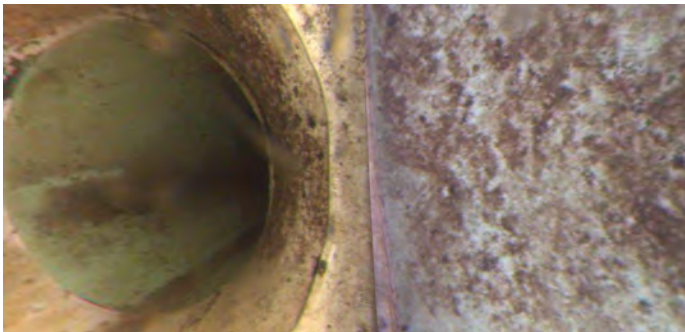
Code:	TF
Description:	Tap Factory

Distance (ft):	30.7
Structural Grade:	0
O&M Grade:	0
Clock Start/From:	10
Clock To:	
1st Value:	4.000
2nd Value:	
Value Percent:	
Continuous Index:	
Within 8" of Joint:	
Remarks:

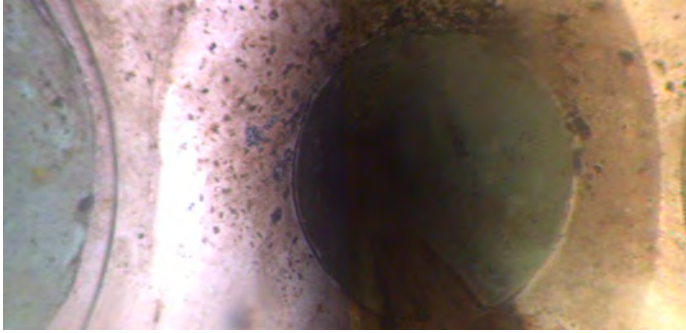
Code: **TFA**
Description: **Tap Factory Active**

Distance (ft): **59.8**
Structural Grade: **0**
O&M Grade: **0**
Clock Start/From: **2**
Clock To:
1st Value: **4.000**
2nd Value:
Value Percent:
Continuous Index:
Within 8" of Joint:
Remarks:

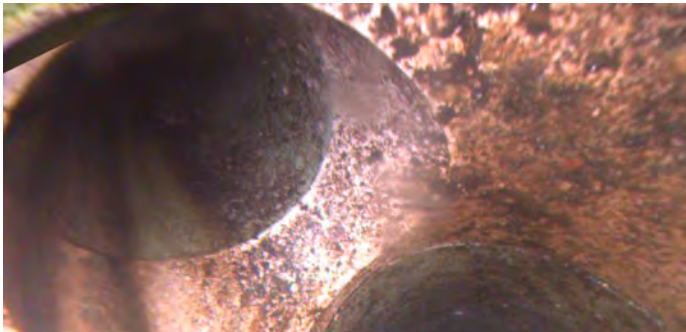
Code: **TF**
Description: **Tap Factory**

Distance (ft): **130.6**
Structural Grade: **0**
O&M Grade: **0**
Clock Start/From: **10**
Clock To:
1st Value: **4.000**
2nd Value:
Value Percent:
Continuous Index:
Within 8" of Joint:
Remarks:

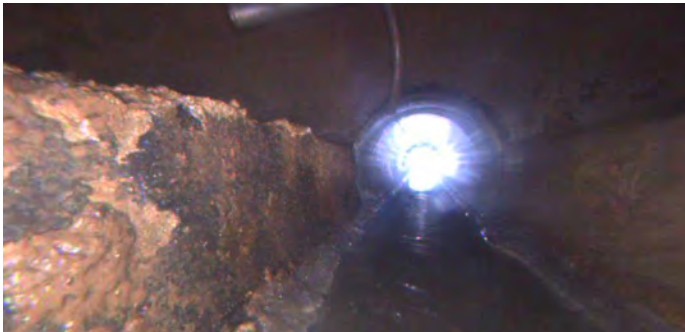
Code: **AMH**
Description: **Manhole**

Distance (ft): **269.0**
Structural Grade: **0**
O&M Grade: **0**
Clock Start/From:
Clock To:
1st Value:
2nd Value:
Value Percent:
Continuous Index:
Within 8" of Joint: **NO**
Remarks: **M-607-049**
