Profile/Photo Observation Report

Street:	FOXCROFT STREET	Flow Control:	Not Controlled
City:	Hobart, IN	Year Renewed:	
Location:	Yard	Tape/Media #:	
Purpose:	Routine Assessment	Dia/Height:	8"
Use:	Sanitary	Material:	PVC
Drain Area:	NA	Lining:	
Category:	NA		
Comment:	Flow direction is marked wrong.

Location Details:		Direction of Survey:	Upstream
US MH:	M-607-049	DS MH:	M-607-048
		Total Length Surveyed (ft):	269.0

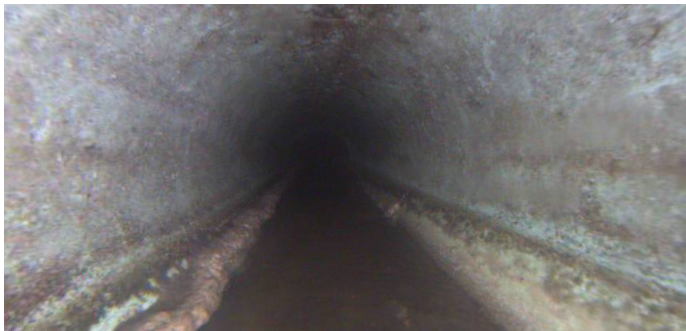
Code: **AMH**
Description: **Manhole**

Distance (ft): **.0**
Structural Grade: **0**
O&M Grade: **0**
Clock Start/From:
Clock To:
1st Value:
2nd Value:
Value Percent:
Continuous Index:
Within 8" of Joint: **NO**
Remarks: **M-607-048**

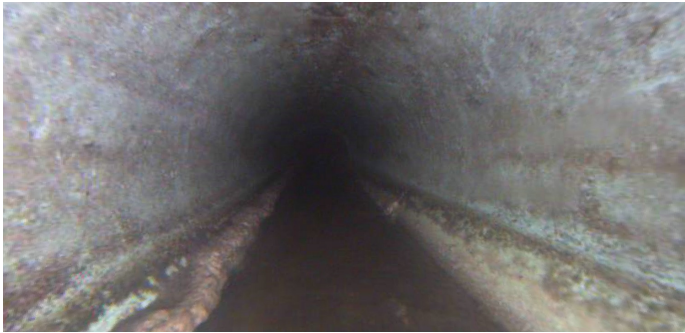
Code:	MWL
Description:	Water Level

Distance (ft):	.0
Structural Grade:	0
O&M Grade:	0
Clock Start/From:	
Clock To:	
1st Value:	
2nd Value:	
Value Percent:	10.000
Continuous Index:	
Within 8" of Joint:	NO
Remarks:

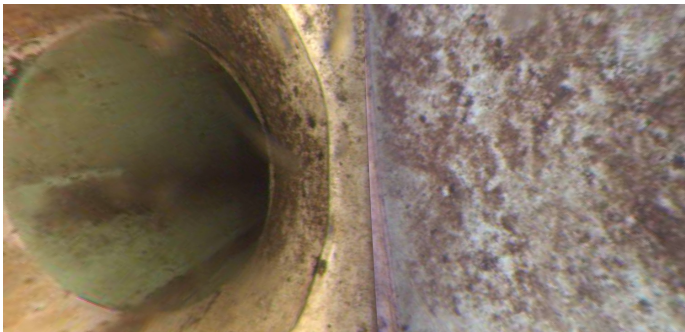
Code:	TF
Description:	Tap Factory

Distance (ft):	30.7
Structural Grade:	0
O&M Grade:	0
Clock Start/From:	10
Clock To:	
1st Value:	4.000
2nd Value:	
Value Percent:	
Continuous Index:	
Within 8" of Joint:	
Remarks:

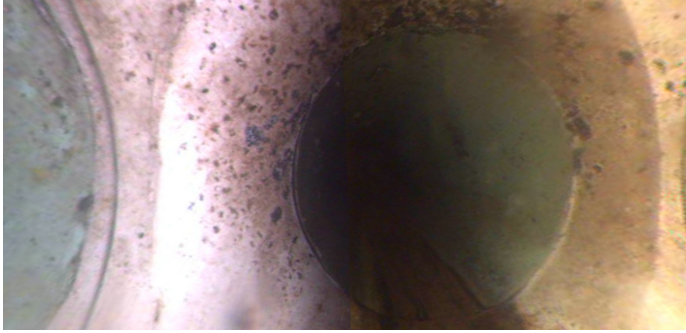
Code: **TFA**
Description: **Tap Factory Active**

Distance (ft): **59.8**
Structural Grade: **0**
O&M Grade: **0**
Clock Start/From: **2**
Clock To:
1st Value: **4.000**
2nd Value:
Value Percent:
Continuous Index:
Within 8" of Joint:
Remarks:

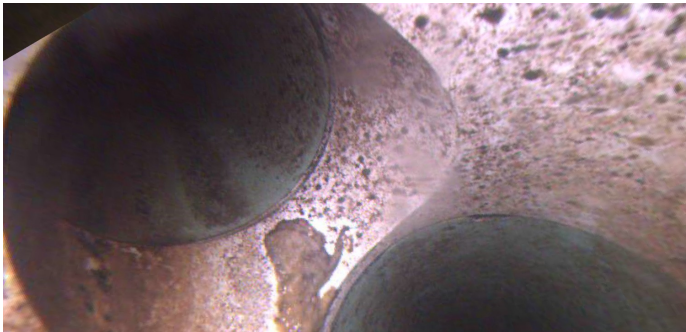
Code: **TF**
Description: **Tap Factory**

Distance (ft): **84.0**
Structural Grade: **0**
O&M Grade: **0**
Clock Start/From: **10**
Clock To:
1st Value: **4.000**
2nd Value:
Value Percent:
Continuous Index:
Within 8" of Joint:
Remarks:

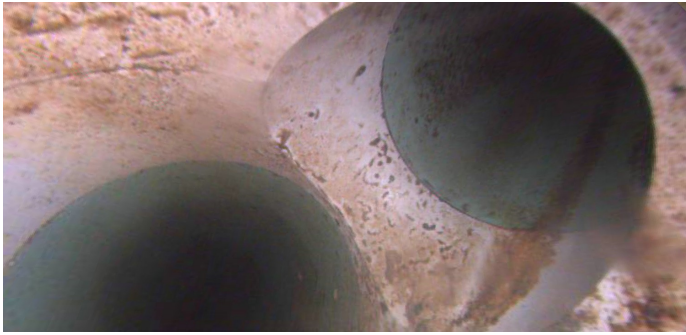
Code: **TF**
Description: **Tap Factory**

Distance (ft): **108.8**
Structural Grade: **0**
O&M Grade: **0**
Clock Start/From: **2**
Clock To:
1st Value: **4.000**
2nd Value:
Value Percent:
Continuous Index:
Within 8" of Joint:
Remarks:

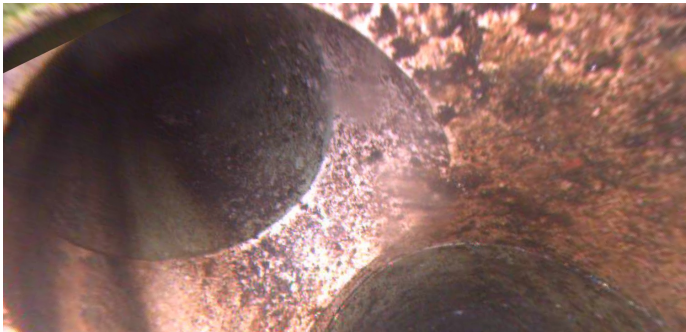
Code: **TF**
Description: **Tap Factory**

Distance (ft): **130.6**
Structural Grade: **0**
O&M Grade: **0**
Clock Start/From: **10**
Clock To:
1st Value: **4.000**
2nd Value:
Value Percent:
Continuous Index:
Within 8" of Joint:
Remarks:

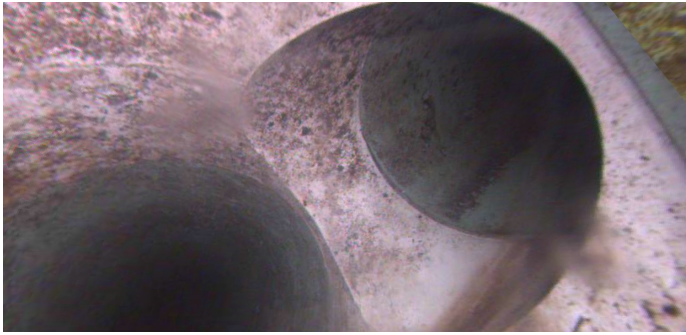
Code: **TF**
Description: **Tap Factory**

Distance (ft): **133.2**
Structural Grade: **0**
O&M Grade: **0**
Clock Start/From: **2**
Clock To:
1st Value: **4.000**
2nd Value:
Value Percent:
Continuous Index:
Within 8" of Joint:
Remarks:

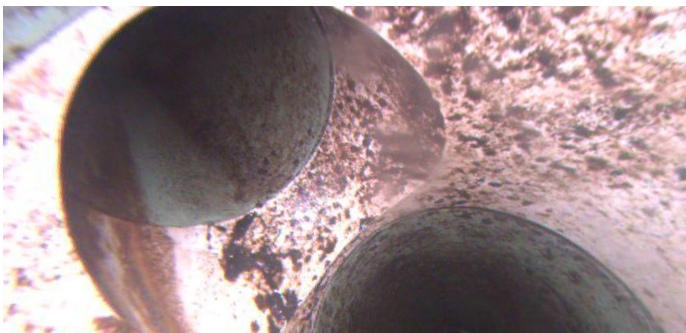
Code: **TF**
Description: **Tap Factory**

Distance (ft): **182.0**
Structural Grade: **0**
O&M Grade: **0**
Clock Start/From: **10**
Clock To:
1st Value: **4.000**
2nd Value:
Value Percent:
Continuous Index:
Within 8" of Joint:
Remarks:

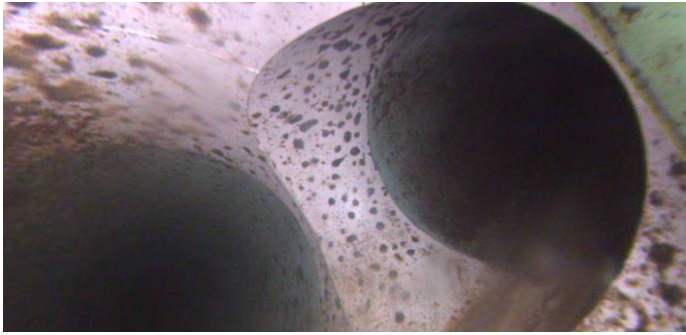
Code: **TF**
Description: **Tap Factory**

Distance (ft): **186.9**
Structural Grade: **0**
O&M Grade: **0**
Clock Start/From: **2**
Clock To:
1st Value: **4.000**
2nd Value:
Value Percent:
Continuous Index:
Within 8" of Joint:
Remarks:

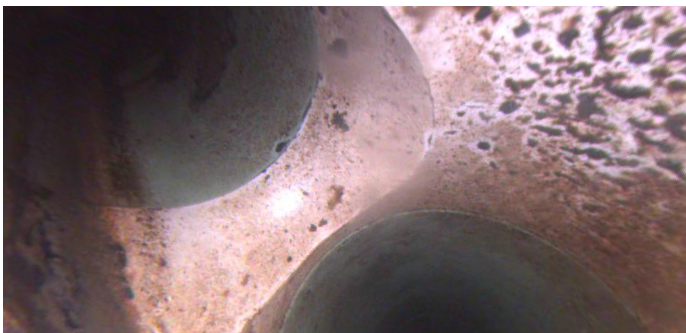
Code: **TF**
Description: **Tap Factory**

Distance (ft): **225.1**
Structural Grade: **0**
O&M Grade: **0**
Clock Start/From: **10**
Clock To:
1st Value: **4.000**
2nd Value:
Value Percent:
Continuous Index:
Within 8" of Joint:
Remarks:

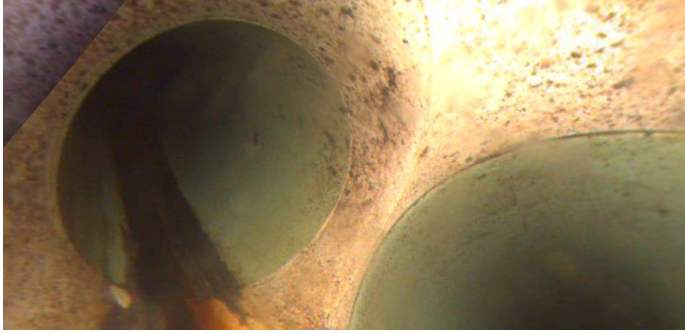
Code: **TF**
Description: **Tap Factory**

Distance (ft): **251.8**
Structural Grade: **0**
O&M Grade: **0**
Clock Start/From: **2**
Clock To:
1st Value: **4.000**
2nd Value:
Value Percent:
Continuous Index:
Within 8" of Joint:
Remarks:

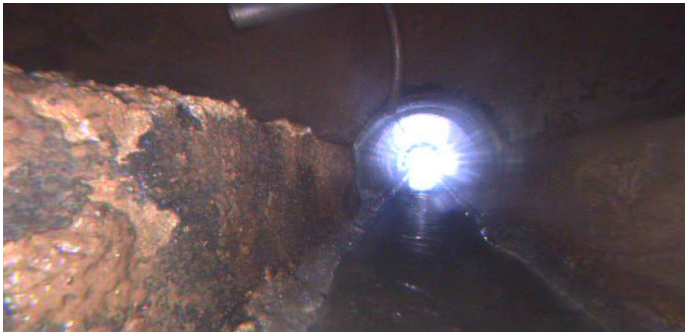
Code: **AMH**
Description: **Manhole**

Distance (ft): **269.0**
Structural Grade: **0**
O&M Grade: **0**
Clock Start/From:
Clock To:
1st Value:
2nd Value:
Value Percent:
Continuous Index:
Within 8" of Joint: **NO**
Remarks: **M-607-049**
