Profile/Photo Observation Report

Date:	04/03/2018	Weather:		Coding:	PACP 6.0
Pipe Length (ft):	125.0	Owner:	NA	Pre Clean:	No Pre-Cleaning
P.O.#:		Surveyor:	Jen Costello	PSR:	P-607-049-050
Customer:		Clean Date:	01/01/1900	Shape:	C

Street:	MEDLEE DR	Flow Control:	Not Controlled
City:	Hobart, IN	Year Renewed:	
Location:	Yard	Tape/Media #:	
Purpose:	Routine Assessment	Dia/Height:	10"
Use:	Sanitary	Material:	PVC
Drain Area:	NA	Lining:	
Category:	NA		
Comment:

Location Details:		Direction of Survey:	Upstream
US MH:	M-607-050	DS MH:	M-607-049
		Total Length Surveyed (ft):	120.9

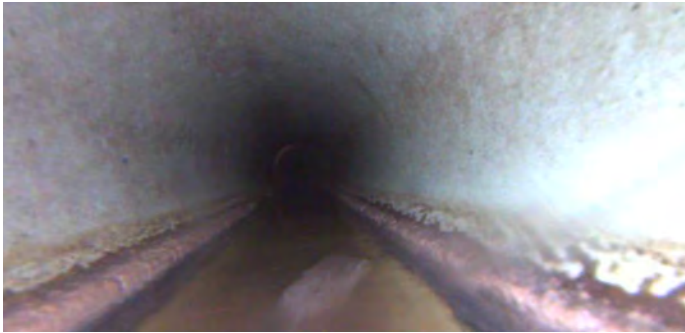
Code:	MWL
Description:	Water Level

Distance (ft):	.0
Structural Grade:	0
O&M Grade:	0
Clock Start/From:	
Clock To:	
1st Value:	
2nd Value:	
Value Percent:	10.000
Continuous Index:	
Within 8" of Joint:	NO
Remarks:

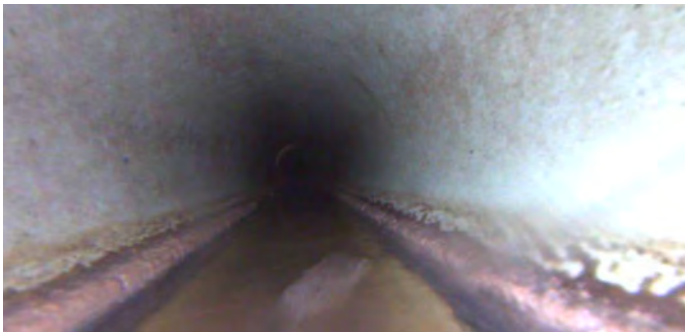
Code:	DAGS
Description:	Deposits Attached Grease

Distance (ft):	.0
Structural Grade:	0
O&M Grade:	2
Clock Start/From:	8
Clock To:	4
1st Value:	
2nd Value:	
Value Percent:	5.000
Continuous Index:	S01
Within 8" of Joint:	NO
Remarks:

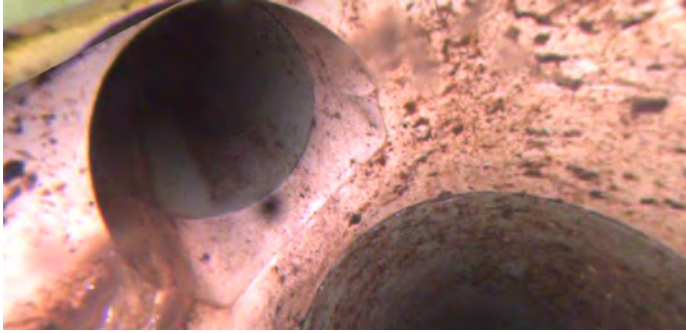
Code: **TF**
Description: **Tap Factory**

Distance (ft): **5.2**
Structural Grade: **0**
O&M Grade: **0**
Clock Start/From: **11**
Clock To:
1st Value: **4.000**
2nd Value:
Value Percent:
Continuous Index:
Within 8" of Joint:
Remarks:

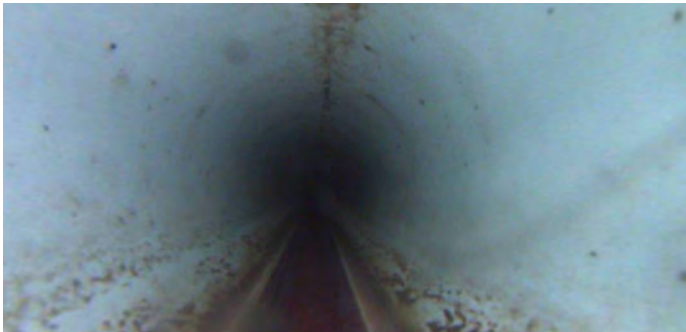
Code: **DAGS**
Description: **Deposits Attached Grease**

Distance (ft): **28.0**
Structural Grade: **0**
O&M Grade: **2**
Clock Start/From: **8**
Clock To: **4**
1st Value:
2nd Value:
Value Percent: **5.000**
Continuous Index: **F01**
Within 8" of Joint: **NO**
Remarks:

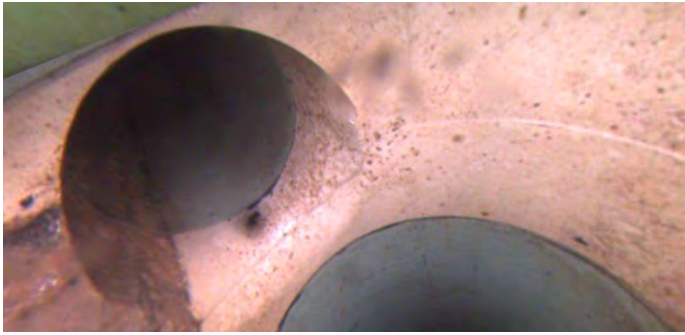
Code: **TF**
Description: **Tap Factory**

Distance (ft): **48.3**
Structural Grade: **0**
O&M Grade: **0**
Clock Start/From: **11**
Clock To:
1st Value: **4.000**
2nd Value:
Value Percent:
Continuous Index:
Within 8" of Joint:
Remarks:

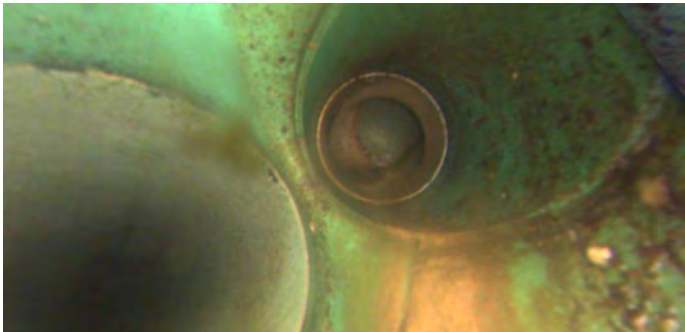
Code: **TF**
Description: **Tap Factory**

Distance (ft): **109.9**
Structural Grade: **0**
O&M Grade: **0**
Clock Start/From: **10**
Clock To:
1st Value: **4.000**
2nd Value:
Value Percent:
Continuous Index:
Within 8" of Joint:
Remarks:

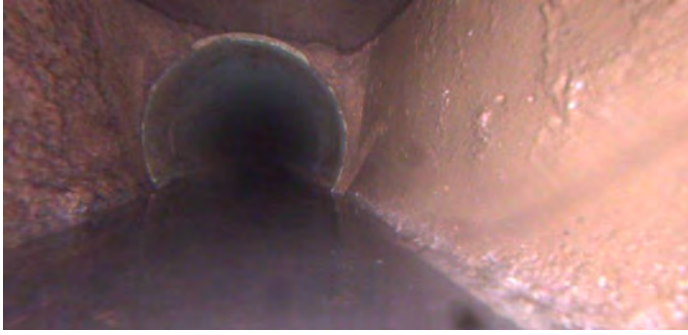
Code:	AMH
Description:	Manhole
Distance (ft):	120.9
Structural Grade:	0
O&M Grade:	0
Clock Start/From:	
Clock To:	
1st Value:	
2nd Value:	
Value Percent:	
Continuous Index:	
Within 8" of Joint:	NO
Remarks:	M-607-050
