Profile/Photo Observation Report

Street:	FOXCROFT STREET	Flow Control:	Not Controlled
City:	Hobart, IN	Year Renewed:	
Location:	Yard	Tape/Media #:	
Purpose:	Routine Assessment	Dia/Height:	10"
Use:	Sanitary	Material:	PVC
Drain Area:	NA	Lining:	
Category:	NA		
Comment:

Location Details:		Direction of Survey:	Upstream
US MH:	M-607-050	DS MH:	M-607-049
		Total Length Surveyed (ft):	120.9

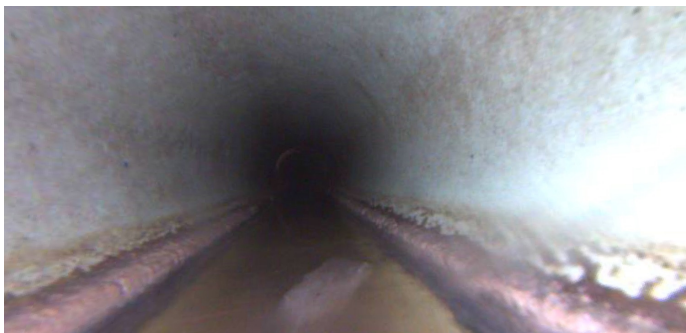
Code: **AMH**
Description: **Manhole**

Distance (ft): **.0**
Structural Grade: **0**
O&M Grade: **0**
Clock Start/From:
Clock To:
1st Value:
2nd Value:
Value Percent:
Continuous Index:
Within 8" of Joint: **NO**
Remarks: **M-607-049**

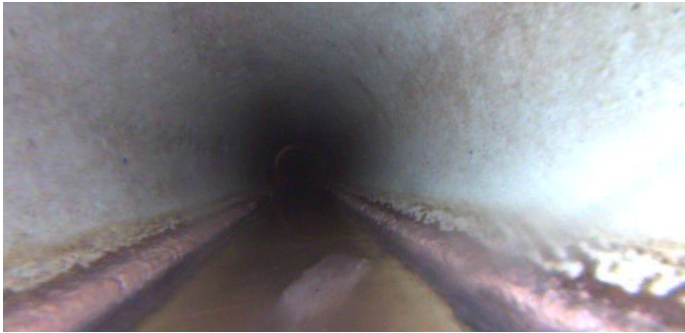
Code:	MWL
Description:	Water Level

Distance (ft):	.0
Structural Grade:	0
O&M Grade:	0
Clock Start/From:	
Clock To:	
1st Value:	
2nd Value:	
Value Percent:	10.000
Continuous Index:	
Within 8" of Joint:	NO
Remarks:

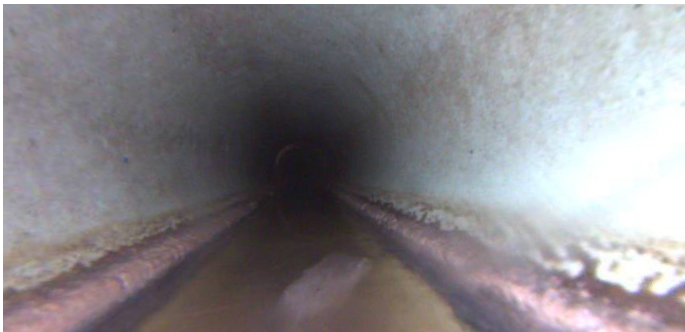
Code:	DAGS
Description:	Deposits Attached Grease

Distance (ft):	.0
Structural Grade:	0
O&M Grade:	2
Clock Start/From:	8
Clock To:	4
1st Value:	
2nd Value:	
Value Percent:	5.000
Continuous Index:	S01
Within 8" of Joint:	NO
Remarks:

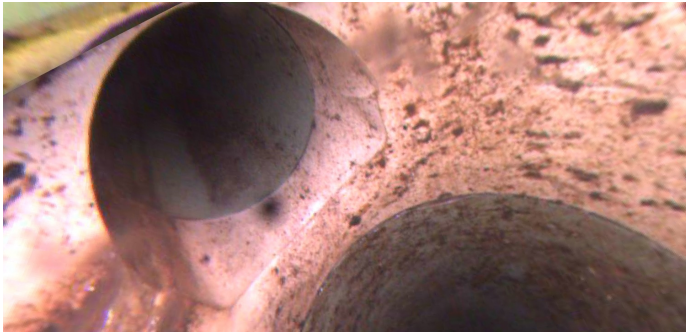
Code: **TF**
Description: **Tap Factory**

Distance (ft): **5.2**
Structural Grade: **0**
O&M Grade: **0**
Clock Start/From: **11**
Clock To:
1st Value: **4.000**
2nd Value:
Value Percent:
Continuous Index:
Within 8" of Joint:
Remarks:

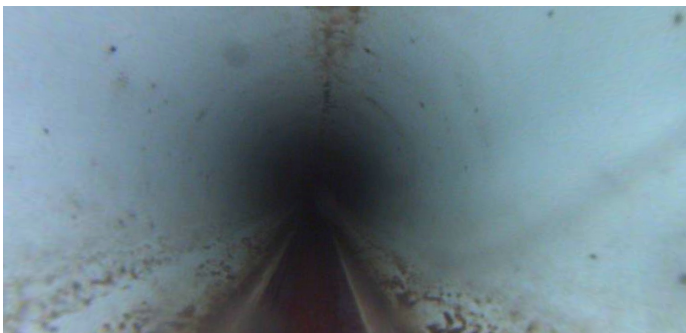
Code: **DAGS**
Description: **Deposits Attached Grease**

Distance (ft): **28.0**
Structural Grade: **0**
O&M Grade: **2**
Clock Start/From: **8**
Clock To: **4**
1st Value:
2nd Value:
Value Percent: **5.000**
Continuous Index: **F01**
Within 8" of Joint: **NO**
Remarks:

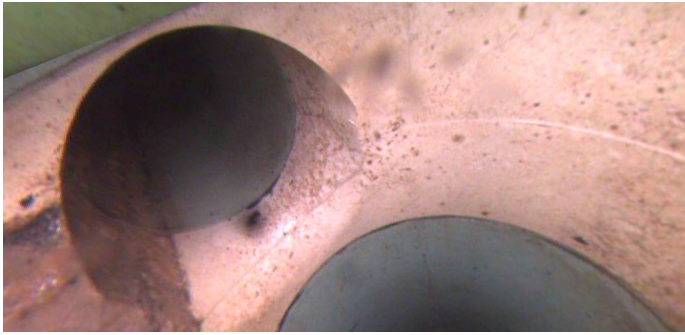
Code: **TF**
Description: **Tap Factory**

Distance (ft): **48.3**
Structural Grade: **0**
O&M Grade: **0**
Clock Start/From: **11**
Clock To:
1st Value: **4.000**
2nd Value:
Value Percent:
Continuous Index:
Within 8" of Joint:
Remarks:

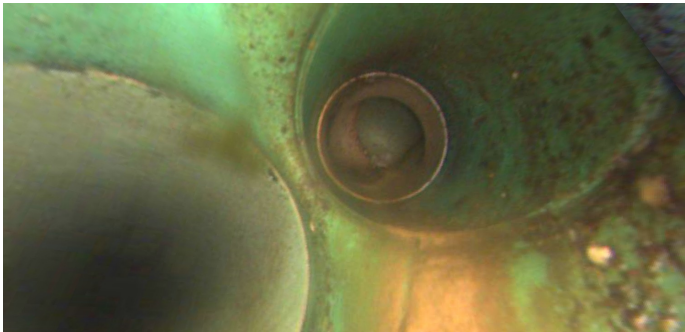
Code: **TF**
Description: **Tap Factory**

Distance (ft): **109.9**
Structural Grade: **0**
O&M Grade: **0**
Clock Start/From: **10**
Clock To:
1st Value: **4.000**
2nd Value:
Value Percent:
Continuous Index:
Within 8" of Joint:
Remarks:

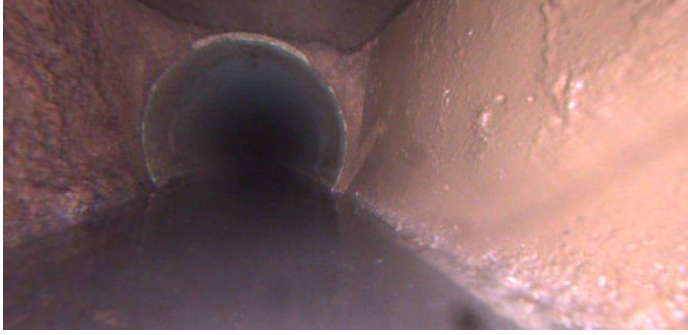
Code:	AMH
Description:	Manhole
Distance (ft):	120.9
Structural Grade:	0
O&M Grade:	0
Clock Start/From:	
Clock To:	
1st Value:	
2nd Value:	
Value Percent:	
Continuous Index:	
Within 8" of Joint:	NO
Remarks:	M-607-050
