## Profile/Photo Observation Report

Date:	<b>04/11/2018</b>	Weather:		Coding:	<b>PACP 6.0</b>
Pipe Length (ft):	<b>89.9</b>	Owner:	<b>NA</b>	Pre Clean:	<b>No Pre-Cleaning</b>
P.O.#:		Surveyor:	<b>Jen Costello</b>	PSR:	<b>P-607-050-051</b>
Customer:		Clean Date:	<b>01/01/1900</b>	Shape:	<b>C</b>

Street:	<b>MEDLEE DR</b>	Flow Control:	<b>Not Controlled</b>
City:	<b>Hobart, IN</b>	Year Renewed:	
Location:	<b>Yard</b>	Tape/Media #:	
Purpose:	<b>Routine Assessment</b>	Dia/Height:	<b>10"</b>
Use:	<b>Sanitary</b>	Material:	<b>PVC</b>
Drain Area:	<b>NA</b>	Lining:	
Category:	<b>NA</b>		
Comment:	<b>Flow direction is marked wrong.</b>		
Location Details:		Direction of Survey:	<b>Upstream</b>
US MH:	<b>M-607-051</b>	DS MH:	<b>M-607-050</b>
		Total Length Surveyed (ft):	<b>88.7</b>

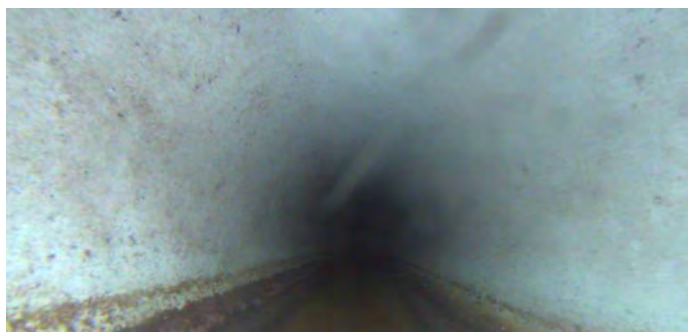
Code: **AMH**  
Description: **Manhole**

Distance (ft): **.0**  
Structural Grade: **0**  
O&M Grade: **0**  
Clock Start/From:  
Clock To:  
1st Value:  
2nd Value:  
Value Percent:  
Continuous Index:  
Within 8" of Joint: **NO**  
Remarks: **M-607-050**

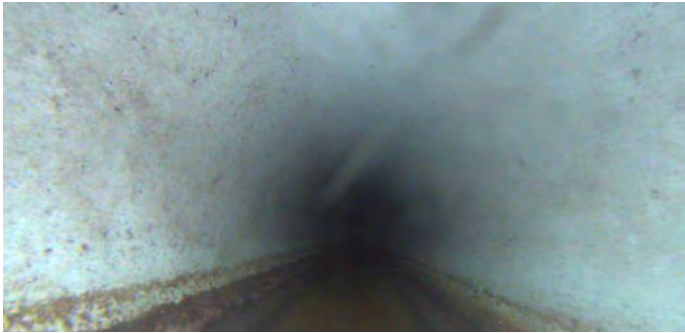
Code:	<b>MWL</b>
Description:	<b>Water Level</b>

Distance (ft):	<b>.0</b>
Structural Grade:	<b>0</b>
O&M Grade:	<b>0</b>
Clock Start/From:	
Clock To:	
1st Value:	
2nd Value:	
Value Percent:	<b>5.000</b>
Continuous Index:	
Within 8" of Joint:	<b>NO</b>
Remarks:

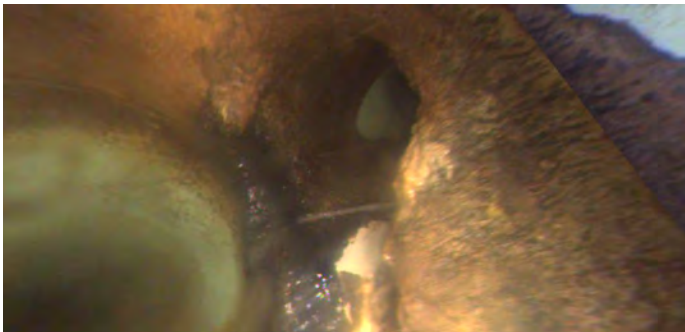
Code:	<b>TFD</b>
Description:	<b>Tap Factory Defective</b>

Distance (ft):	<b>58.7</b>
Structural Grade:	<b>0</b>
O&M Grade:	<b>2</b>
Clock Start/From:	<b>10</b>
Clock To:	
1st Value:	<b>4.000</b>
2nd Value:	
Value Percent:	
Continuous Index:	
Within 8" of Joint:	
Remarks:	<b>dae</b>

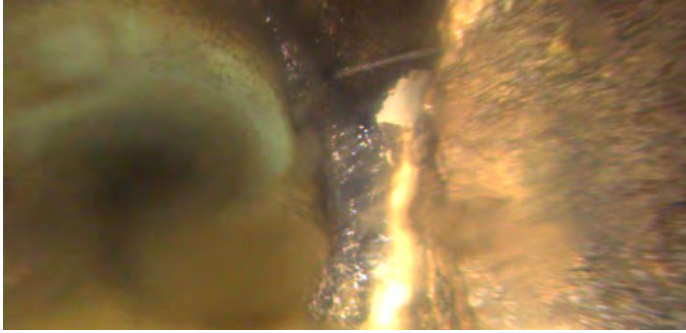
Code: **DAE**  
Description: **Deposits Attached Encrustation**

Distance (ft): **58.7**  
Structural Grade: **0**  
O&M Grade: **2**  
Clock Start/From: **7**  
Clock To: **11**  
1st Value:  
2nd Value:  
Value Percent: **10.000**  
Continuous Index:  
Within 8" of Joint: **NO**  
Remarks:

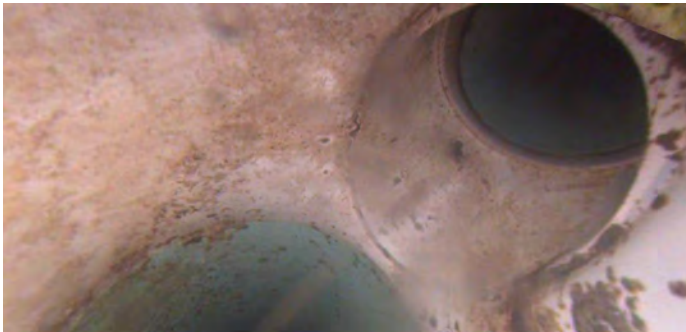
Code: **TF**  
Description: **Tap Factory**

Distance (ft): **60.6**  
Structural Grade: **0**  
O&M Grade: **0**  
Clock Start/From: **1**  
Clock To:  
1st Value: **4.000**  
2nd Value:  
Value Percent:  
Continuous Index:  
Within 8" of Joint:  
Remarks:

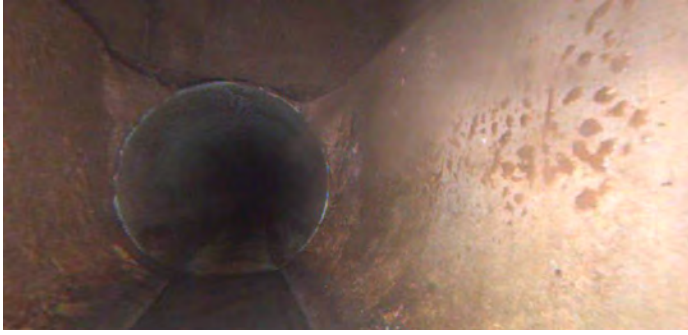
Code:	<b>AMH</b>
Description:	<b>Manhole</b>
Distance (ft):	<b>88.7</b>
Structural Grade:	<b>0</b>
O&M Grade:	<b>0</b>
Clock Start/From:	
Clock To:	
1st Value:	
2nd Value:	
Value Percent:	
Continuous Index:	
Within 8" of Joint:	<b>NO</b>
Remarks:	<b>M-607-051</b>
