Profile/Photo Observation Report

Date:	04/11/2018	Weather:		Coding:	PACP 6.0
Pipe Length (ft):	89.9	Owner:	NA	Pre Clean:	No Pre-Cleaning
P.O.#:		Surveyor:	Jen Costello	PSR:	P-607-050-051
Customer:		Clean Date:	01/01/1900	Shape:	C

Street:	FOXCROFT STREET	Flow Control:	Not Controlled
City:	Hobart, IN	Year Renewed:	
Location:	Yard	Tape/Media #:	
Purpose:	Routine Assessment	Dia/Height:	10"
Use:	Sanitary	Material:	PVC
Drain Area:	NA	Lining:	
Category:	NA		
Comment:	Flow direction is marked wrong.		
Location Details:		Direction of Survey:	Upstream
US MH:	M-607-051	DS MH:	M-607-050
		Total Length Surveyed (ft):	88.7

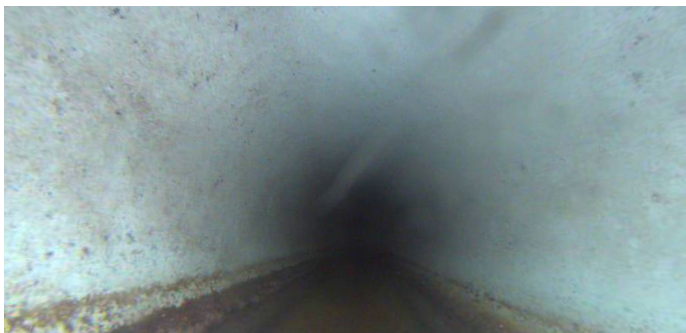
Code: **AMH**
Description: **Manhole**

Distance (ft): **.0**
Structural Grade: **0**
O&M Grade: **0**
Clock Start/From:
Clock To:
1st Value:
2nd Value:
Value Percent:
Continuous Index:
Within 8" of Joint: **NO**
Remarks: **M-607-050**

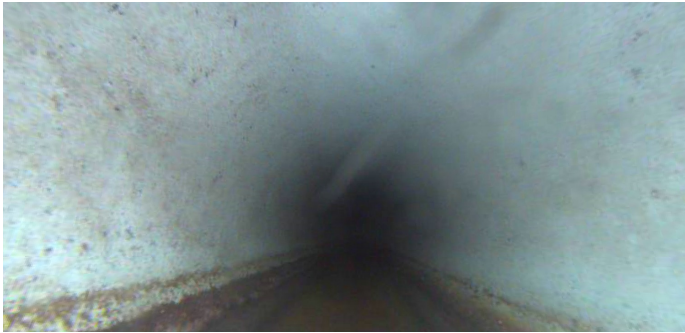
Code:	MWL
Description:	Water Level

Distance (ft):	.0
Structural Grade:	0
O&M Grade:	0
Clock Start/From:	
Clock To:	
1st Value:	
2nd Value:	
Value Percent:	5.000
Continuous Index:	
Within 8" of Joint:	NO
Remarks:

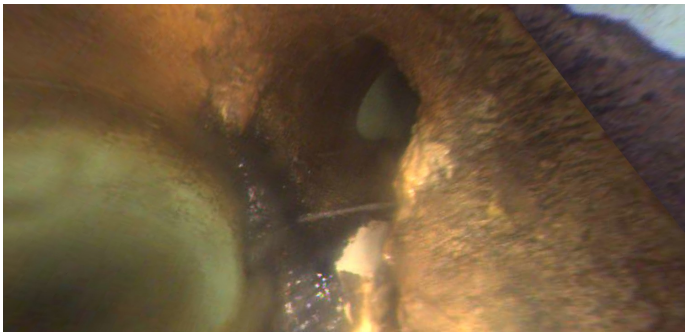
Code:	TFD
Description:	Tap Factory Defective

Distance (ft):	58.7
Structural Grade:	0
O&M Grade:	2
Clock Start/From:	10
Clock To:	
1st Value:	4.000
2nd Value:	
Value Percent:	
Continuous Index:	
Within 8" of Joint:	
Remarks:	dae

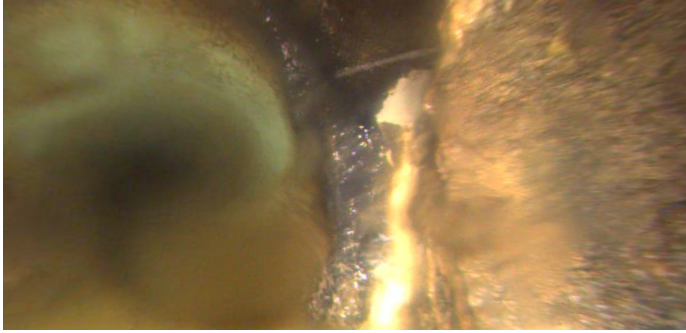
Code: **DAE**
Description: **Deposits Attached Encrustation**

Distance (ft): **58.7**
Structural Grade: **0**
O&M Grade: **2**
Clock Start/From: **7**
Clock To: **11**
1st Value:
2nd Value:
Value Percent: **10.000**
Continuous Index:
Within 8" of Joint: **NO**
Remarks:

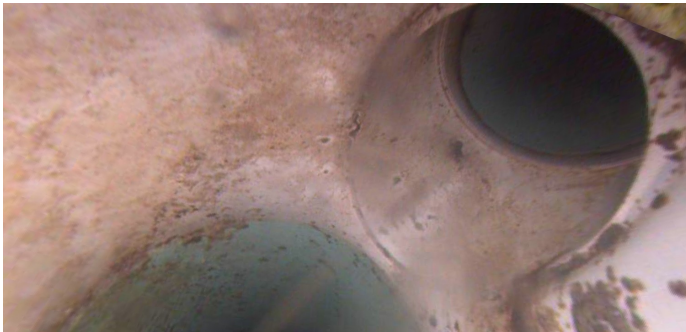
Code: **TF**
Description: **Tap Factory**

Distance (ft): **60.6**
Structural Grade: **0**
O&M Grade: **0**
Clock Start/From: **1**
Clock To:
1st Value: **4.000**
2nd Value:
Value Percent:
Continuous Index:
Within 8" of Joint:
Remarks:

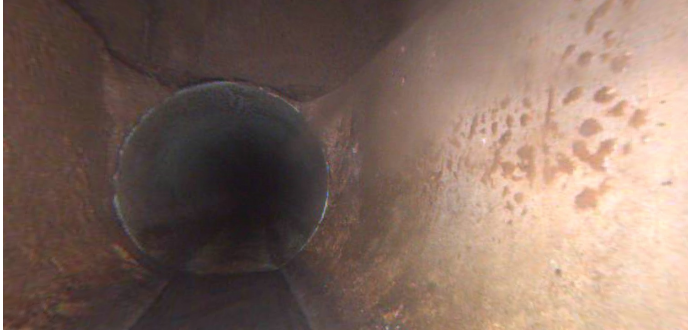
Code:	AMH
Description:	Manhole
Distance (ft):	88.7
Structural Grade:	0
O&M Grade:	0
Clock Start/From:	
Clock To:	
1st Value:	
2nd Value:	
Value Percent:	
Continuous Index:	
Within 8" of Joint:	NO
Remarks:	M-607-051
