Profile/Photo Observation Report

Street:	MEDLEE DR	Flow Control:	Not Controlled
City:	Hobart, IN	Year Renewed:	
Location:	Yard	Tape/Media #:	
Purpose:	Routine Assessment	Dia/Height:	10"
Use:	Sanitary	Material:	PVC
Drain Area:	NA	Lining:	
Category:	NA		
Comment:	Flow direction is marked wrong.

Location Details:		Direction of Survey:	Downstream
US MH:	M-607-052	DS MH:	M-607-051
		Total Length Surveyed (ft):	112.4

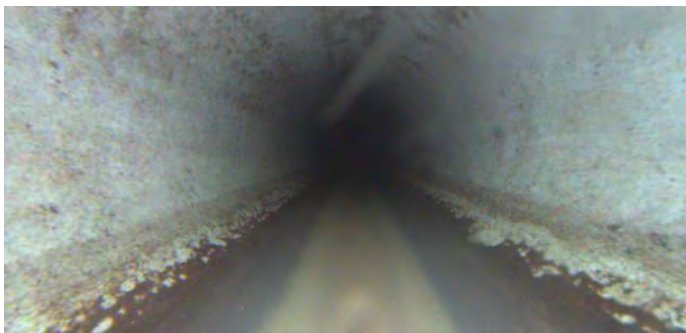
Code: **AMH**
Description: **Manhole**

Distance (ft): **.0**
Structural Grade: **0**
O&M Grade: **0**
Clock Start/From:
Clock To:
1st Value:
2nd Value:
Value Percent:
Continuous Index:
Within 8" of Joint: **NO**
Remarks: **M-607-052**

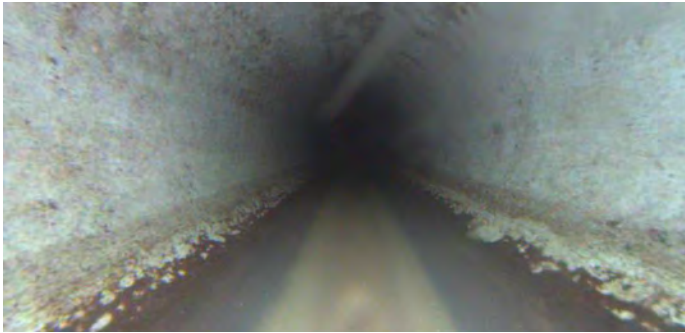
Code:	MWL
Description:	Water Level

Distance (ft):	.0
Structural Grade:	0
O&M Grade:	0
Clock Start/From:	
Clock To:	
1st Value:	
2nd Value:	
Value Percent:	10.000
Continuous Index:	
Within 8" of Joint:	NO
Remarks:

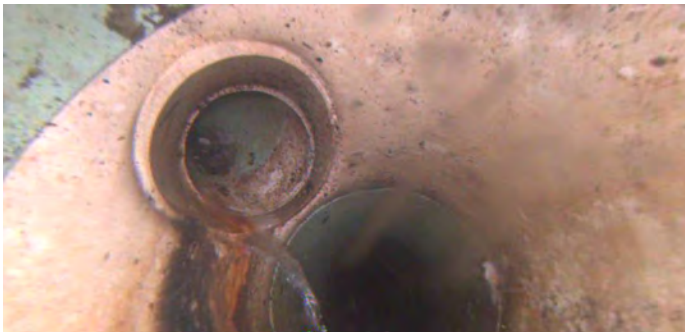
Code:	TFA
Description:	Tap Factory Active

Distance (ft):	48.4
Structural Grade:	0
O&M Grade:	0
Clock Start/From:	10
Clock To:	
1st Value:	4.000
2nd Value:	
Value Percent:	
Continuous Index:	
Within 8" of Joint:	
Remarks:

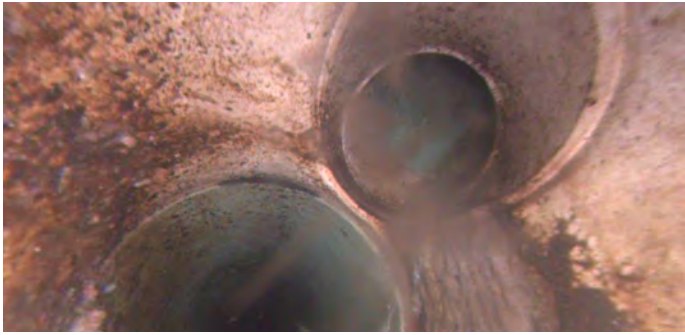
Code: **TFA**
Description: **Tap Factory Active**

Distance (ft): **51.8**
Structural Grade: **0**
O&M Grade: **0**
Clock Start/From: **3**
Clock To:
1st Value: **4.000**
2nd Value:
Value Percent:
Continuous Index:
Within 8" of Joint:
Remarks:

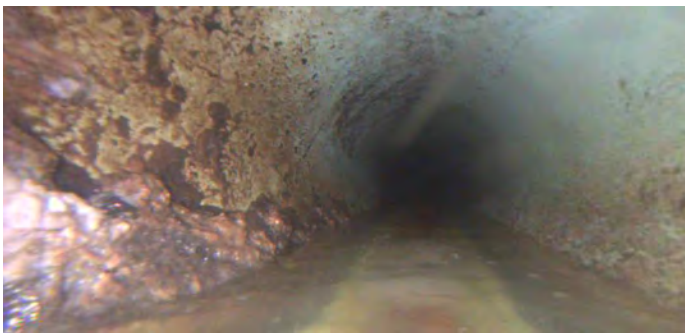
Code: **DAGS**
Description: **Deposits Attached Grease**

Distance (ft): **52.6**
Structural Grade: **0**
O&M Grade: **2**
Clock Start/From: **8**
Clock To: **9**
1st Value:
2nd Value:
Value Percent: **5.000**
Continuous Index:
Within 8" of Joint: **NO**
Remarks:

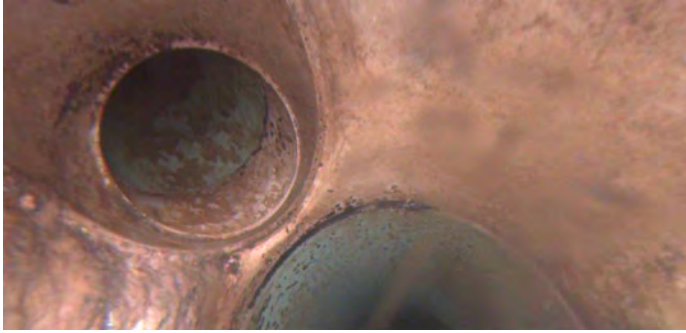
Code: **TFA**
Description: **Tap Factory Active**

Distance (ft): **91.1**
Structural Grade: **0**
O&M Grade: **0**
Clock Start/From: **10**
Clock To:
1st Value: **4.000**
2nd Value:
Value Percent:
Continuous Index:
Within 8" of Joint:
Remarks:

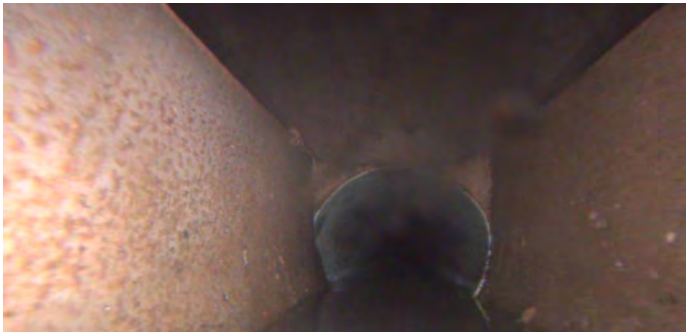
Code: **AMH**
Description: **Manhole**

Distance (ft): **112.4**
Structural Grade: **0**
O&M Grade: **0**
Clock Start/From:
Clock To:
1st Value:
2nd Value:
Value Percent:
Continuous Index:
Within 8" of Joint: **NO**
Remarks: **M-607-051**
