Profile/Photo Observation Report

Street:	FOXCROFT STREET	Flow Control:	Not Controlled
City:	Hobart, IN	Year Renewed:	
Location:	Yard	Tape/Media #:	
Purpose:	Routine Assessment	Dia/Height:	10"
Use:	Sanitary	Material:	PVC
Drain Area:	NA	Lining:	
Category:	NA		
Comment:	Flow direction is marked wrong.		
Location Details:		Direction of Survey:	Downstream
US MH:	M-607-052	DS MH:	M-607-051
		Total Length Surveyed (ft):	112.4

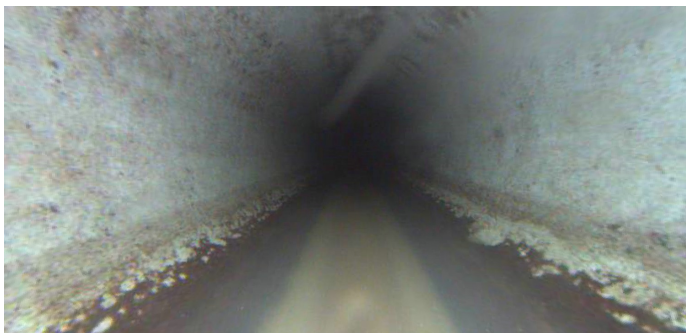
Code: **AMH**
Description: **Manhole**

Distance (ft): **.0**
Structural Grade: **0**
O&M Grade: **0**
Clock Start/From:
Clock To:
1st Value:
2nd Value:
Value Percent:
Continuous Index:
Within 8" of Joint: **NO**
Remarks: **M-607-052**

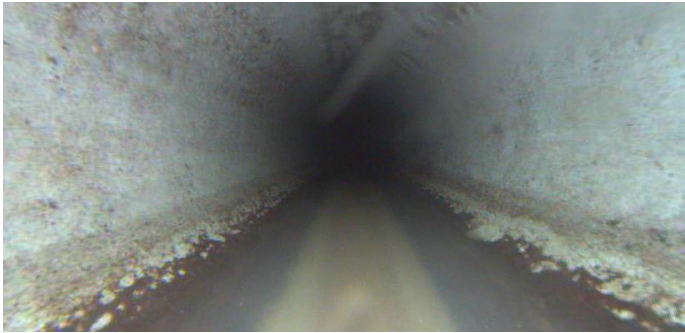
Code: **MWL**
Description: **Water Level**

Distance (ft): **.0**
Structural Grade: **0**
O&M Grade: **0**
Clock Start/From:
Clock To:
1st Value:
2nd Value:
Value Percent: **10.000**
Continuous Index:
Within 8" of Joint: **NO**
Remarks:

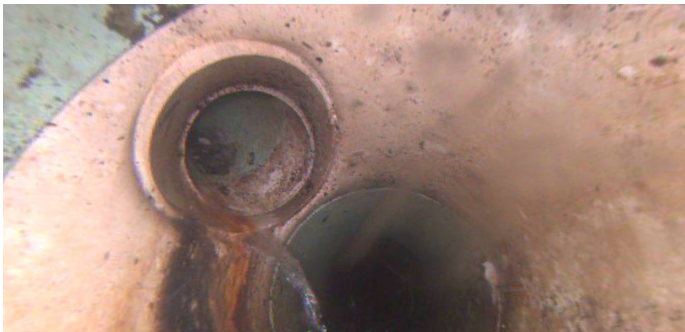
Code: **TFA**
Description: **Tap Factory Active**

Distance (ft): **48.4**
Structural Grade: **0**
O&M Grade: **0**
Clock Start/From: **10**
Clock To:
1st Value: **4.000**
2nd Value:
Value Percent:
Continuous Index:
Within 8" of Joint:
Remarks:

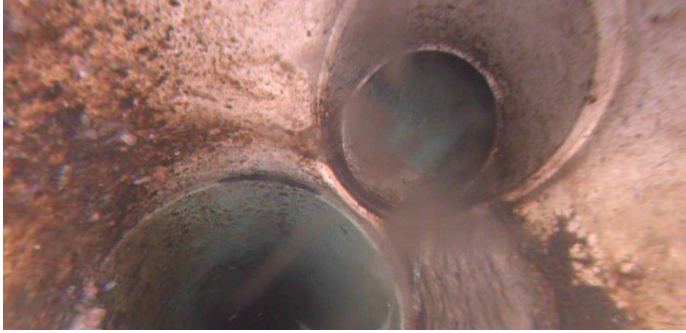
Code: **TFA**
Description: **Tap Factory Active**

Distance (ft): **51.8**
Structural Grade: **0**
O&M Grade: **0**
Clock Start/From: **3**
Clock To:
1st Value: **4.000**
2nd Value:
Value Percent:
Continuous Index:
Within 8" of Joint:
Remarks:

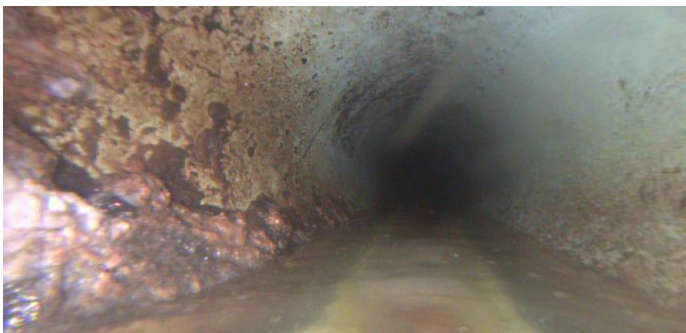
Code: **DAGS**
Description: **Deposits Attached Grease**

Distance (ft): **52.6**
Structural Grade: **0**
O&M Grade: **2**
Clock Start/From: **8**
Clock To: **9**
1st Value:
2nd Value:
Value Percent: **5.000**
Continuous Index:
Within 8" of Joint: **NO**
Remarks:

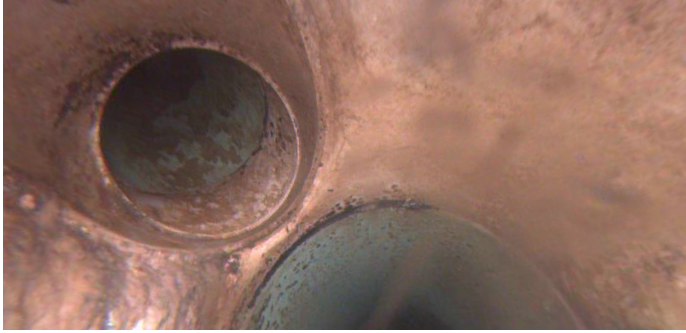
Code: **TFA**
Description: **Tap Factory Active**

Distance (ft): **91.1**
Structural Grade: **0**
O&M Grade: **0**
Clock Start/From: **10**
Clock To:
1st Value: **4.000**
2nd Value:
Value Percent:
Continuous Index:
Within 8" of Joint:
Remarks:

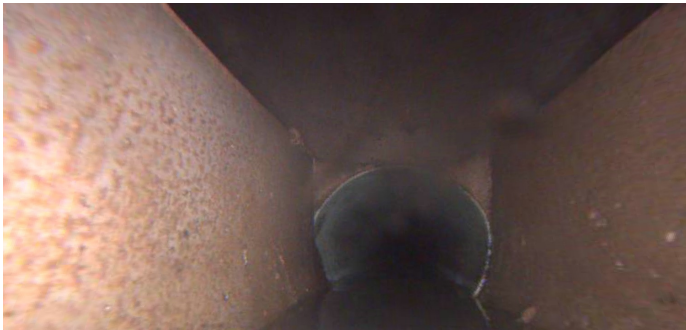
Code: **AMH**
Description: **Manhole**

Distance (ft): **112.4**
Structural Grade: **0**
O&M Grade: **0**
Clock Start/From:
Clock To:
1st Value:
2nd Value:
Value Percent:
Continuous Index:
Within 8" of Joint: **NO**
Remarks: **M-607-051**
