Profile/Photo Observation Report

Date:	04/11/2018	Weather:		Coding:	PACP 6.0
Pipe Length (ft):	158.0	Owner:	NA	Pre Clean:	No Pre-Cleaning
P.O.#:		Surveyor:	Jen Costello	PSR:	P-607-052-053
Customer:		Clean Date:	01/01/1900	Shape:	C

Street:	MEDLEE DR	Flow Control:	Not Controlled
City:	Hobart, IN	Year Renewed:	
Location:	Yard	Tape/Media #:	
Purpose:	Routine Assessment	Dia/Height:	10"
Use:	Sanitary	Material:	PVC
Drain Area:	NA	Lining:	
Category:	NA		
Comment:	Flow direction is marked wrong.		
Location Details:		Direction of Survey:	Upstream
US MH:	M-607-053	DS MH:	M-607-052
		Total Length Surveyed (ft):	148.7

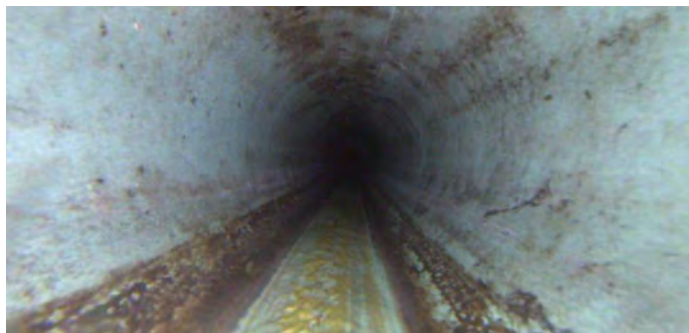
Code: AMH

Description: Manhole

Distance (ft): .0

Remarks: M-607-052

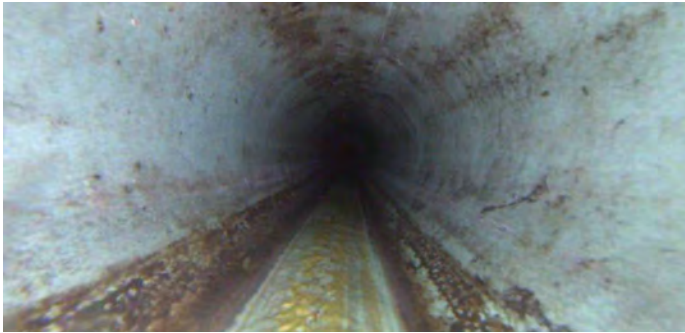
Code:	MWL
Description:	Water Level

Distance (ft):	.0
Structural Grade:	0
O&M Grade:	0
Clock Start/From:	
Clock To:	
1st Value:	
2nd Value:	
Value Percent:	5.000
Continuous Index:	
Within 8" of Joint:	NO
Remarks:

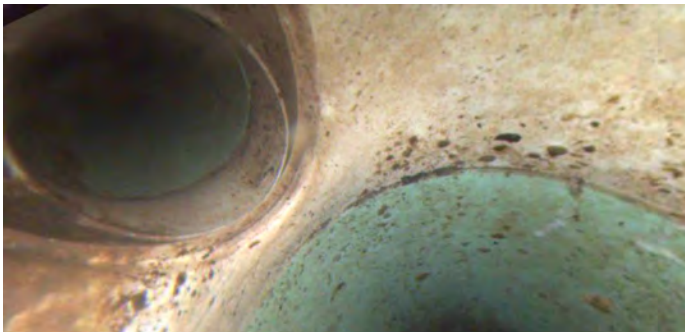
Code:	TF
Description:	Tap Factory

Distance (ft):	9.9
Structural Grade:	0
O&M Grade:	0
Clock Start/From:	2
Clock To:	
1st Value:	4.000
2nd Value:	
Value Percent:	
Continuous Index:	
Within 8" of Joint:	
Remarks:

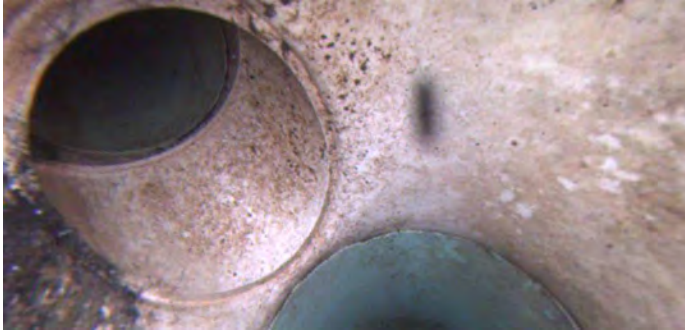
Code: **TF**
Description: **Tap Factory**

Distance (ft): **22.5**
Structural Grade: **0**
O&M Grade: **0**
Clock Start/From: **10**
Clock To:
1st Value: **4.000**
2nd Value:
Value Percent:
Continuous Index:
Within 8" of Joint:
Remarks:

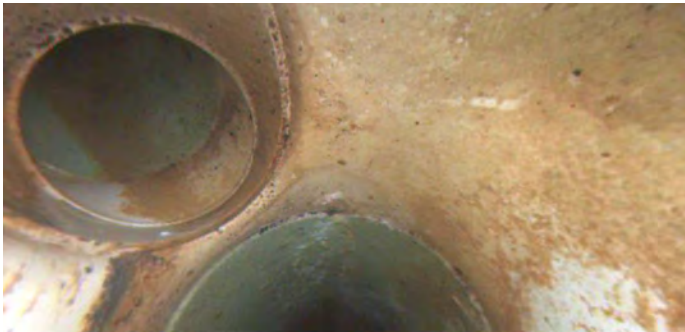
Code: **TF**
Description: **Tap Factory**

Distance (ft): **80.0**
Structural Grade: **0**
O&M Grade: **0**
Clock Start/From: **1**
Clock To:
1st Value: **4.000**
2nd Value:
Value Percent:
Continuous Index:
Within 8" of Joint:
Remarks:

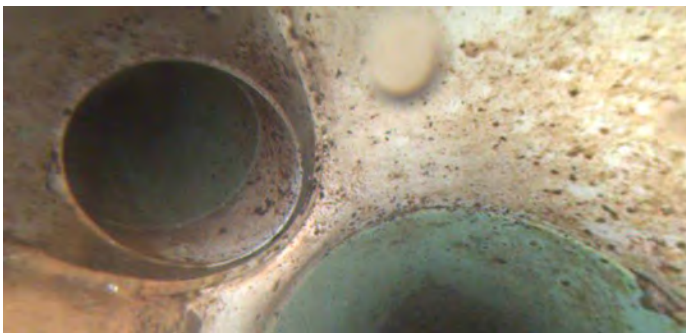
Code: **TF**
Description: **Tap Factory**

Distance (ft): **126.6**
Structural Grade: **0**
O&M Grade: **0**
Clock Start/From: **2**
Clock To:
1st Value: **4.000**
2nd Value:
Value Percent:
Continuous Index:
Within 8" of Joint:
Remarks:

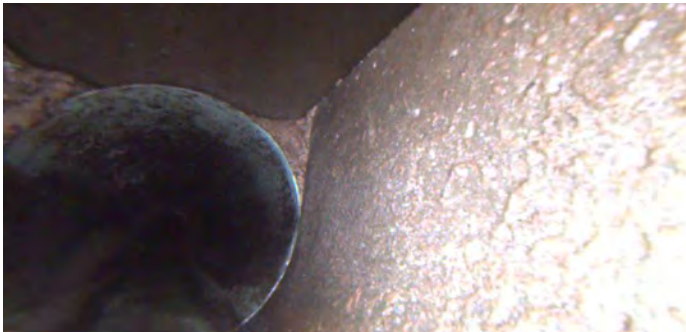
Code: **AMH**
Description: **Manhole**

Distance (ft): **148.7**
Structural Grade: **0**
O&M Grade: **0**
Clock Start/From:
Clock To:
1st Value:
2nd Value:
Value Percent:
Continuous Index:
Within 8" of Joint: **NO**
Remarks: **M-607-053**
