## Profile/Photo Observation Report

Date:	<b>04/11/2018</b>	Weather:		Coding:	<b>PACP 6.0</b>
Pipe Length (ft):	<b>158.0</b>	Owner:	<b>NA</b>	Pre Clean:	<b>No Pre-Cleaning</b>
P.O.#:		Surveyor:	<b>Jen Costello</b>	PSR:	<b>P-607-052-053</b>
Customer:		Clean Date:	<b>01/01/1900</b>	Shape:	<b>C</b>

Street:	<b>FOXCROFT STREET</b>	Flow Control:	<b>Not Controlled</b>
City:	<b>Hobart, IN</b>	Year Renewed:	
Location:	<b>Yard</b>	Tape/Media #:	
Purpose:	<b>Routine Assessment</b>	Dia/Height:	<b>10"</b>
Use:	<b>Sanitary</b>	Material:	<b>PVC</b>
Drain Area:	<b>NA</b>	Lining:	
Category:	<b>NA</b>		
Comment:	<b>Flow direction is marked wrong.</b>		
Location Details:		Direction of Survey:	<b>Upstream</b>
US MH:	<b>M-607-053</b>	DS MH:	<b>M-607-052</b>
		Total Length Surveyed (ft):	<b>148.7</b>

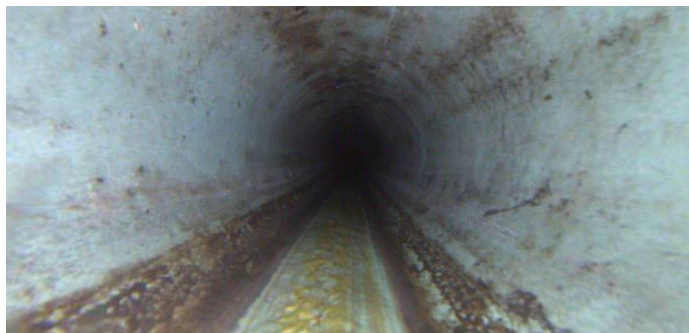
AMH

Manhole

.0

M-607-052

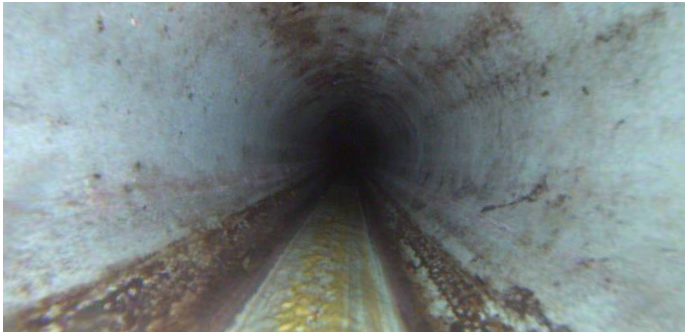
Code: **MWL**  
Description: **Water Level**

Distance (ft): **.0**  
Structural Grade: **0**  
O&M Grade: **0**  
Clock Start/From:  
Clock To:  
1st Value:  
2nd Value:  
Value Percent: **5.000**  
Continuous Index:  
Within 8" of Joint: **NO**  
Remarks:

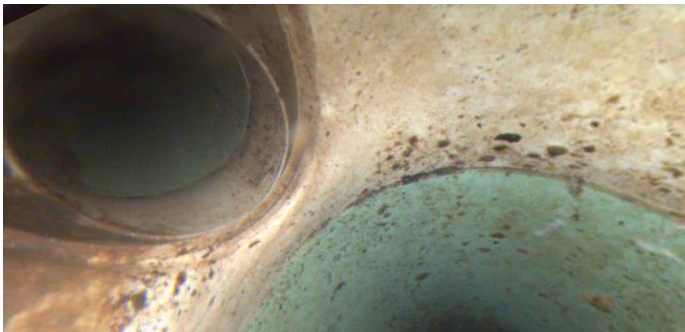
Code: **TF**  
Description: **Tap Factory**

Distance (ft): **9.9**  
Structural Grade: **0**  
O&M Grade: **0**  
Clock Start/From: **2**  
Clock To:  
1st Value: **4.000**  
2nd Value:  
Value Percent:  
Continuous Index:  
Within 8" of Joint:  
Remarks:

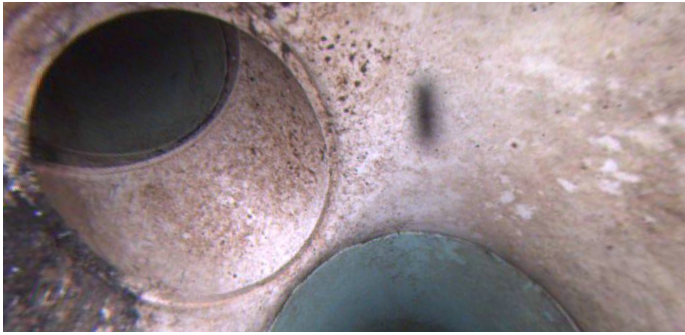
Code: **TF**  
Description: **Tap Factory**

Distance (ft): **22.5**  
Structural Grade: **0**  
O&M Grade: **0**  
Clock Start/From: **10**  
Clock To:  
1st Value: **4.000**  
2nd Value:  
Value Percent:  
Continuous Index:  
Within 8" of Joint:  
Remarks:

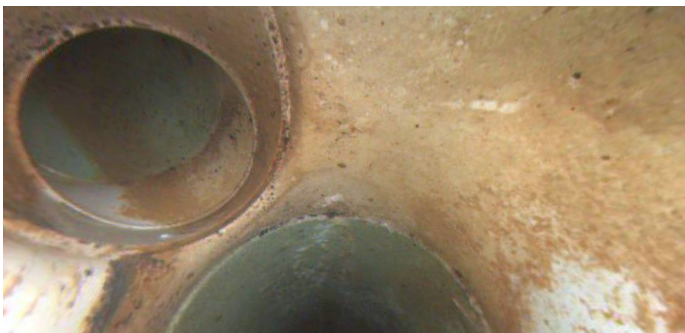
Code: **TF**  
Description: **Tap Factory**

Distance (ft): **80.0**  
Structural Grade: **0**  
O&M Grade: **0**  
Clock Start/From: **1**  
Clock To:  
1st Value: **4.000**  
2nd Value:  
Value Percent:  
Continuous Index:  
Within 8" of Joint:  
Remarks:

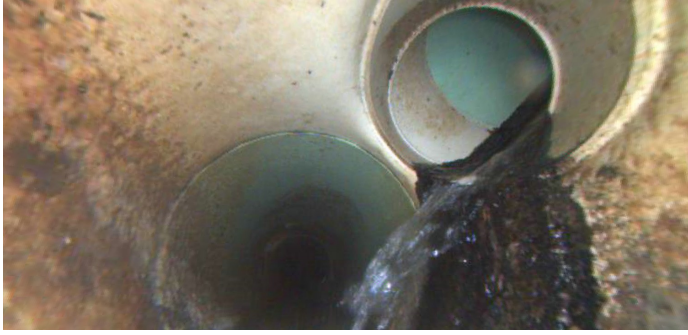
Code: **TFA**  
Description: **Tap Factory Active**

Distance (ft): **83.5**  
Structural Grade: **0**  
O&M Grade: **0**  
Clock Start/From: **10**  
Clock To:  
1st Value: **4.000**  
2nd Value:  
Value Percent:  
Continuous Index:  
Within 8" of Joint:  
Remarks:

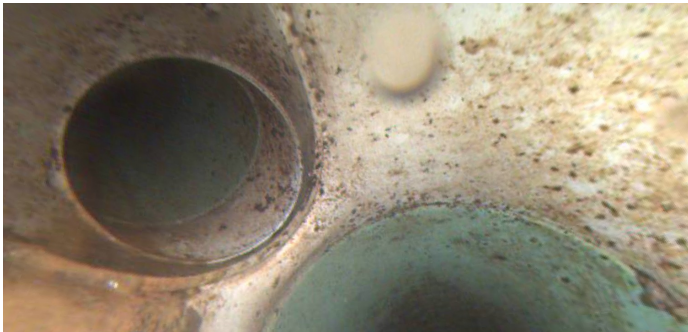
Code: **TF**  
Description: **Tap Factory**

Distance (ft): **126.6**  
Structural Grade: **0**  
O&M Grade: **0**  
Clock Start/From: **2**  
Clock To:  
1st Value: **4.000**  
2nd Value:  
Value Percent:  
Continuous Index:  
Within 8" of Joint:  
Remarks:

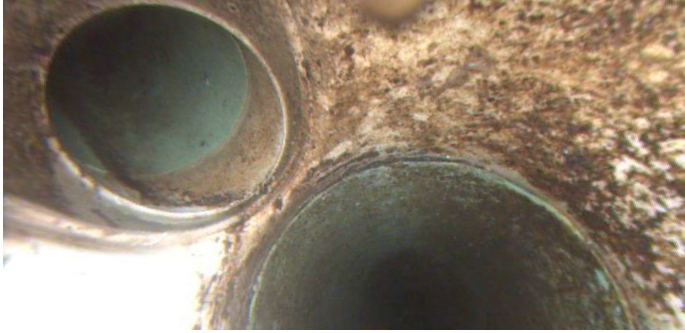
Code: **TF**  
Description: **Tap Factory**

Distance (ft): **134.4**  
Structural Grade: **0**  
O&M Grade: **0**  
Clock Start/From: **2**  
Clock To:  
1st Value: **4.000**  
2nd Value:  
Value Percent:  
Continuous Index:  
Within 8" of Joint:  
Remarks:

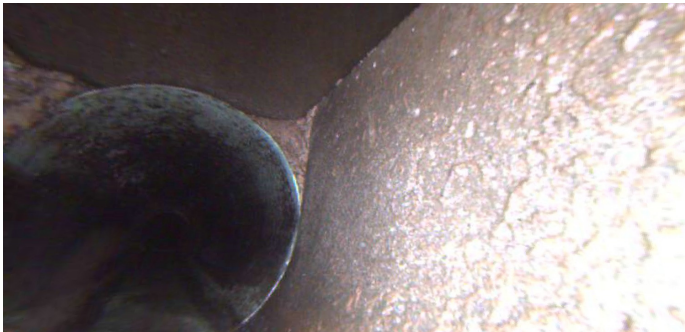
Code: **AMH**  
Description: **Manhole**

Distance (ft): **148.7**  
Structural Grade: **0**  
O&M Grade: **0**  
Clock Start/From:  
Clock To:  
1st Value:  
2nd Value:  
Value Percent:  
Continuous Index:  
Within 8" of Joint: **NO**  
Remarks: **M-607-053**
