Profile/Photo Observation Report

Street:	FOXCROFT STREET	Flow Control:	Not Controlled
City:	Hobart, IN	Year Renewed:	
Location:	Yard	Tape/Media #:	
Purpose:	Routine Assessment	Dia/Height:	10"
Use:	Sanitary	Material:	PVC
Drain Area:	NA	Lining:	
Category:	NA		
Comment:			
Location Details:		Direction of Survey:	Upstream
US MH:	M-607-054	DS MH:	M-607-071
		Total Length Surveyed (ft):	323.9

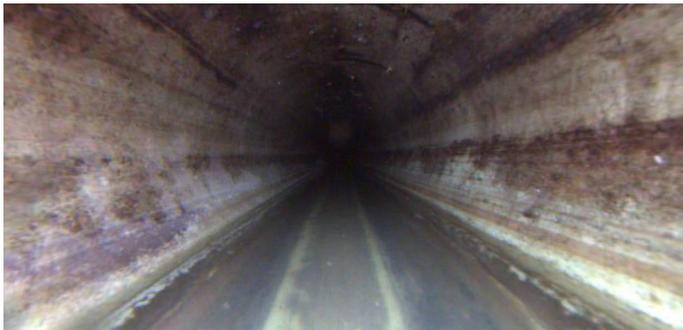
Code: **AMH**
 Description: **Manhole**

Distance (ft): **.0**
 Structural Grade: **0**
 O&M Grade: **0**
 Clock Start/From:
 Clock To:
 1st Value:
 2nd Value:
 Value Percent:
 Continuous Index:
 Within 8" of Joint: **NO**
 Remarks: **M-607-071**

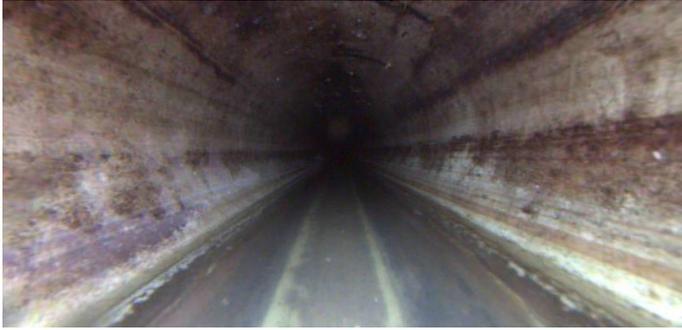
Code: **MWL**
Description: **Water Level**

Distance (ft): **.0**
Structural Grade: **0**
O&M Grade: **0**
Clock Start/From:
Clock To:
1st Value:
2nd Value:
Value Percent: **10.000**
Continuous Index:
Within 8" of Joint: **NO**
Remarks:

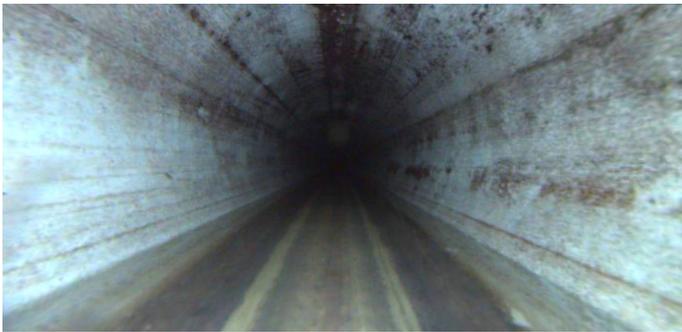
Code: **MWL**
Description: **Water Level**

Distance (ft): **66.2**
Structural Grade: **0**
O&M Grade: **0**
Clock Start/From:
Clock To:
1st Value:
2nd Value:
Value Percent: **20.000**
Continuous Index:
Within 8" of Joint: **NO**
Remarks:

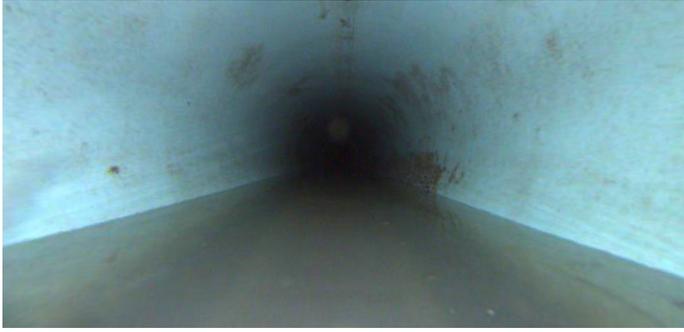
Code: **MWL**
Description: **Water Level**

Distance (ft): **245.0**
Structural Grade: **0**
O&M Grade: **0**
Clock Start/From:
Clock To:
1st Value:
2nd Value:
Value Percent: **30.000**
Continuous Index:
Within 8" of Joint: **NO**
Remarks:

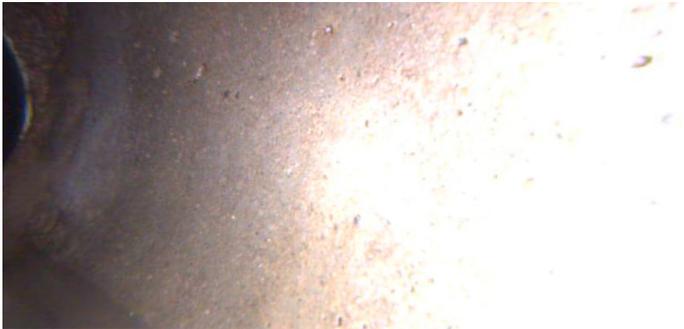
Code: **AMH**
Description: **Manhole**

Distance (ft): **323.9**
Structural Grade: **0**
O&M Grade: **0**
Clock Start/From:
Clock To:
1st Value:
2nd Value:
Value Percent:
Continuous Index:
Within 8" of Joint: **NO**
Remarks: **M-607-054**
