## Profile/Photo Observation Report

Street:	<b>FOXCROFT STREET</b>	Flow Control:	<b>Not Controlled</b>
City:	<b>Hobart, IN</b>	Year Renewed:	
Location:	<b>Yard</b>	Tape/Media #:	
Purpose:	<b>Routine Assessment</b>	Dia/Height:	<b>12"</b>
Use:	<b>Sanitary</b>	Material:	<b>PVC</b>
Drain Area:	<b>NA</b>	Lining:	
Category:	<b>NA</b>		
Comment:

Location Details:		Direction of Survey:	<b>Upstream</b>
US MH:	<b>M-607-059</b>	DS MH:	<b>M-607-058</b>
		Total Length Surveyed (ft):	<b>71.0</b>

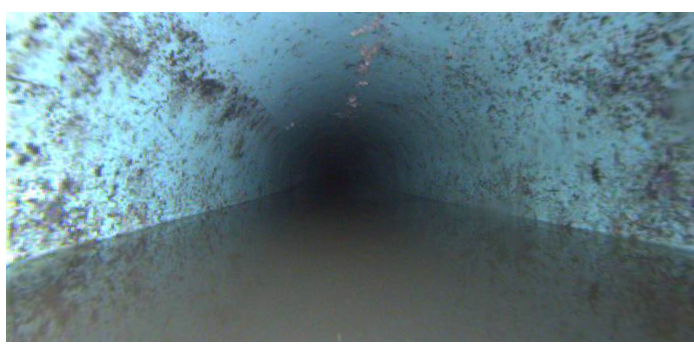
Code: **AMH**  
Description: **Manhole**

Distance (ft): **.0**  
Structural Grade: **0**  
O&M Grade: **0**  
Clock Start/From:  
Clock To:  
1st Value:  
2nd Value:  
Value Percent:  
Continuous Index:  
Within 8" of Joint: **NO**  
Remarks: **M-607-058**

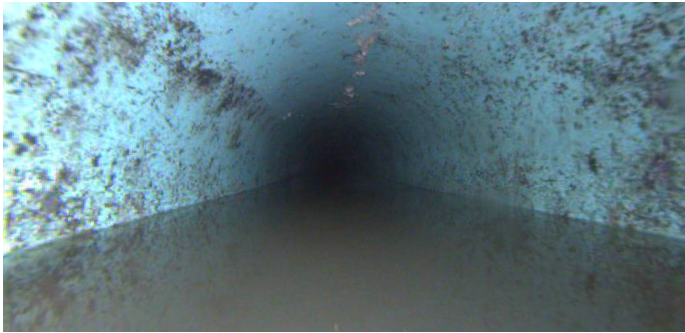
Code:	<b>MWL</b>
Description:	<b>Water Level</b>

Distance (ft):	<b>.0</b>
Structural Grade:	<b>0</b>
O&M Grade:	<b>0</b>
Clock Start/From:	
Clock To:	
1st Value:	
2nd Value:	
Value Percent:	<b>40.000</b>
Continuous Index:	
Within 8" of Joint:	<b>NO</b>
Remarks:

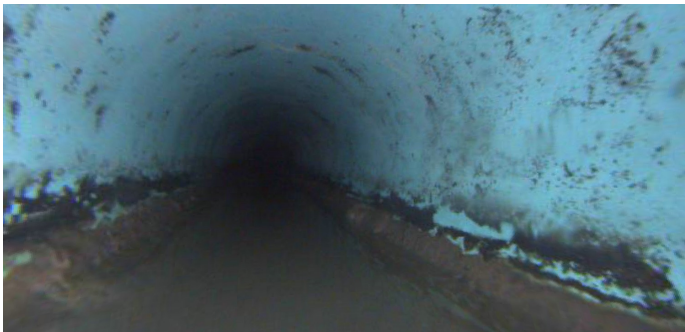
Code:	<b>DAGS</b>
Description:	<b>Deposits Attached Grease</b>

Distance (ft):	<b>5.5</b>
Structural Grade:	<b>0</b>
O&M Grade:	<b>2</b>
Clock Start/From:	<b>8</b>
Clock To:	<b>4</b>
1st Value:	
2nd Value:	
Value Percent:	<b>5.000</b>
Continuous Index:	<b>S01</b>
Within 8" of Joint:	<b>NO</b>
Remarks:

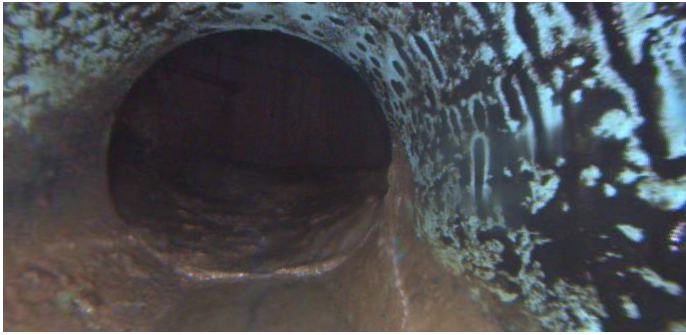
Code: **DAGS**  
Description: **Deposits Attached Grease**

Distance (ft): **69.0**  
Structural Grade: **0**  
O&M Grade: **2**  
Clock Start/From: **8**  
Clock To: **4**  
1st Value:  
2nd Value:  
Value Percent: **5.000**  
Continuous Index: **F01**  
Within 8" of Joint: **NO**  
Remarks:

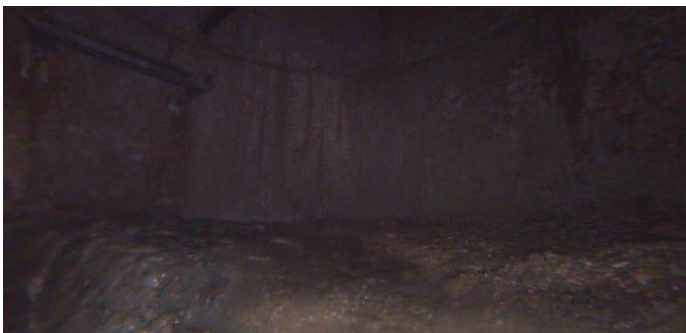
Code: **AMH**  
Description: **Manhole**

Distance (ft): **71.0**  
Structural Grade: **0**  
O&M Grade: **0**  
Clock Start/From:  
Clock To:  
1st Value:  
2nd Value:  
Value Percent:  
Continuous Index:  
Within 8" of Joint: **NO**  
Remarks: **M-607-059**
