## Profile/Photo Observation Report

Street:	<b>West 14th Street</b>	Flow Control:	<b>Not Controlled</b>
City:	<b>Hobart, IN</b>	Year Renewed:	
Location:	<b>Light Highway</b>	Tape/Media #:	<b>DEP215</b>
Purpose:	<b>Routine Assessment</b>	Dia/Height:	<b>15"</b>
Use:	<b>Sanitary</b>	Material:	<b>PVC</b>
Drain Area:		Lining:	
Category:	<b>NA</b>		
Comment:	<b>YES501824 Submittal 2</b>

Location Details:		Direction of Survey:	<b>Upstream</b>
US MH:	<b>M-607-061</b>	DS MH:	<b>M-607-064</b>
		Total Length Surveyed (ft):	<b>396.3</b>

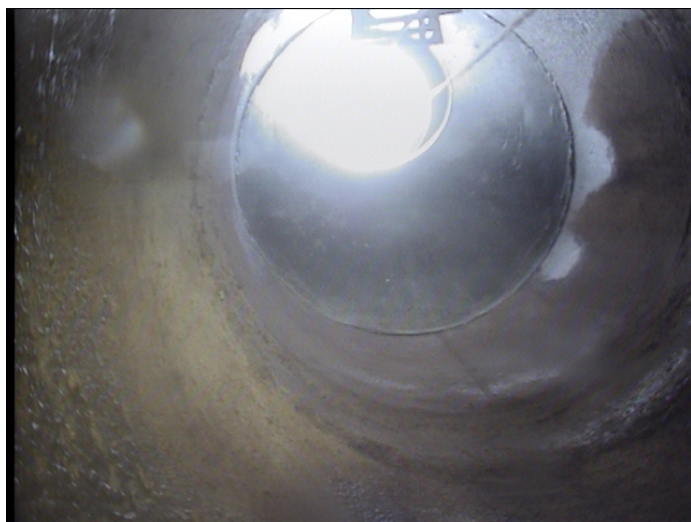
Code: **AMH**  
Description: **Manhole**

Distance (ft): **.0**  
Structural Grade: **0**  
O&M Grade: **0**  
Clock Start/From:  
Clock To:  
1st Value:  
2nd Value:  
Value Percent:  
Continuous Index:  
Within 8" of Joint: **NO**  
Remarks: **M-607-064**

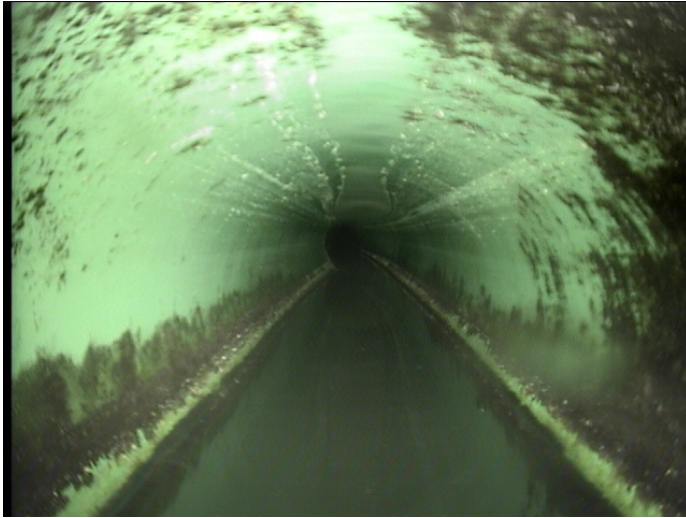
Code:	<b>MWL</b>
Description:	<b>Water Level</b>
Distance (ft):	<b>.0</b>
Structural Grade:	<b>0</b>
O&M Grade:	<b>0</b>
Clock Start/From:	
Clock To:	
1st Value:	
2nd Value:	
Value Percent:	<b>10.000</b>
Continuous Index:	
Within 8" of Joint:	<b>NO</b>
Remarks:

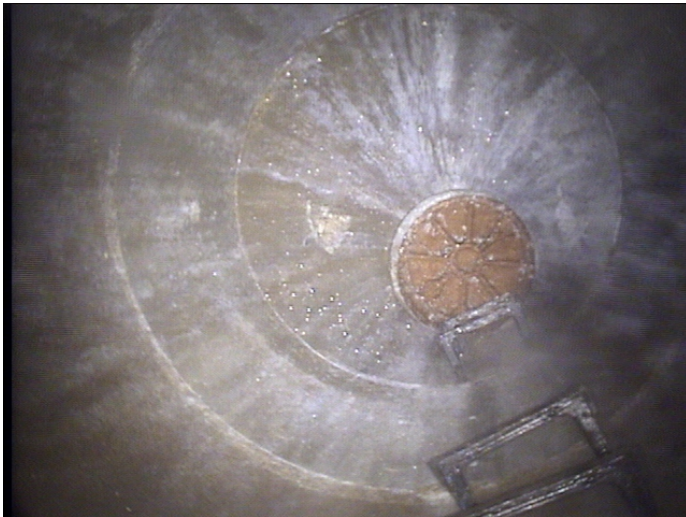
Code:	<b>AMH</b>
Description:	<b>Manhole</b>
Distance (ft):	<b>396.3</b>
Structural Grade:	<b>0</b>
O&M Grade:	<b>0</b>
Clock Start/From:	
Clock To:	
1st Value:	
2nd Value:	
Value Percent:	
Continuous Index:	
Within 8" of Joint:	<b>NO</b>
Remarks:	<b>M-607-061</b>
