Profile/Photo Observation Report

Street:	FOXCROFT STREET	Flow Control:	Not Controlled
City:	Hobart, IN	Year Renewed:	
Location:	Yard	Tape/Media #:	
Purpose:	Routine Assessment	Dia/Height:	8"
Use:	Sanitary	Material:	PVC
Drain Area:	NA	Lining:	
Category:	NA		
Comment:

Location Details:		Direction of Survey:	Upstream
US MH:	M-607-066	DS MH:	M-608-022
		Total Length Surveyed (ft):	74.4

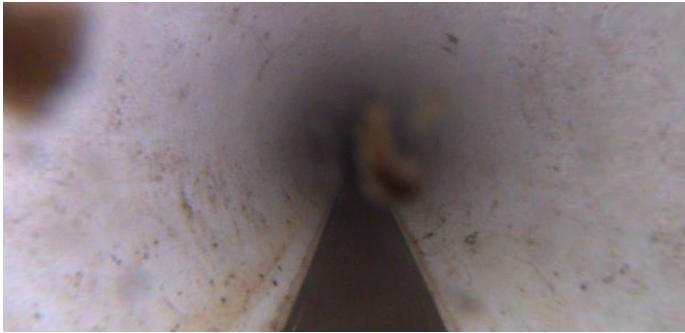
Code:	MWL
Description:	Water Level

Distance (ft):	.0
Structural Grade:	0
O&M Grade:	0
Clock Start/From:	
Clock To:	
1st Value:	
2nd Value:	
Value Percent:	5.000
Continuous Index:	
Within 8" of Joint:	NO
Remarks:

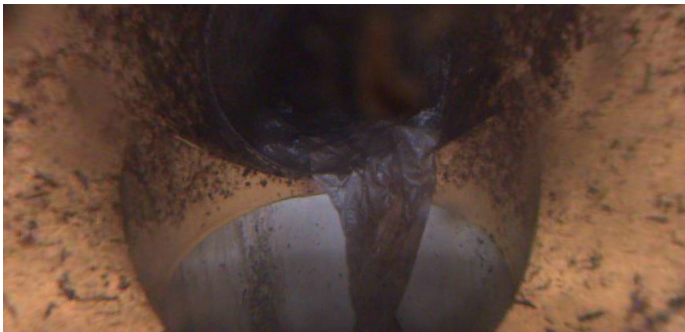
Code:	TF
Description:	Tap Factory

Distance (ft):	72.0
Structural Grade:	0
O&M Grade:	0
Clock Start/From:	6
Clock To:	
1st Value:	6.000
2nd Value:	
Value Percent:	
Continuous Index:	
Within 8" of Joint:	
Remarks:	drop connection

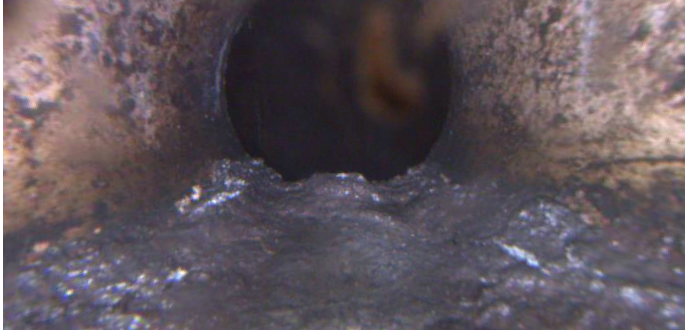
Code: **DSF**
Description: **Deposits Settled Fine**

Distance (ft): **73.0**
Structural Grade: **0**
O&M Grade: **3**
Clock Start/From: **4**
Clock To: **8**
1st Value:
2nd Value:
Value Percent: **20.000**
Continuous Index:
Within 8" of Joint: **NO**
Remarks:
