Profile/Photo Observation Report

Street:	W 14TH ST	Flow Control:	Not Controlled
City:	Hobart, IN	Year Renewed:	
Location:	Yard	Tape/Media #:	
Purpose:	Routine Assessment	Dia/Height:	12"
Use:	Sanitary	Material:	PVC
Drain Area:	NA	Lining:	
Category:	NA		
Comment:

Location Details:		Direction of Survey:	Upstream
US MH:	M-607-067	DS MH:	M-607-065
		Total Length Surveyed (ft):	351.9

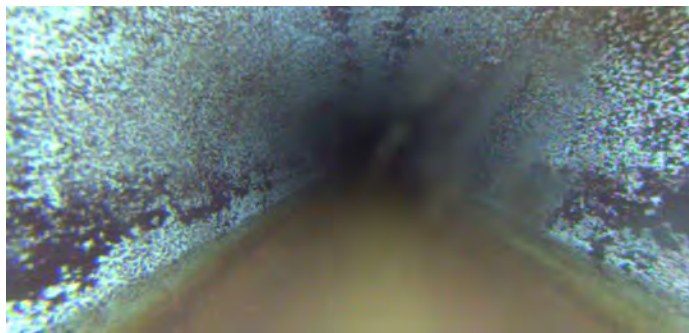
Code: **AMH**
Description: **Manhole**

Distance (ft): **.0**
Structural Grade: **0**
O&M Grade: **0**
Clock Start/From:
Clock To:
1st Value:
2nd Value:
Value Percent:
Continuous Index:
Within 8" of Joint: **NO**
Remarks: **M-607-065**

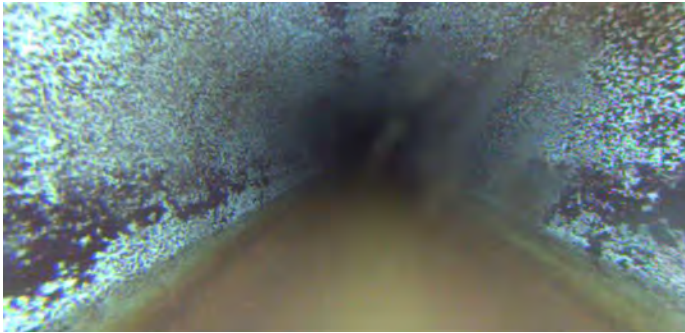
Code:	MWL
Description:	Water Level

Distance (ft):	.0
Structural Grade:	0
O&M Grade:	0
Clock Start/From:	
Clock To:	
1st Value:	
2nd Value:	
Value Percent:	30.000
Continuous Index:	
Within 8" of Joint:	NO
Remarks:

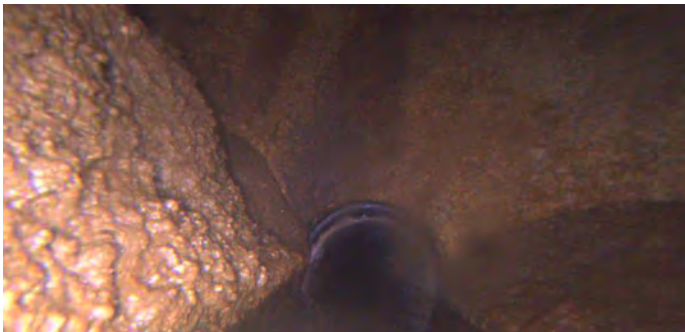
Code:	AMH
Description:	Manhole

Distance (ft):	351.9
Structural Grade:	0
O&M Grade:	0
Clock Start/From:	
Clock To:	
1st Value:	
2nd Value:	
Value Percent:	
Continuous Index:	
Within 8" of Joint:	NO
Remarks:	M-607-067
