Profile/Photo Observation Report

Street:	FOXCROFT STREET	Flow Control:	Not Controlled
City:	Hobart, IN	Year Renewed:	
Location:	Yard	Tape/Media #:	
Purpose:	Routine Assessment	Dia/Height:	12"
Use:	Sanitary	Material:	PVC
Drain Area:	NA	Lining:	
Category:	NA		
Comment:

Location Details:		Direction of Survey:	Upstream
US MH:	M-607-067	DS MH:	M-607-065
		Total Length Surveyed (ft):	351.9

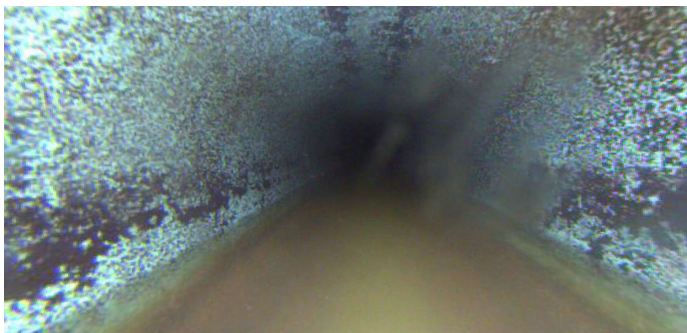
Code: **AMH**
Description: **Manhole**

Distance (ft): **.0**
Structural Grade: **0**
O&M Grade: **0**
Clock Start/From:
Clock To:
1st Value:
2nd Value:
Value Percent:
Continuous Index:
Within 8" of Joint: **NO**
Remarks: **M-607-065**

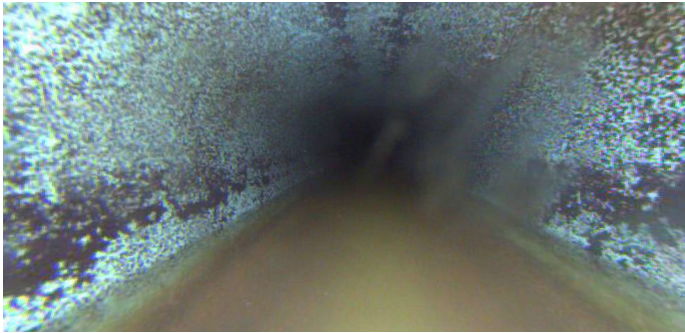
Code:	MWL
Description:	Water Level

Distance (ft):	.0
Structural Grade:	0
O&M Grade:	0
Clock Start/From:	
Clock To:	
1st Value:	
2nd Value:	
Value Percent:	30.000
Continuous Index:	
Within 8" of Joint:	NO
Remarks:

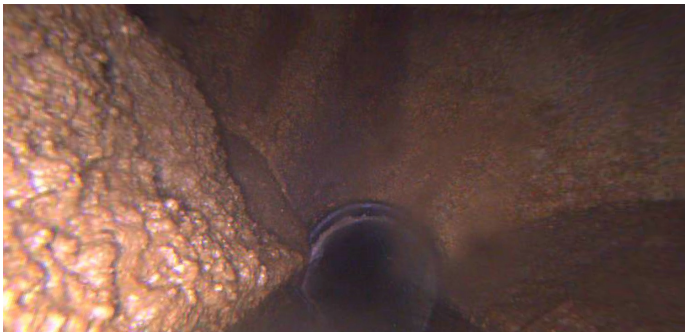
Code:	AMH
Description:	Manhole

Distance (ft):	351.9
Structural Grade:	0
O&M Grade:	0
Clock Start/From:	
Clock To:	
1st Value:	
2nd Value:	
Value Percent:	
Continuous Index:	
Within 8" of Joint:	NO
Remarks:	M-607-067
