Profile/Photo Observation Report

Street:	FOXCROFT STREET	Flow Control:	Not Controlled
City:	Hobart, IN	Year Renewed:	
Location:	Yard	Tape/Media #:	
Purpose:	Routine Assessment	Dia/Height:	8"
Use:	Sanitary	Material:	PVC
Drain Area:	NA	Lining:	
Category:	NA		
Comment:

Location Details:		Direction of Survey:	Downstream
US MH:	M-607-069	DS MH:	M-607-038
		Total Length Surveyed (ft):	70.9

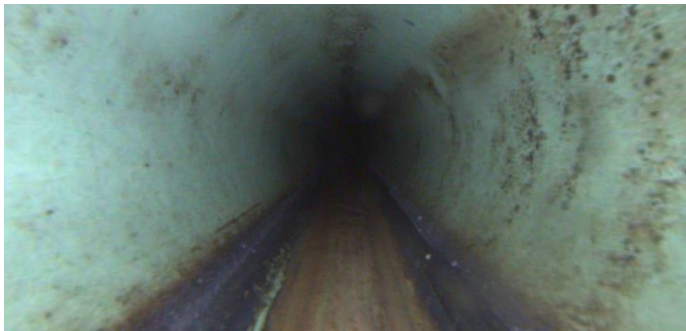
Code: **AMH**
Description: **Manhole**

Distance (ft): **.0**
Structural Grade: **0**
O&M Grade: **0**
Clock Start/From:
Clock To:
1st Value:
2nd Value:
Value Percent:
Continuous Index:
Within 8" of Joint: **NO**
Remarks: **M-607-069**

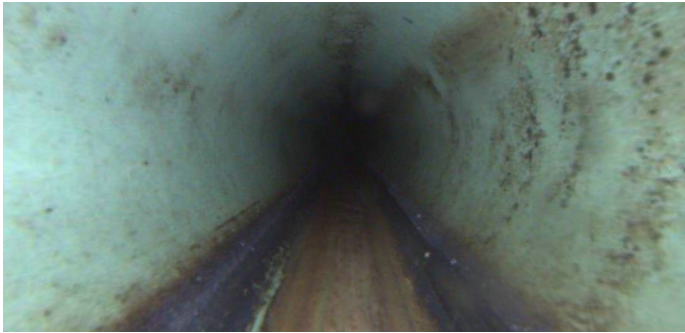
Code:	MWL
Description:	Water Level

Distance (ft):	.0
Structural Grade:	0
O&M Grade:	0
Clock Start/From:	
Clock To:	
1st Value:	
2nd Value:	
Value Percent:	5.000
Continuous Index:	
Within 8" of Joint:	NO
Remarks:

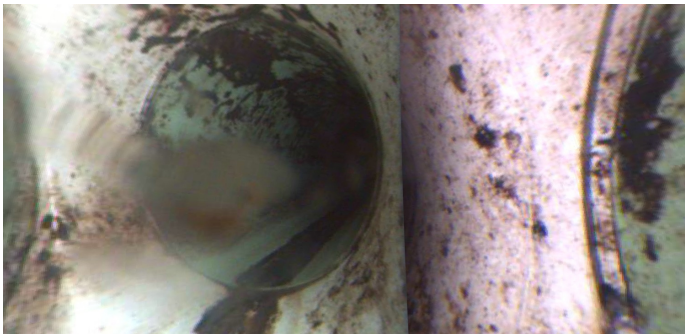
Code:	TFA
Description:	Tap Factory Active

Distance (ft):	55.0
Structural Grade:	0
O&M Grade:	0
Clock Start/From:	9
Clock To:	
1st Value:	4.000
2nd Value:	
Value Percent:	
Continuous Index:	
Within 8" of Joint:	
Remarks:

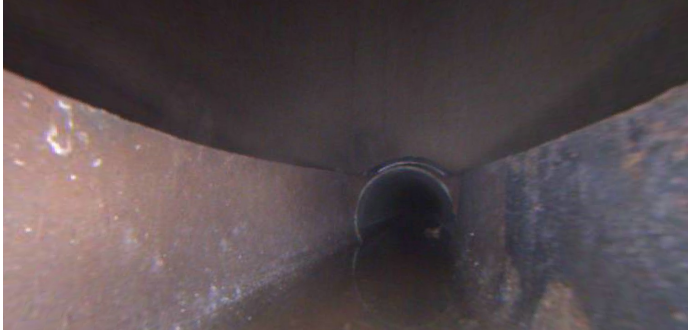
Code:	AMH
Description:	Manhole
Distance (ft):	70.9
Structural Grade:	0
O&M Grade:	0
Clock Start/From:	
Clock To:	
1st Value:	
2nd Value:	
Value Percent:	
Continuous Index:	
Within 8" of Joint:	NO
Remarks:	M-607-038
