Profile/Photo Observation Report

Street:	W 10TH ST	Flow Control:	Not Controlled
City:	Hobart, IN	Year Renewed:	
Location:	Yard	Tape/Media #:	
Purpose:	Routine Assessment	Dia/Height:	10"
Use:	Sanitary	Material:	PVC
Drain Area:	NA	Lining:	
Category:	NA		
Comment:

Location Details:		Direction of Survey:	Downstream
US MH:	M-607-071	DS MH:	M-607-022
		Total Length Surveyed (ft):	35.0

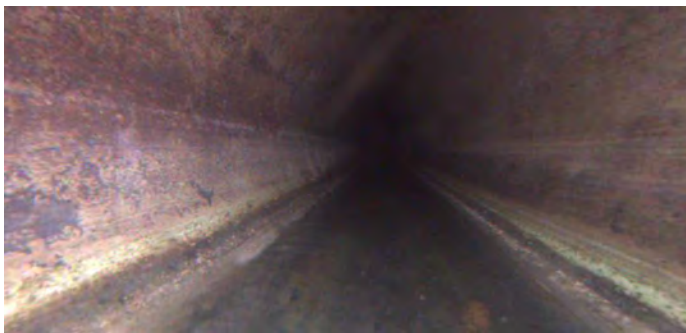
Code: **AMH**
Description: **Manhole**

Distance (ft): **.0**
Structural Grade: **0**
O&M Grade: **0**
Clock Start/From:
Clock To:
1st Value:
2nd Value:
Value Percent:
Continuous Index:
Within 8" of Joint: **NO**
Remarks: **M-607-071**

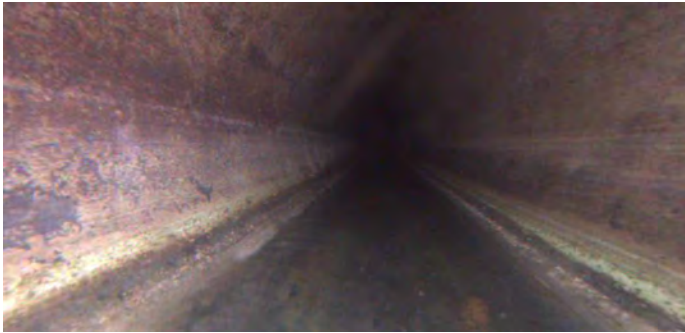
Code:	MWL
Description:	Water Level

Distance (ft):	.0
Structural Grade:	0
O&M Grade:	0
Clock Start/From:	
Clock To:	
1st Value:	
2nd Value:	
Value Percent:	5.000
Continuous Index:	
Within 8" of Joint:	NO
Remarks:

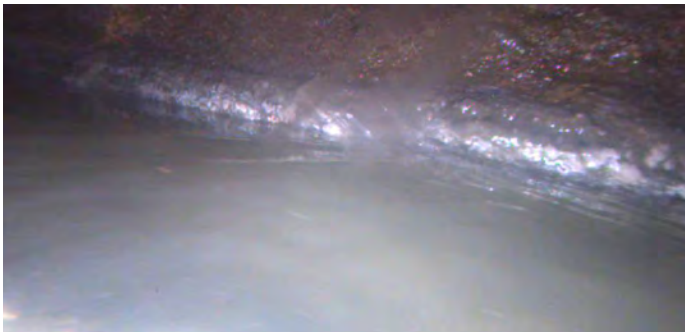
Code:	AMH
Description:	Manhole

Distance (ft):	35.0
Structural Grade:	0
O&M Grade:	0
Clock Start/From:	
Clock To:	
1st Value:	
2nd Value:	
Value Percent:	
Continuous Index:	
Within 8" of Joint:	NO
Remarks:	M-607-022
