Profile/Photo Observation Report

Date:	06/21/2023	Weather:		Coding:	PACP 7.0
Pipe Length (ft):	155.6	Owner:	City of Hobart	Pre Clean:	No Pre-Cleaning
P.O.#:	YES502259	Surveyor:	S. Bucklin	PSR:	M-607-072-M-607-074
Customer:	City of Hobart	Clean Date:		Shape:	C

Street:	South Ash Street	Flow Control:	Not Controlled
City:	Hobart, IN	Year Renewed:	
Location:	Easement/Right of Way	Tape/Media #:	
Purpose:	Routine Assessment	Dia/Height:	8"
Use:	Sanitary Sewage Pipe	Material:	PVC
Drain Area:		Lining:	None
Category:	NA

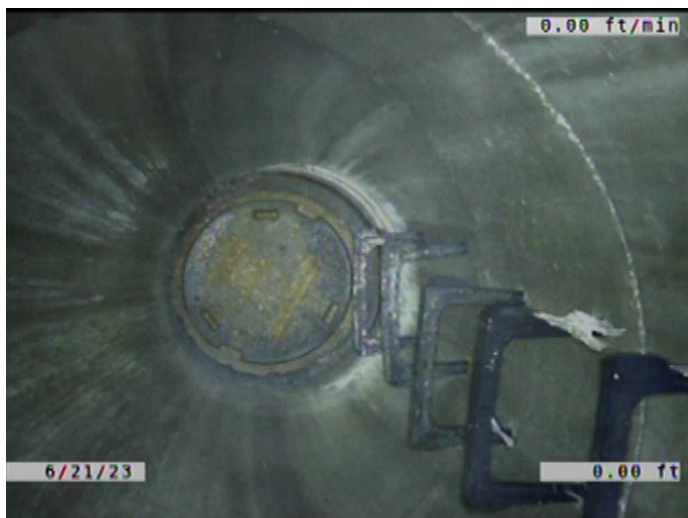
Code: **AMH**
Description: **Manhole**

Distance (ft): **.0**
Structural Grade: **0**
O&M Grade: **0**
Clock Start/From:
Clock To:
1st Value:
2nd Value:
Value Percent:
Continuous Index:
Within 8" of Joint: **NO**
Remarks: **M-607-074**

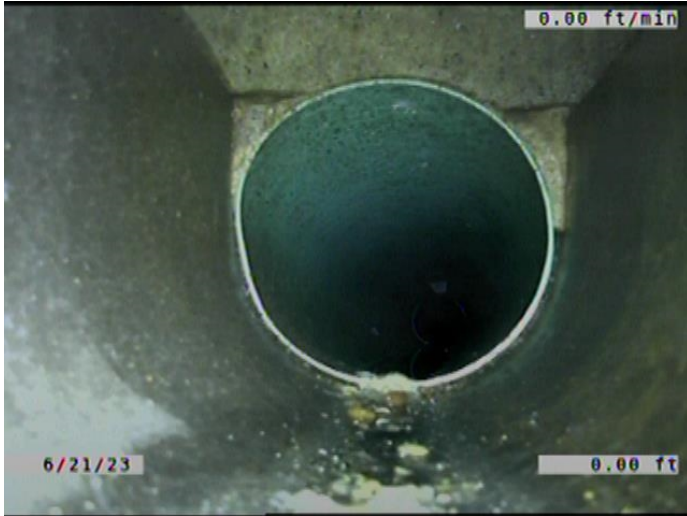
Code: **MWL**
Description: **Miscellaneous Water Level**

Distance (ft): **.0**
Structural Grade: **0**
O&M Grade: **0**
Clock Start/From:
Clock To:
1st Value:
2nd Value:
Value Percent: **5.000**
Continuous Index:
Within 8" of Joint: **NO**
Remarks:

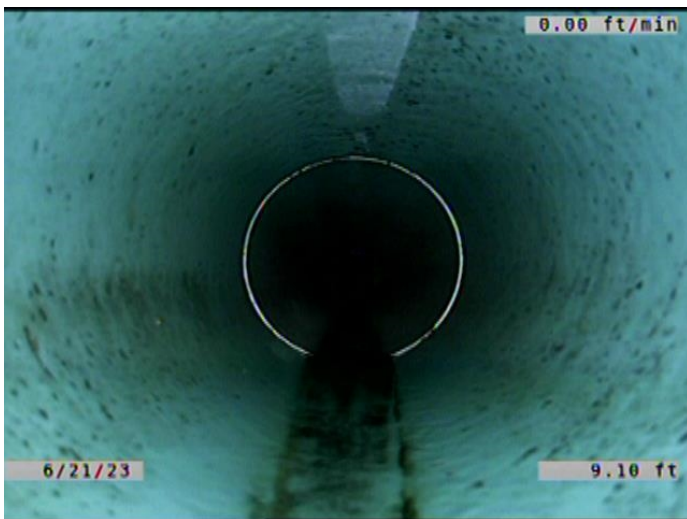
Code: **MWLS**
Description: **Miscellaneous Water Level Sag**

Distance (ft): **9.1**
Structural Grade: **2**
O&M Grade: **0**
Clock Start/From:
Clock To:
1st Value:
2nd Value:
Value Percent: **5.000**
Continuous Index: **S01**
Within 8" of Joint: **NO**
Remarks:

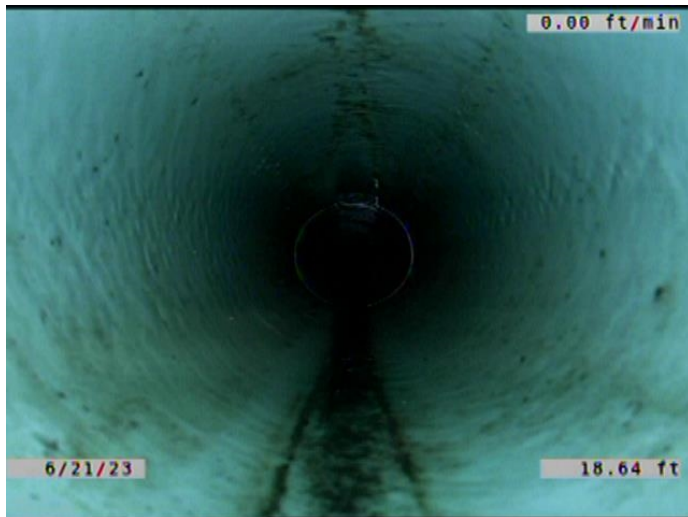
Code: **MWLS**
Description: **Miscellaneous Water Level Sag**

Distance (ft): **18.6**
Structural Grade: **2**
O&M Grade: **0**
Clock Start/From:
Clock To:
1st Value:
2nd Value:
Value Percent: **5.000**
Continuous Index: **F01**
Within 8" of Joint: **NO**
Remarks:

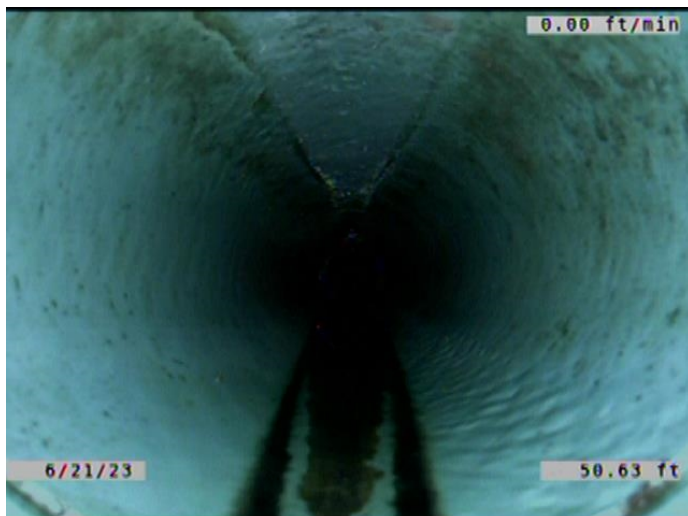
Code: **MWLS**
Description: **Miscellaneous Water Level Sag**

Distance (ft): **50.6**
Structural Grade: **2**
O&M Grade: **0**
Clock Start/From:
Clock To:
1st Value:
2nd Value:
Value Percent: **10.000**
Continuous Index: **S02**
Within 8" of Joint: **NO**
Remarks:

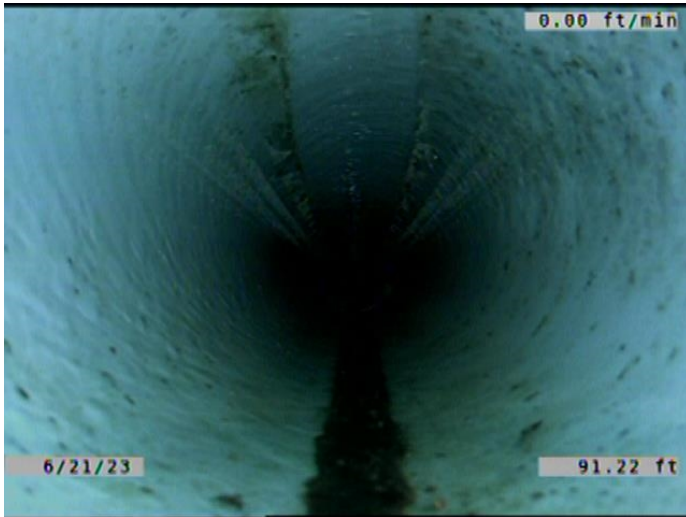
Code: **MWLS**
Description: **Miscellaneous Water Level Sag**

Distance (ft): **91.2**
Structural Grade: **2**
O&M Grade: **0**
Clock Start/From:
Clock To:
1st Value:
2nd Value:
Value Percent: **10.000**
Continuous Index: **F02**
Within 8" of Joint: **NO**
Remarks:

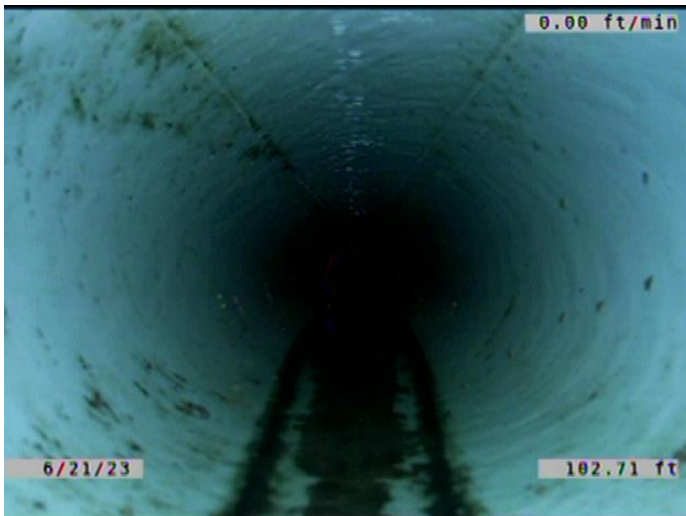
Code: **MWLS**
Description: **Miscellaneous Water Level Sag**

Distance (ft): **102.7**
Structural Grade: **2**
O&M Grade: **0**
Clock Start/From:
Clock To:
1st Value:
2nd Value:
Value Percent: **15.000**
Continuous Index: **S03**
Within 8" of Joint: **NO**
Remarks:

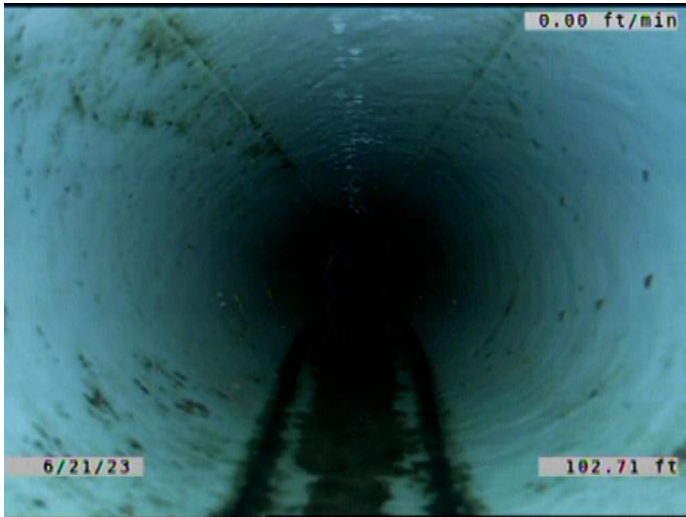
Code: **DSF**
Description: **Deposits Settled Fine**

Distance (ft): **102.7**
Structural Grade: **0**
O&M Grade: **2**
Clock Start/From: **5**
Clock To: **7**
1st Value:
2nd Value:
Value Percent: **5.000**
Continuous Index: **S04**
Within 8" of Joint: **YES**
Remarks:

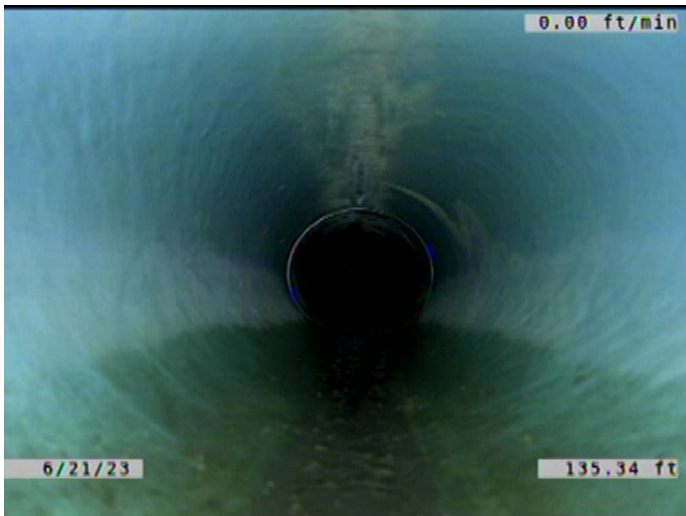
Code: **MWLS**
Description: **Miscellaneous Water Level Sag**

Distance (ft): **135.3**
Structural Grade: **2**
O&M Grade: **0**
Clock Start/From:
Clock To:
1st Value:
2nd Value:
Value Percent: **15.000**
Continuous Index: **F03**
Within 8" of Joint: **NO**
Remarks:

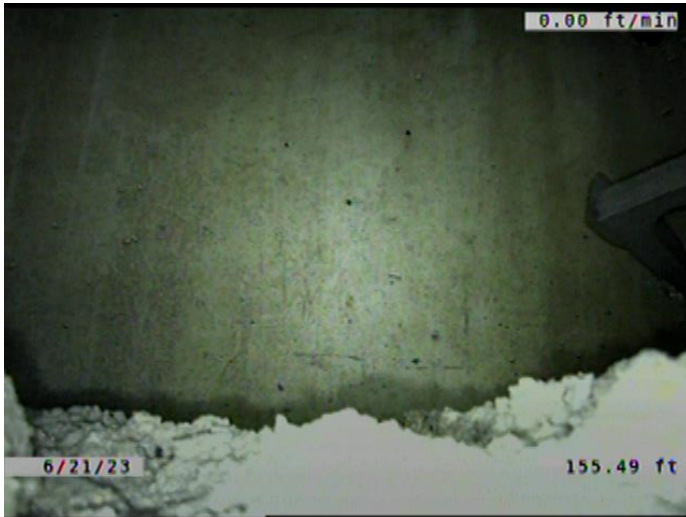
Code: **DSF**
 Description: **Deposits Settled Fine**

Distance (ft): **155.5**
 Structural Grade: **0**
 O&M Grade: **2**
 Clock Start/From: **5**
 Clock To: **7**
 1st Value:
 2nd Value:
 Value Percent: **5.000**
 Continuous Index: **F04**
 Within 8" of Joint: **YES**
 Remarks:

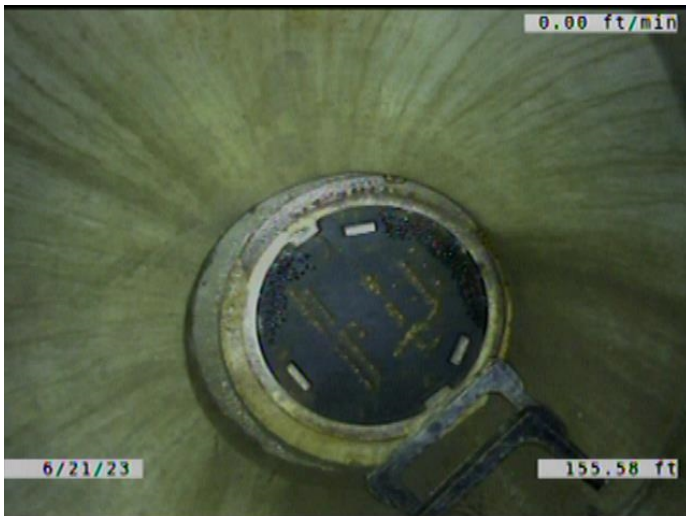
Code: **AMH**
 Description: **Manhole**

Distance (ft): **155.6**
 Structural Grade: **0**
 O&M Grade: **0**
 Clock Start/From:
 Clock To:
 1st Value:
 2nd Value:
 Value Percent:
 Continuous Index:
 Within 8" of Joint: **NO**
 Remarks: **M-607-072**
