## Profile/Photo Observation Report

Date:	<b>04/03/2018</b>	Weather:		Coding:	<b>PACP 6.0</b>
Pipe Length (ft):	<b>255.5</b>	Owner:	<b>NA</b>	Pre Clean:	<b>No Pre-Cleaning</b>
P.O.#:		Surveyor:	<b>Jen Costello</b>	PSR:	<b>P-607-073-074</b>
Customer:		Clean Date:	<b>01/01/1900</b>	Shape:	<b>C</b>

Street:	<b>S ASH ST</b>	Flow Control:	<b>Not Controlled</b>
City:	<b>Hobart, IN</b>	Year Renewed:	
Location:	<b>Yard</b>	Tape/Media #:	
Purpose:	<b>Routine Assessment</b>	Dia/Height:	<b>10"</b>
Use:	<b>Sanitary</b>	Material:	<b>PVC</b>
Drain Area:	<b>NA</b>	Lining:	
Category:	<b>NA</b>		
Comment:	<b>Flow direction is marked wrong.</b>		
Location Details:		Direction of Survey:	<b>Downstream</b>
US MH:	<b>M-607-074</b>	DS MH:	<b>M-607-073</b>
		Total Length Surveyed (ft):	<b>255.2</b>

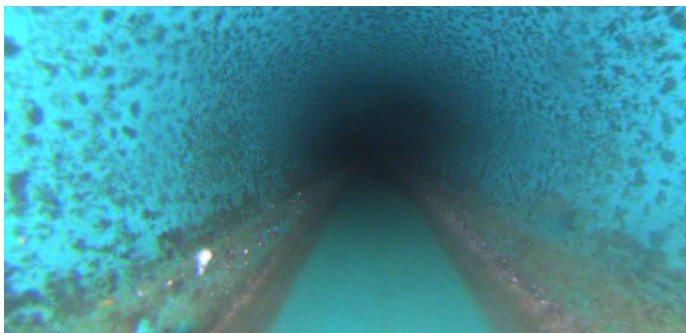
Code: **AMH**  
Description: **Manhole**

Distance (ft): **.0**  
Structural Grade: **0**  
O&M Grade: **0**  
Clock Start/From:  
Clock To:  
1st Value:  
2nd Value:  
Value Percent:  
Continuous Index:  
Within 8" of Joint: **NO**  
Remarks: **M-607-074**

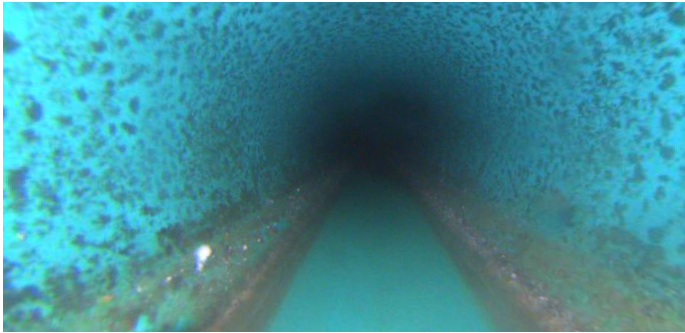
Code:	<b>MWL</b>
Description:	<b>Water Level</b>

Distance (ft):	<b>.0</b>
Structural Grade:	<b>0</b>
O&M Grade:	<b>0</b>
Clock Start/From:	
Clock To:	
1st Value:	
2nd Value:	
Value Percent:	<b>5.000</b>
Continuous Index:	
Within 8" of Joint:	<b>NO</b>
Remarks:

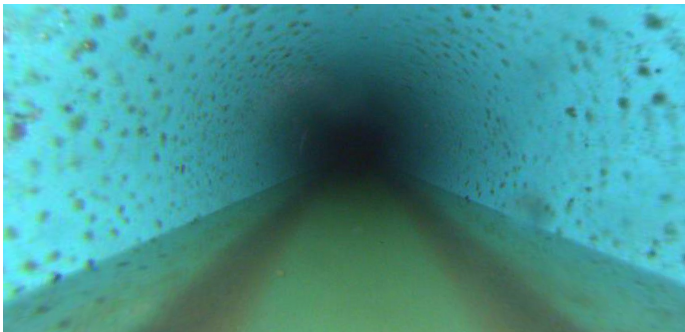
Code:	<b>MWL</b>
Description:	<b>Water Level</b>

Distance (ft):	<b>142.1</b>
Structural Grade:	<b>0</b>
O&M Grade:	<b>0</b>
Clock Start/From:	
Clock To:	
1st Value:	
2nd Value:	
Value Percent:	<b>30.000</b>
Continuous Index:	
Within 8" of Joint:	<b>NO</b>
Remarks:

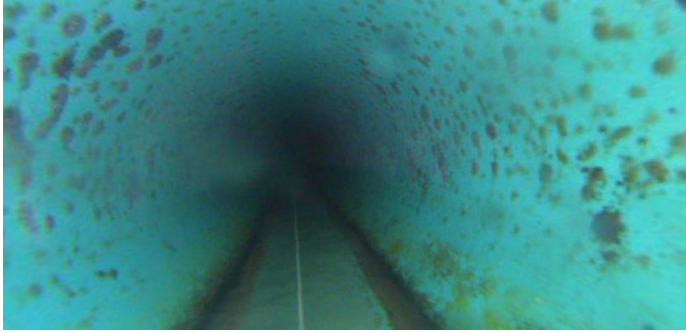
Code: **MGO**  
Description: **General Observation**

Distance (ft): **241.8**  
Structural Grade: **0**  
O&M Grade: **0**  
Clock Start/From:  
Clock To:  
1st Value:  
2nd Value:  
Value Percent:  
Continuous Index:  
Within 8" of Joint: **NO**  
Remarks: **REAR CAMERA**

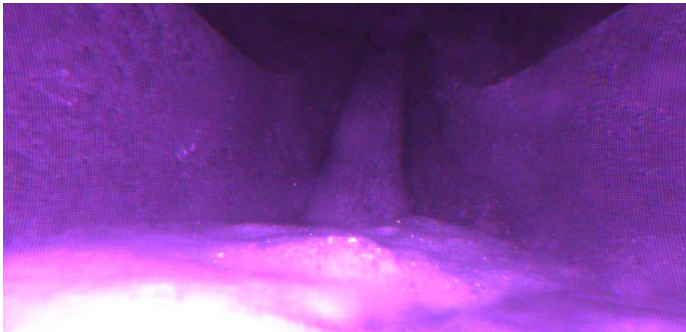
Code: **AMH**  
Description: **Manhole**

Distance (ft): **255.2**  
Structural Grade: **0**  
O&M Grade: **0**  
Clock Start/From:  
Clock To:  
1st Value:  
2nd Value:  
Value Percent:  
Continuous Index:  
Within 8" of Joint: **NO**  
Remarks: **M-607-073**
