## Profile/Photo Observation Report

Date:	<b>03/30/2018</b>	Weather:		Coding:	<b>PACP 6.0</b>
Pipe Length (ft):	<b>205.9</b>	Owner:	<b>NA</b>	Pre Clean:	<b>No Pre-Cleaning</b>
P.O.#:		Surveyor:	<b>Jen Costello</b>	PSR:	<b>P-607-074-075</b>
Customer:		Clean Date:	<b>01/01/1900</b>	Shape:	<b>C</b>

Street:	<b>FOXCROFT STREET</b>	Flow Control:	<b>Not Controlled</b>
City:	<b>Hobart, IN</b>	Year Renewed:	
Location:	<b>Yard</b>	Tape/Media #:	
Purpose:	<b>Routine Assessment</b>	Dia/Height:	<b>8"</b>
Use:	<b>Sanitary</b>	Material:	<b>PVC</b>
Drain Area:	<b>NA</b>	Lining:	
Category:	<b>NA</b>		
Comment:	<b>g</b>

Location Details:		Direction of Survey:	<b>Upstream</b>
US MH:	<b>M-607-074</b>	DS MH:	<b>M-607-075</b>
		Total Length Surveyed (ft):	<b>205.1</b>

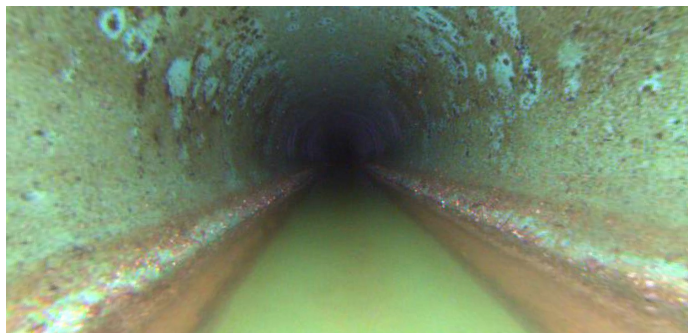
Code: **AMH**  
Description: **Manhole**

Distance (ft): **.0**  
Structural Grade: **0**  
O&M Grade: **0**  
Clock Start/From:  
Clock To:  
1st Value:  
2nd Value:  
Value Percent:  
Continuous Index:  
Within 8" of Joint: **NO**  
Remarks: **M-607-075**

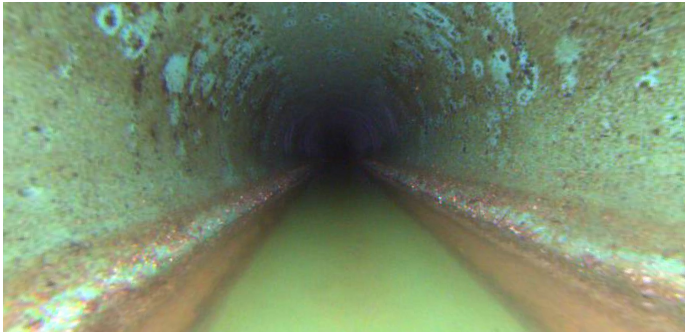
Code:	<b>MWL</b>
Description:	<b>Water Level</b>

Distance (ft):	<b>.0</b>
Structural Grade:	<b>0</b>
O&M Grade:	<b>0</b>
Clock Start/From:	
Clock To:	
1st Value:	
2nd Value:	
Value Percent:	<b>10.000</b>
Continuous Index:	
Within 8" of Joint:	<b>NO</b>
Remarks:

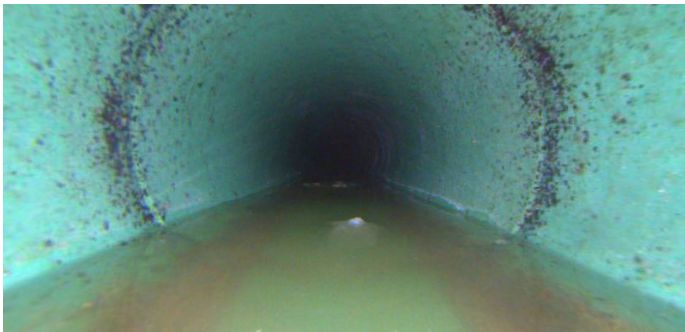
Code:	<b>MWL</b>
Description:	<b>Water Level</b>

Distance (ft):	<b>141.0</b>
Structural Grade:	<b>0</b>
O&M Grade:	<b>0</b>
Clock Start/From:	
Clock To:	
1st Value:	
2nd Value:	
Value Percent:	<b>20.000</b>
Continuous Index:	
Within 8" of Joint:	<b>NO</b>
Remarks:

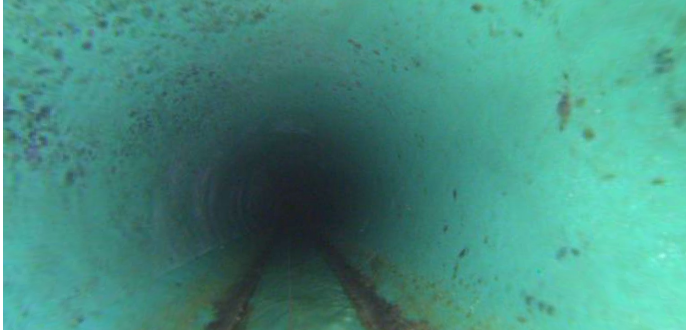
Code: **MGO**  
Description: **General Observation**

Distance (ft): **149.6**  
Structural Grade: **0**  
O&M Grade: **0**  
Clock Start/From:  
Clock To:  
1st Value:  
2nd Value:  
Value Percent:  
Continuous Index:  
Within 8" of Joint: **NO**  
Remarks: **rear camera**

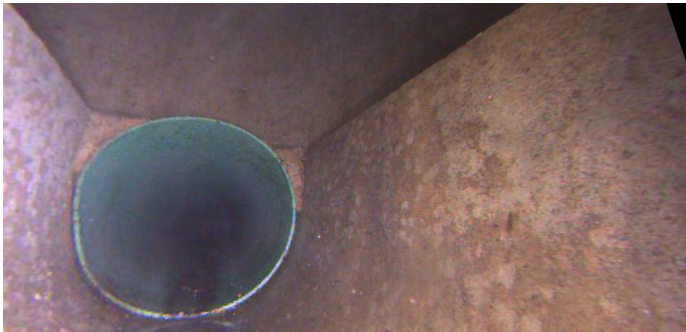
Code: **AMH**  
Description: **Manhole**

Distance (ft): **205.1**  
Structural Grade: **0**  
O&M Grade: **0**  
Clock Start/From:  
Clock To:  
1st Value:  
2nd Value:  
Value Percent:  
Continuous Index:  
Within 8" of Joint: **NO**  
Remarks: **M-607-074**
