Profile/Photo Observation Report

Date:	03/30/2018	Weather:		Coding:	PACP 6.0
Pipe Length (ft):	349.9	Owner:	NA	Pre Clean:	No Pre-Cleaning
P.O.#:		Surveyor:	Jen Costello	PSR:	P-608-041-077
Customer:		Clean Date:	01/01/1900	Shape:	C

Street:	FOXCROFT STREET	Flow Control:	Not Controlled
City:	Hobart, IN	Year Renewed:	
Location:	Light Highway	Tape/Media #:	
Purpose:	Routine Assessment	Dia/Height:	10"
Use:	Sanitary	Material:	PVC
Drain Area:	NA	Lining:	
Category:	NA		
Comment:	Flow direction wrong		
Location Details:		Direction of Survey:	Upstream
US MH:	M-607-077	DS MH:	M-608-041
		Total Length Surveyed (ft):	349.9

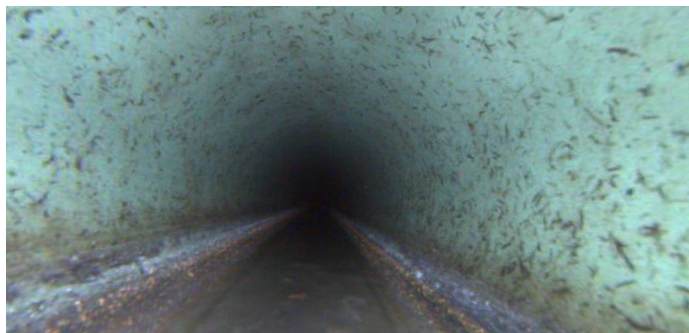
Code: **AMH**
Description: **Manhole**

Distance (ft): **.0**
Structural Grade: **0**
O&M Grade: **0**
Clock Start/From:
Clock To:
1st Value:
2nd Value:
Value Percent:
Continuous Index:
Within 8" of Joint: **NO**
Remarks: **M-608-041**

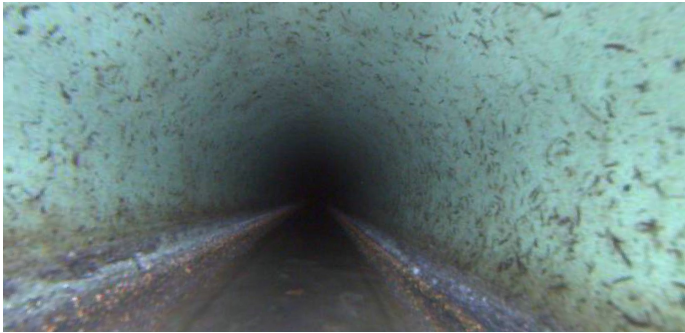
Code:	MWL
Description:	Water Level

Distance (ft):	.0
Structural Grade:	0
O&M Grade:	0
Clock Start/From:	
Clock To:	
1st Value:	
2nd Value:	
Value Percent:	10.000
Continuous Index:	
Within 8" of Joint:	NO
Remarks:

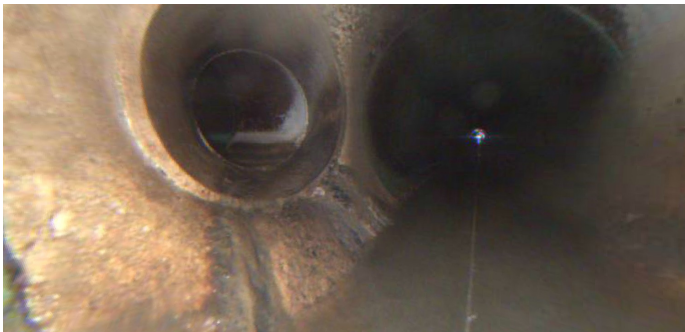
Code:	TF
Description:	Tap Factory

Distance (ft):	130.0
Structural Grade:	0
O&M Grade:	0
Clock Start/From:	3
Clock To:	
1st Value:	4.000
2nd Value:	
Value Percent:	
Continuous Index:	
Within 8" of Joint:	
Remarks:

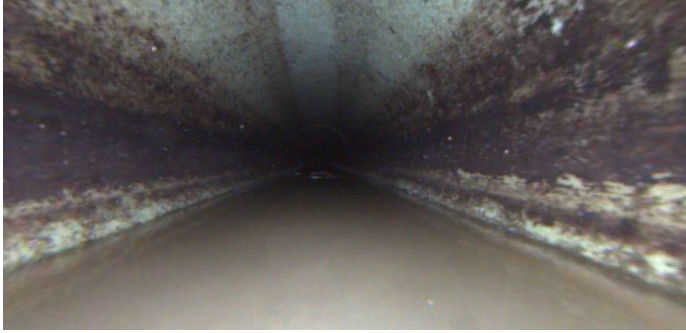
Code: **MWL**
Description: **Water Level**

Distance (ft): **325.2**
Structural Grade: **0**
O&M Grade: **0**
Clock Start/From:
Clock To:
1st Value:
2nd Value:
Value Percent: **30.000**
Continuous Index:
Within 8" of Joint: **NO**
Remarks:

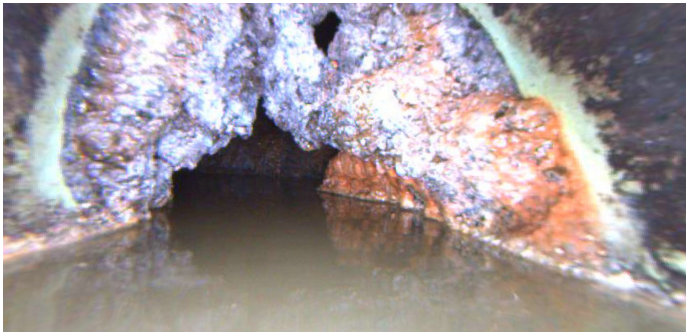
Code: **DAE**
Description: **Deposits Attached Encrustation**

Distance (ft): **347.3**
Structural Grade: **0**
O&M Grade: **5**
Clock Start/From: **8**
Clock To: **4**
1st Value:
2nd Value:
Value Percent: **60.000**
Continuous Index:
Within 8" of Joint: **NO**
Remarks: **AT MH**

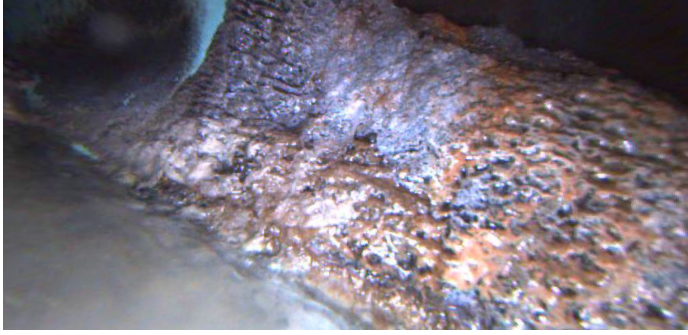
Code:	AMH
Description:	Manhole
Distance (ft):	349.9
Structural Grade:	0
O&M Grade:	0
Clock Start/From:	
Clock To:	
1st Value:	
2nd Value:	
Value Percent:	
Continuous Index:	
Within 8" of Joint:	NO
Remarks:	M-607-077
