Profile/Photo Observation Report

Date:	04/11/2018	Weather:		Coding:	PACP 6.0
Pipe Length (ft):	113.8	Owner:	NA	Pre Clean:	No Pre-Cleaning
P.O.#:		Surveyor:	Jen Costello	PSR:	P-607-078-018
Customer:		Clean Date:	01/01/1900	Shape:	C

Street:	S ASH ST & W 10TH ST	Flow Control:	Not Controlled
City:	Hobart, IN	Year Renewed:	
Location:	Yard	Tape/Media #:	
Purpose:	Routine Assessment	Dia/Height:	8"
Use:	Sanitary	Material:	PVC
Drain Area:	NA	Lining:	
Category:	NA		
Comment:			
Location Details:		Direction of Survey:	Downstream
US MH:	M-607-078	DS MH:	M-607-018
		Total Length Surveyed (ft):	110.8

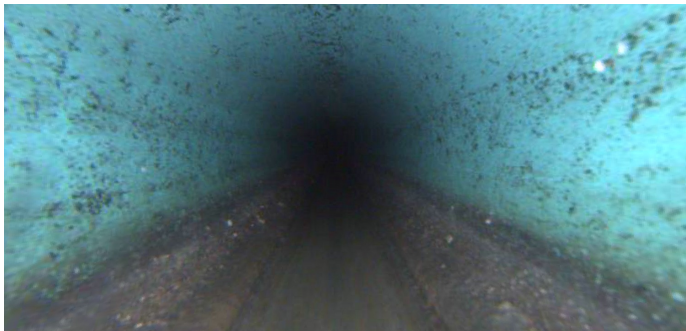
Code: **AMH**
Description: **Manhole**

Distance (ft): **.0**
Structural Grade: **0**
O&M Grade: **0**
Clock Start/From:
Clock To:
1st Value:
2nd Value:
Value Percent:
Continuous Index:
Within 8" of Joint: **NO**
Remarks: **M-607-078**

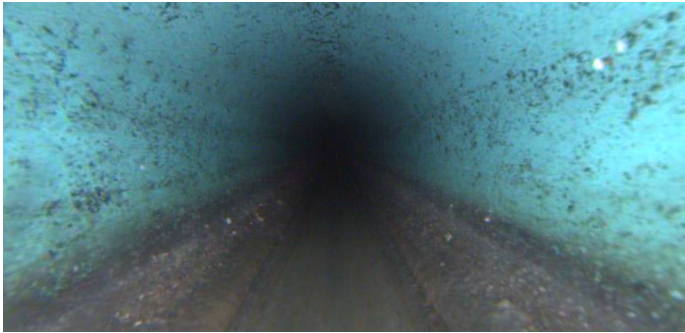
Code:	MWL
Description:	Water Level

Distance (ft):	.0
Structural Grade:	0
O&M Grade:	0
Clock Start/From:	
Clock To:	
1st Value:	
2nd Value:	
Value Percent:	5.000
Continuous Index:	
Within 8" of Joint:	NO
Remarks:

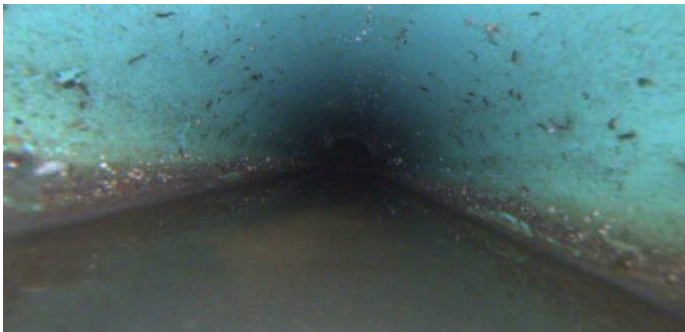
Code:	MWL
Description:	Water Level

Distance (ft):	105.4
Structural Grade:	0
O&M Grade:	0
Clock Start/From:	
Clock To:	
1st Value:	
2nd Value:	
Value Percent:	40.000
Continuous Index:	
Within 8" of Joint:	NO
Remarks:

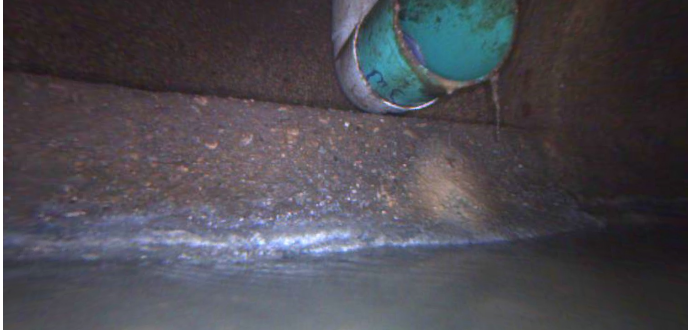
Code:	AMH
Description:	Manhole
Distance (ft):	110.8
Structural Grade:	0
O&M Grade:	0
Clock Start/From:	
Clock To:	
1st Value:	
2nd Value:	
Value Percent:	
Continuous Index:	
Within 8" of Joint:	NO
Remarks:	M-607-018
