Profile/Photo Observation Report

Date:	04/11/2018	Weather:		Coding:	PACP 6.0
Pipe Length (ft):	113.8	Owner:	NA	Pre Clean:	No Pre-Cleaning
P.O.#:		Surveyor:	Jen Costello	PSR:	P-607-078-018
Customer:		Clean Date:	01/01/1900	Shape:	C

Street:	FOXCROFT STREET	Flow Control:	Not Controlled
City:	Hobart, IN	Year Renewed:	
Location:	Yard	Tape/Media #:	
Purpose:	Routine Assessment	Dia/Height:	8"
Use:	Sanitary	Material:	PVC
Drain Area:	NA	Lining:	
Category:	NA		
Comment:

Location Details:		Direction of Survey:	Downstream
US MH:	M-607-078	DS MH:	M-607-018
		Total Length Surveyed (ft):	110.8

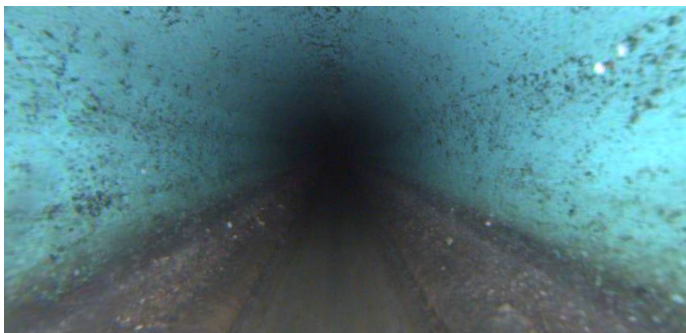
Code: **AMH**
Description: **Manhole**

Distance (ft): **.0**
Structural Grade: **0**
O&M Grade: **0**
Clock Start/From:
Clock To:
1st Value:
2nd Value:
Value Percent:
Continuous Index:
Within 8" of Joint: **NO**
Remarks: **M-607-078**

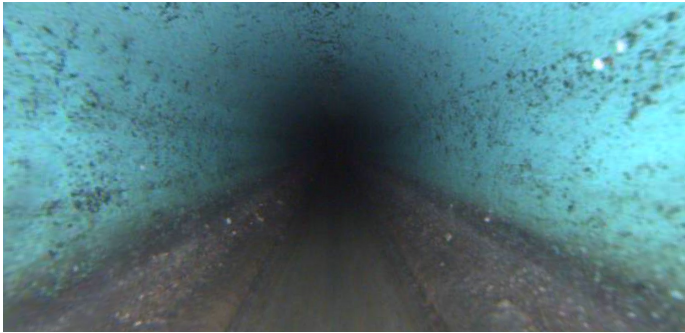
Code:	MWL
Description:	Water Level

Distance (ft):	.0
Structural Grade:	0
O&M Grade:	0
Clock Start/From:	
Clock To:	
1st Value:	
2nd Value:	
Value Percent:	5.000
Continuous Index:	
Within 8" of Joint:	NO
Remarks:

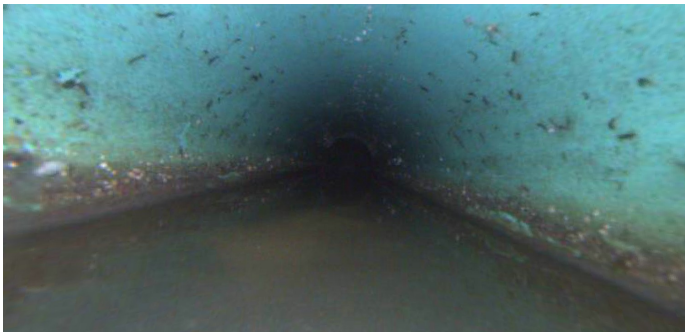
Code:	MWL
Description:	Water Level

Distance (ft):	105.4
Structural Grade:	0
O&M Grade:	0
Clock Start/From:	
Clock To:	
1st Value:	
2nd Value:	
Value Percent:	40.000
Continuous Index:	
Within 8" of Joint:	NO
Remarks:

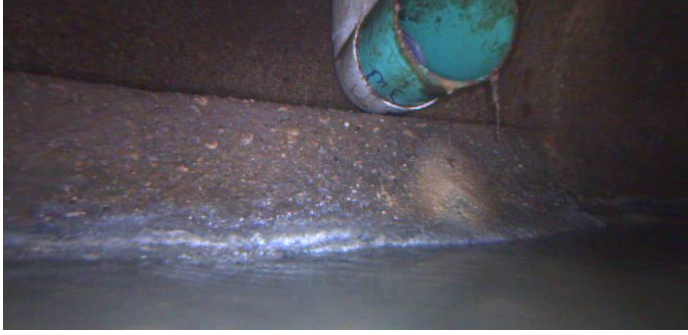
Code:	AMH
Description:	Manhole
Distance (ft):	110.8
Structural Grade:	0
O&M Grade:	0
Clock Start/From:	
Clock To:	
1st Value:	
2nd Value:	
Value Percent:	
Continuous Index:	
Within 8" of Joint:	NO
Remarks:	M-607-018
