Profile/Photo Observation Report

Date:	04/11/2018	Weather:		Coding:	PACP 6.0
Pipe Length (ft):	400.2	Owner:	NA	Pre Clean:	No Pre-Cleaning
P.O.#:		Surveyor:	Jen Costello	PSR:	P-607-079-078
Customer:		Clean Date:	01/01/1900	Shape:	C

Street:	S ASH ST	Flow Control:	Not Controlled
City:	Hobart, IN	Year Renewed:	
Location:	Yard	Tape/Media #:	
Purpose:	Routine Assessment	Dia/Height:	8"
Use:	Sanitary	Material:	PVC
Drain Area:	NA	Lining:	
Category:	NA		
Comment:			
Location Details:		Direction of Survey:	Upstream
US MH:	M-607-079	DS MH:	M-607-078
		Total Length Surveyed (ft):	396.3

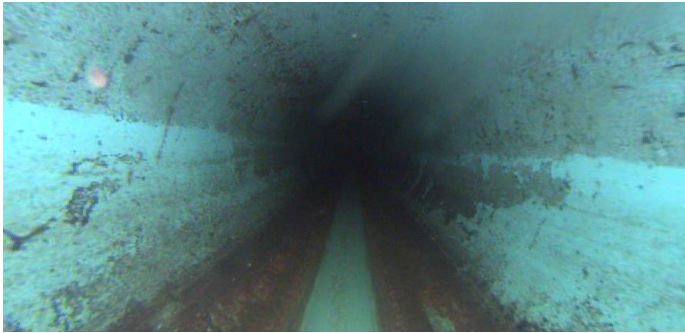
Code:	MWL
Description:	Water Level

Distance (ft):	.0
Structural Grade:	0
O&M Grade:	0
Clock Start/From:	
Clock To:	
1st Value:	
2nd Value:	
Value Percent:	5.000
Continuous Index:	
Within 8" of Joint:	NO
Remarks:

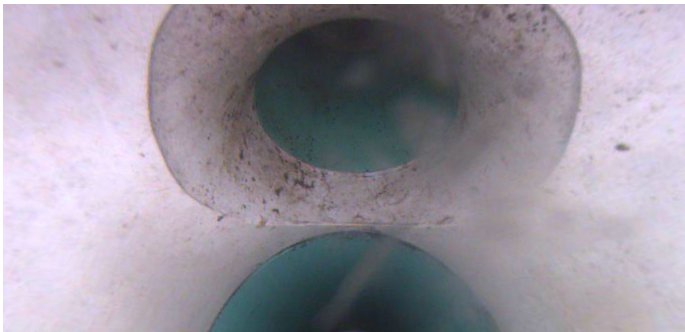
Code:	TF
Description:	Tap Factory

Distance (ft):	169.0
Structural Grade:	0
O&M Grade:	0
Clock Start/From:	12
Clock To:	
1st Value:	4.000
2nd Value:	
Value Percent:	
Continuous Index:	
Within 8" of Joint:	
Remarks:

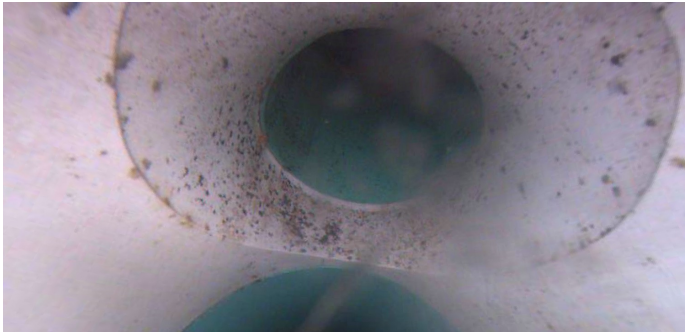
Code: **TF**
Description: **Tap Factory**

Distance (ft): **172.0**
Structural Grade: **0**
O&M Grade: **0**
Clock Start/From: **12**
Clock To:
1st Value: **4.000**
2nd Value:
Value Percent:
Continuous Index:
Within 8" of Joint:
Remarks:

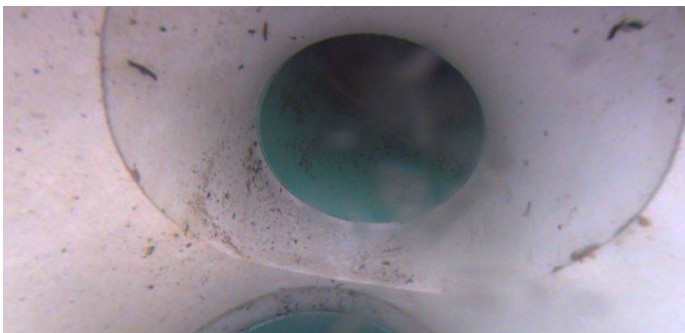
Code: **TF**
Description: **Tap Factory**

Distance (ft): **235.4**
Structural Grade: **0**
O&M Grade: **0**
Clock Start/From: **12**
Clock To:
1st Value: **4.000**
2nd Value:
Value Percent:
Continuous Index:
Within 8" of Joint:
Remarks:

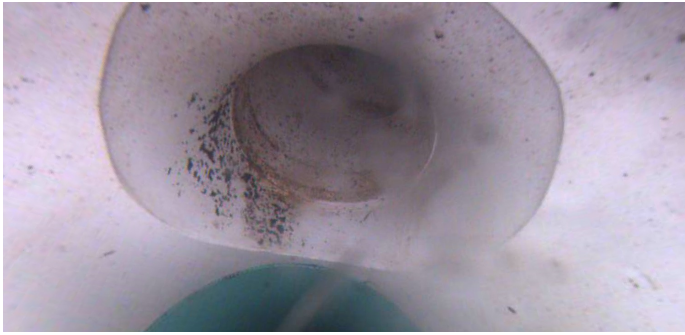
Code: **TF**
Description: **Tap Factory**

Distance (ft): **249.7**
Structural Grade: **0**
O&M Grade: **0**
Clock Start/From: **12**
Clock To:
1st Value: **4.000**
2nd Value:
Value Percent:
Continuous Index:
Within 8" of Joint:
Remarks:

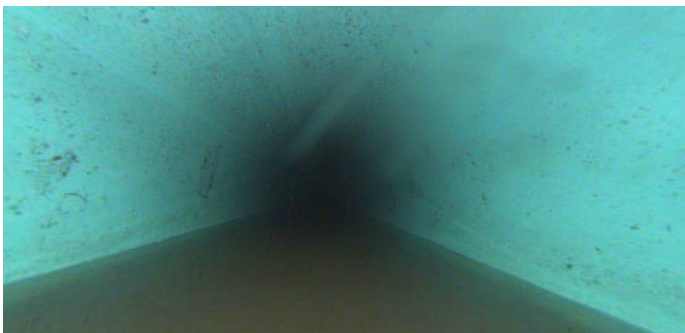
Code: **MWL**
Description: **Water Level**

Distance (ft): **315.9**
Structural Grade: **0**
O&M Grade: **0**
Clock Start/From:
Clock To:
1st Value:
2nd Value:
Value Percent: **40.000**
Continuous Index:
Within 8" of Joint: **NO**
Remarks:

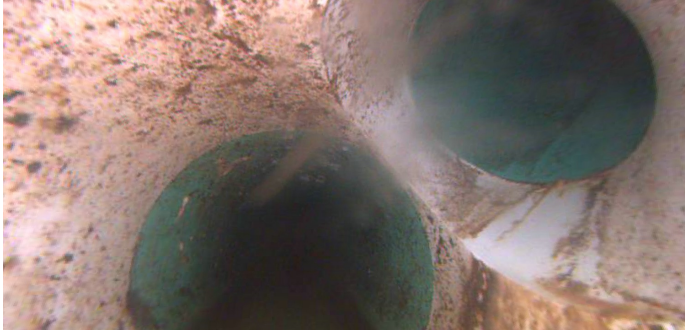
Code: **TF**
Description: **Tap Factory**

Distance (ft): **380.2**
Structural Grade: **0**
O&M Grade: **0**
Clock Start/From: **2**
Clock To:
1st Value: **4.000**
2nd Value:
Value Percent:
Continuous Index:
Within 8" of Joint:
Remarks:

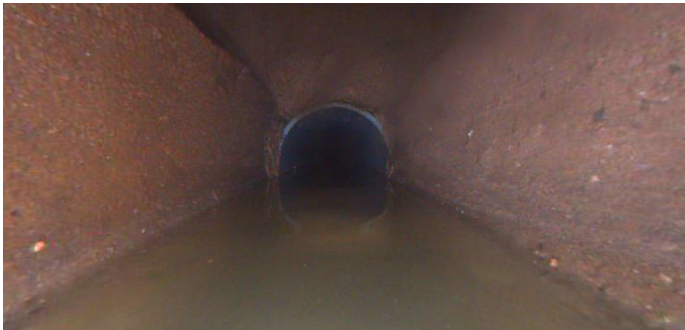
Code: **AMH**
Description: **Manhole**

Distance (ft): **396.3**
Structural Grade: **0**
O&M Grade: **0**
Clock Start/From:
Clock To:
1st Value:
2nd Value:
Value Percent:
Continuous Index:
Within 8" of Joint: **NO**
Remarks: **M-607-079**
