## Profile/Photo Observation Report

Street:	<b>FOXCROFT STREET</b>	Flow Control:	<b>Not Controlled</b>
City:	<b>Hobart, IN</b>	Year Renewed:	
Location:	<b>Yard</b>	Tape/Media #:	
Purpose:	<b>Routine Assessment</b>	Dia/Height:	<b>8"</b>
Use:	<b>Sanitary</b>	Material:	<b>PVC</b>
Drain Area:	<b>NA</b>	Lining:	
Category:	<b>NA</b>		
Comment:

Location Details:		Direction of Survey:	<b>Downstream</b>
US MH:	<b>M-607-080</b>	DS MH:	<b>M-607-079</b>
		Total Length Surveyed (ft):	<b>351.8</b>

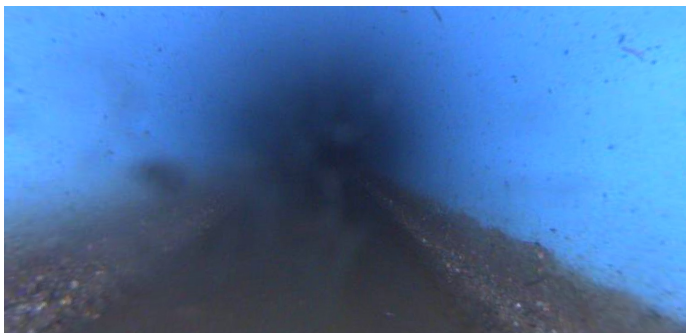
Code: **AMH**  
Description: **Manhole**

Distance (ft): **.0**  
Structural Grade: **0**  
O&M Grade: **0**  
Clock Start/From:  
Clock To:  
1st Value:  
2nd Value:  
Value Percent:  
Continuous Index:  
Within 8" of Joint: **NO**  
Remarks: **M-607-080**

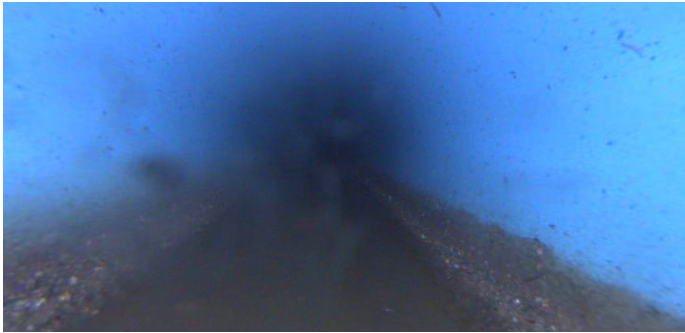
Code:	<b>MWL</b>
Description:	<b>Water Level</b>

Distance (ft):	<b>.0</b>
Structural Grade:	<b>0</b>
O&M Grade:	<b>0</b>
Clock Start/From:	
Clock To:	
1st Value:	
2nd Value:	
Value Percent:	<b>10.000</b>
Continuous Index:	
Within 8" of Joint:	<b>NO</b>
Remarks:

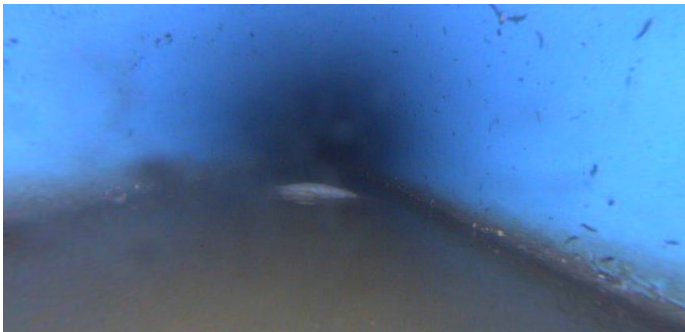
Code:	<b>MWL</b>
Description:	<b>Water Level</b>

Distance (ft):	<b>19.7</b>
Structural Grade:	<b>0</b>
O&M Grade:	<b>0</b>
Clock Start/From:	
Clock To:	
1st Value:	
2nd Value:	
Value Percent:	<b>40.000</b>
Continuous Index:	
Within 8" of Joint:	<b>NO</b>
Remarks:

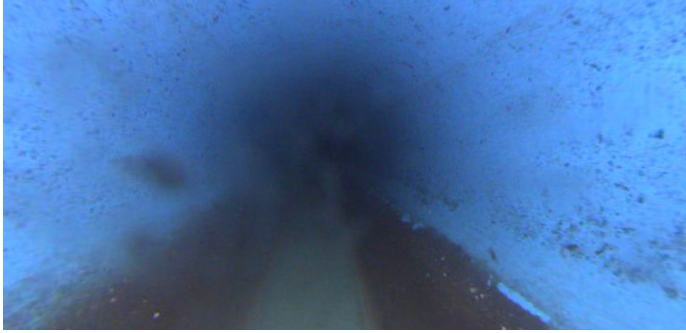
Code: **MWL**  
Description: **Water Level**

Distance (ft): **42.9**  
Structural Grade: **0**  
O&M Grade: **0**  
Clock Start/From:  
Clock To:  
1st Value:  
2nd Value:  
Value Percent: **5.000**  
Continuous Index:  
Within 8" of Joint: **NO**  
Remarks:

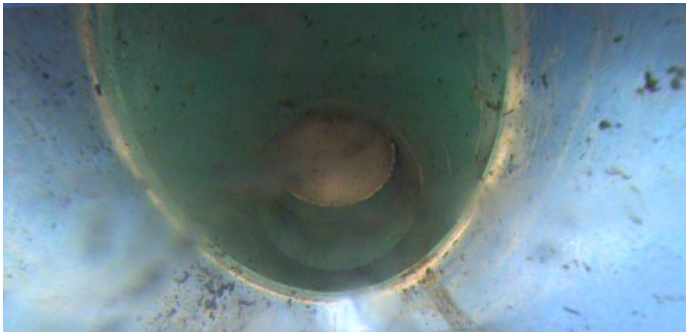
Code: **TF**  
Description: **Tap Factory**

Distance (ft): **71.8**  
Structural Grade: **0**  
O&M Grade: **0**  
Clock Start/From: **12**  
Clock To:  
1st Value: **4.000**  
2nd Value:  
Value Percent:  
Continuous Index:  
Within 8" of Joint:  
Remarks:

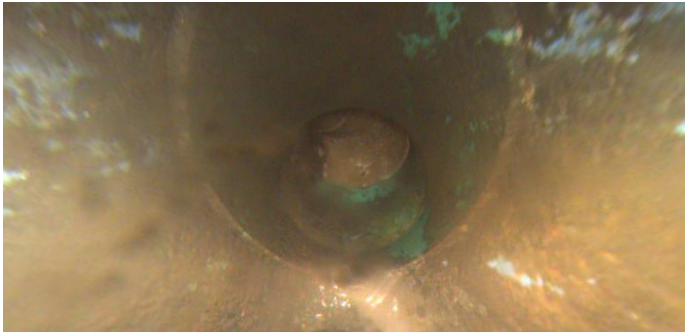
Code: **TF**  
Description: **Tap Factory**

Distance (ft): **86.9**  
Structural Grade: **0**  
O&M Grade: **0**  
Clock Start/From: **12**  
Clock To:  
1st Value: **4.000**  
2nd Value:  
Value Percent:  
Continuous Index:  
Within 8" of Joint:  
Remarks:

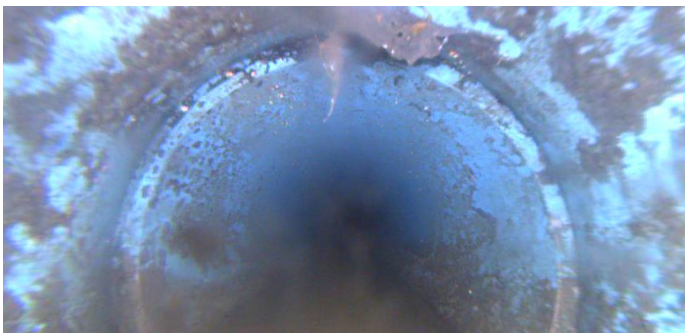
Code: **RFJ**  
Description: **Roots Fine Joint**

Distance (ft): **86.9**  
Structural Grade: **0**  
O&M Grade: **1**  
Clock Start/From: **12**  
Clock To:  
1st Value:  
2nd Value:  
Value Percent:  
Continuous Index:  
Within 8" of Joint: **YES**  
Remarks:

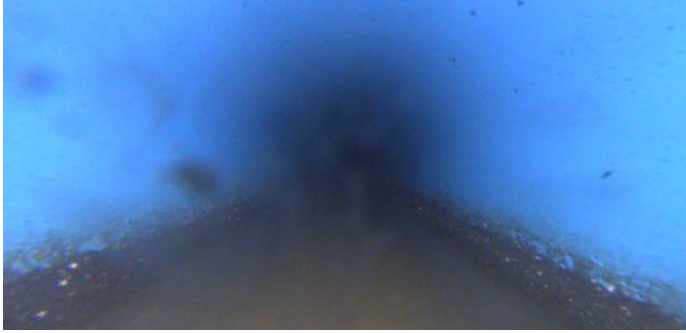
Code: **MWL**  
Description: **Water Level**

Distance (ft): **96.9**  
Structural Grade: **0**  
O&M Grade: **0**  
Clock Start/From:  
Clock To:  
1st Value:  
2nd Value:  
Value Percent: **20.000**  
Continuous Index:  
Within 8" of Joint: **NO**  
Remarks:

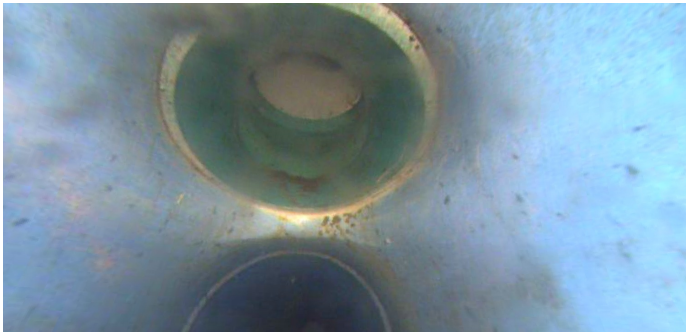
Code: **TF**  
Description: **Tap Factory**

Distance (ft): **137.9**  
Structural Grade: **0**  
O&M Grade: **0**  
Clock Start/From: **12**  
Clock To:  
1st Value: **4.000**  
2nd Value:  
Value Percent:  
Continuous Index:  
Within 8" of Joint:  
Remarks:

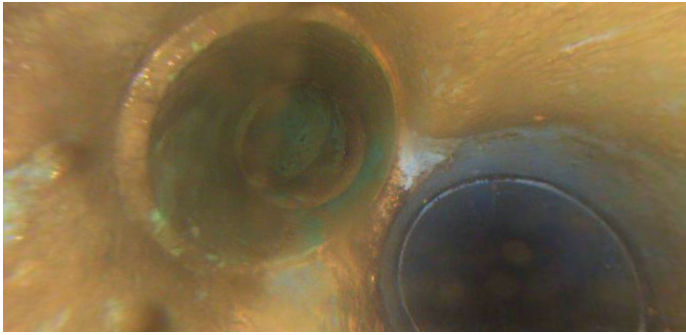
Code: **TF**  
Description: **Tap Factory**

Distance (ft): **313.7**  
Structural Grade: **0**  
O&M Grade: **0**  
Clock Start/From: **2**  
Clock To:  
1st Value: **4.000**  
2nd Value:  
Value Percent:  
Continuous Index:  
Within 8" of Joint:  
Remarks:

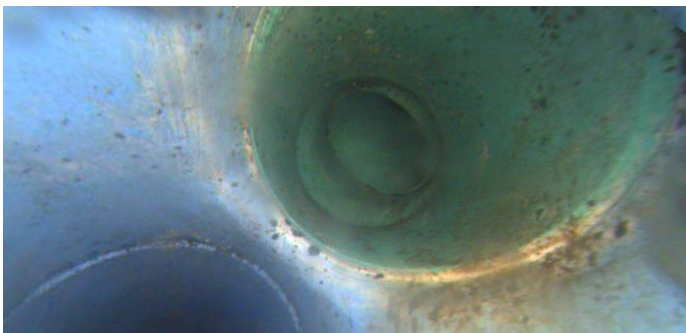
Code: **TF**  
Description: **Tap Factory**

Distance (ft): **337.1**  
Structural Grade: **0**  
O&M Grade: **0**  
Clock Start/From: **11**  
Clock To:  
1st Value: **4.000**  
2nd Value:  
Value Percent:  
Continuous Index:  
Within 8" of Joint:  
Remarks:

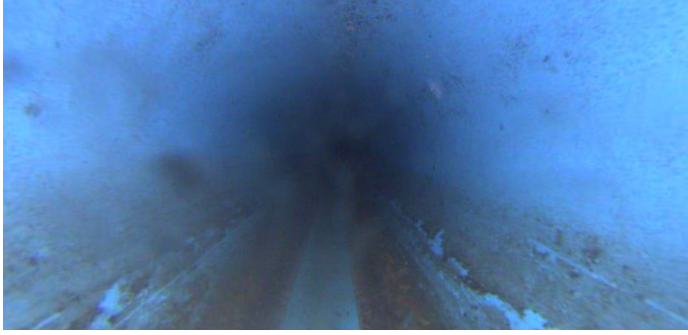
Code: **MSA**  
Description: **Abandoned Survey**

Distance (ft): **351.8**  
Structural Grade: **0**  
O&M Grade: **0**  
Clock Start/From:  
Clock To:  
1st Value:  
2nd Value:  
Value Percent:  
Continuous Index:  
Within 8" of Joint: **NO**  
Remarks: **unknown**
