Profile/Photo Observation Report

Street:	FOXCROFT STREET	Flow Control:	Not Controlled
City:	Hobart, IN	Year Renewed:	
Location:	Yard	Tape/Media #:	
Purpose:	Routine Assessment	Dia/Height:	12"
Use:	Sanitary	Material:	PVC
Drain Area:	NA	Lining:	
Category:	NA		
Comment:	MH_F at 5 ft false		
Location Details:		Direction of Survey:	Upstream
US MH:	M-608-003	DS MH:	M-608-002
		Total Length Surveyed (ft):	4.9

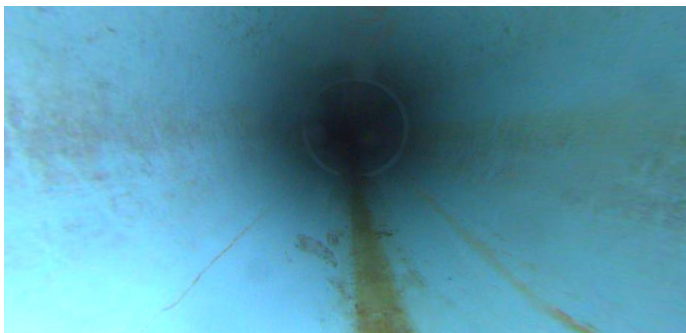
Code: **AMH**
Description: **Manhole**

Distance (ft): **.0**
Structural Grade: **0**
O&M Grade: **0**
Clock Start/From:
Clock To:
1st Value:
2nd Value:
Value Percent:
Continuous Index:
Within 8" of Joint: **NO**
Remarks: **M-608-002**

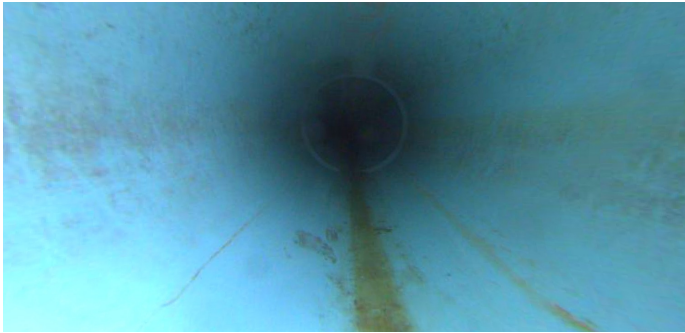
Code:	MWL
Description:	Water Level

Distance (ft):	.0
Structural Grade:	0
O&M Grade:	0
Clock Start/From:	
Clock To:	
1st Value:	
2nd Value:	
Value Percent:	5.000
Continuous Index:	
Within 8" of Joint:	NO
Remarks:

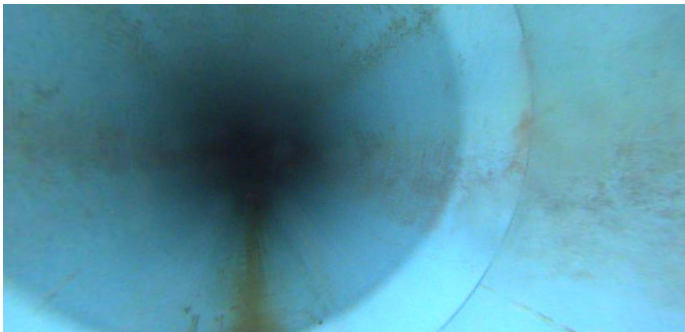
Code:	MSA
Description:	Abandoned Survey

Distance (ft):	4.0
Structural Grade:	0
O&M Grade:	0
Clock Start/From:	
Clock To:	
1st Value:	
2nd Value:	
Value Percent:	
Continuous Index:	
Within 8" of Joint:	NO
Remarks:	unknown
