Profile/Photo Observation Report

Street:	FOXCROFT STREET	Flow Control:	Not Controlled
City:	Hobart, IN	Year Renewed:	
Location:	Yard	Tape/Media #:	
Purpose:	Routine Assessment	Dia/Height:	8"
Use:	Sanitary	Material:	PVC
Drain Area:	NA	Lining:	
Category:	NA		
Comment:

Location Details:		Direction of Survey:	Downstream
US MH:	M-608-005	DS MH:	M-608-010
		Total Length Surveyed (ft):	47.7

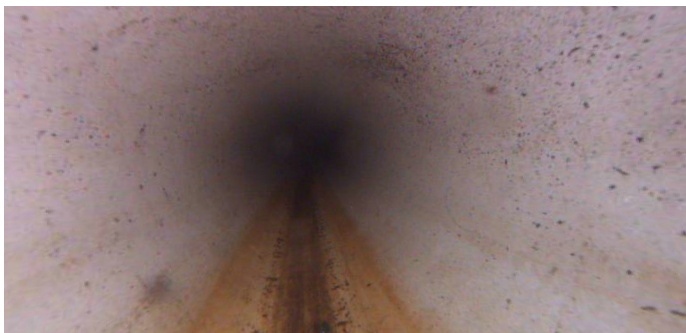
Code: **AMH**
Description: **Manhole**

Distance (ft): **.0**
Structural Grade: **0**
O&M Grade: **0**
Clock Start/From:
Clock To:
1st Value:
2nd Value:
Value Percent:
Continuous Index:
Within 8" of Joint: **NO**
Remarks: **M-608-005**

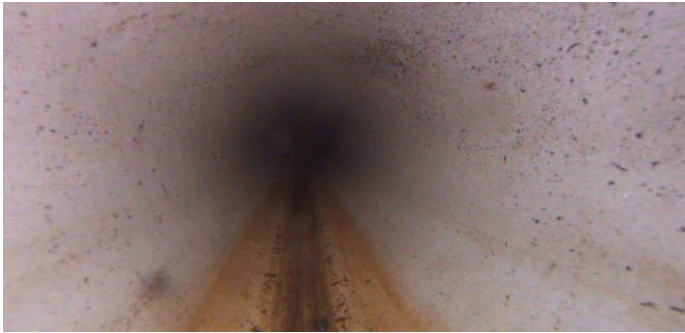
Code:	MWL
Description:	Water Level

Distance (ft):	.0
Structural Grade:	0
O&M Grade:	0
Clock Start/From:	
Clock To:	
1st Value:	
2nd Value:	
Value Percent:	5.000
Continuous Index:	
Within 8" of Joint:	NO
Remarks:

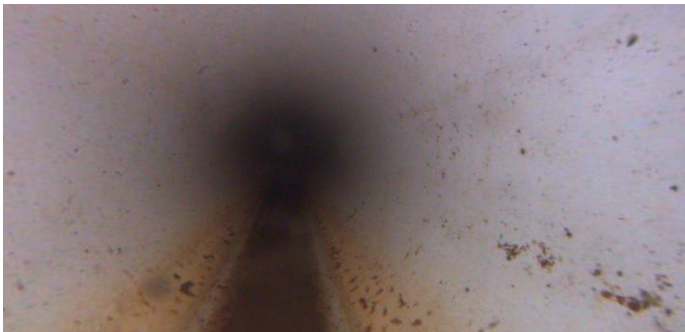
Code:	MSA
Description:	Abandoned Survey

Distance (ft):	47.7
Structural Grade:	0
O&M Grade:	0
Clock Start/From:	
Clock To:	
1st Value:	
2nd Value:	
Value Percent:	
Continuous Index:	
Within 8" of Joint:	NO
Remarks:	debris
