Profile/Photo Observation Report

Date:	10/11/2018	Weather:		Coding:	PACP 6.0
Pipe Length (ft):	362.4	Owner:	NA	Pre Clean:	Not Known
P.O.#:		Surveyor:	Selasie Honu	PSR:	P-608-010-005
Customer:		Clean Date:	01/01/1900	Shape:	C

Location Details:		Direction of Survey:	Upstream
US MH:	M-608-005	DS MH:	M-608-010
		Total Length Surveyed (ft):	286.1

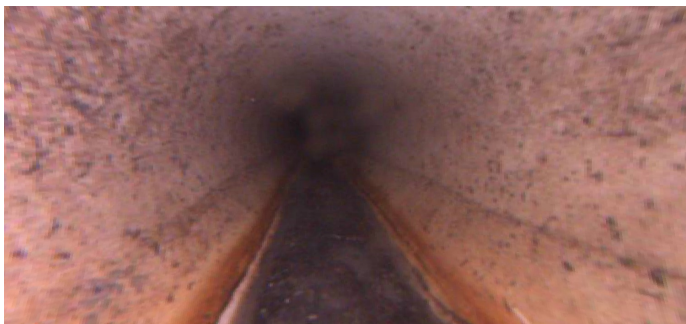
Code: **AMH**
Description: **Manhole**

Distance (ft): **.0**
Structural Grade: **0**
O&M Grade: **0**
Clock Start/From:
Clock To:
1st Value:
2nd Value:
Value Percent:
Continuous Index:
Within 8" of Joint: **NO**
Remarks: **M-608-010**

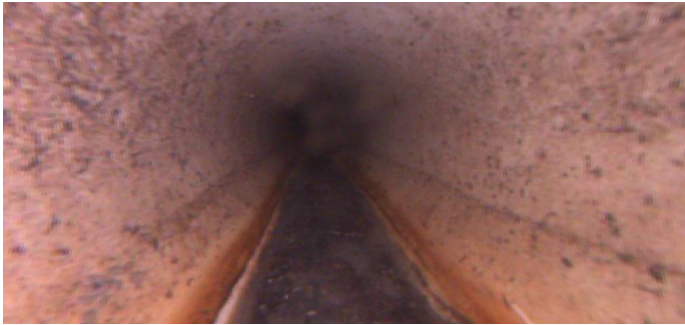
Code:	MWL
Description:	Water Level

Distance (ft):	.0
Structural Grade:	0
O&M Grade:	0
Clock Start/From:	
Clock To:	
1st Value:	
2nd Value:	
Value Percent:	5.000
Continuous Index:	
Within 8" of Joint:	NO
Remarks:

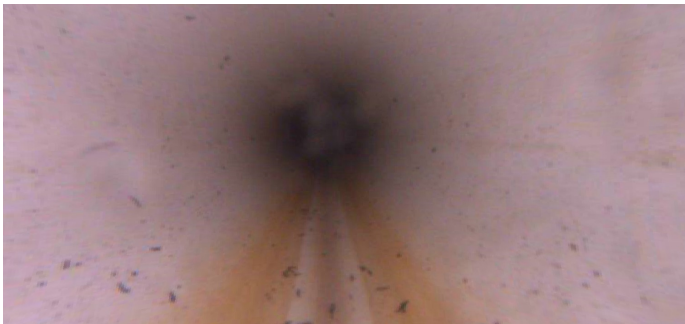
Code:	MSA
Description:	Abandoned Survey

Distance (ft):	286.1
Structural Grade:	0
O&M Grade:	0
Clock Start/From:	
Clock To:	
1st Value:	
2nd Value:	
Value Percent:	
Continuous Index:	
Within 8" of Joint:	NO
Remarks:	camera stopped
