Profile/Photo Observation Report

Street:	61st. Ave.	Flow Control:	Not Controlled
City:	Hobart, IN	Year Renewed:	
Location:	Light Highway	Tape/Media #:	
Purpose:	Routine Assessment	Dia/Height:	8"
Use:	Sanitary	Material:	PVC
Drain Area:	NA	Lining:	
Category:	NA		
Comment:

Location Details:		Direction of Survey:	Downstream
US MH:	M-608-005	DS MH:	M-608-010
		Total Length Surveyed (ft):	149.4

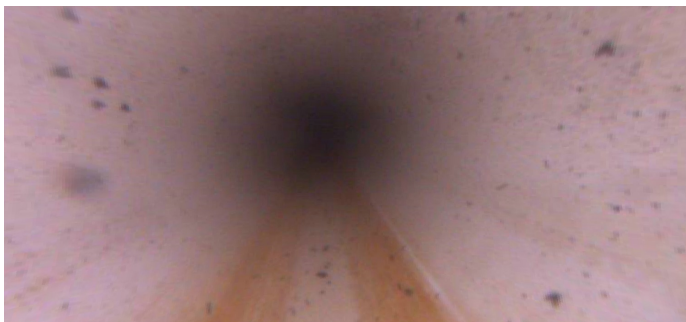
Code: **AMH**
Description: **Manhole**

Distance (ft): **.0**
Structural Grade: **0**
O&M Grade: **0**
Clock Start/From:
Clock To:
1st Value:
2nd Value:
Value Percent:
Continuous Index:
Within 8" of Joint: **NO**
Remarks: **M-608-005**

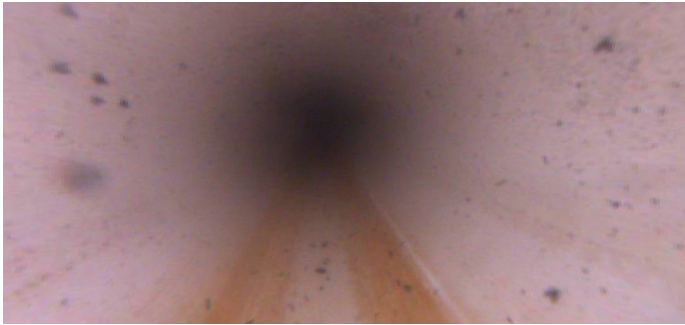
Code:	MWL
Description:	Water Level

Distance (ft):	.0
Structural Grade:	0
O&M Grade:	0
Clock Start/From:	
Clock To:	
1st Value:	
2nd Value:	
Value Percent:	5.000
Continuous Index:	
Within 8" of Joint:	NO
Remarks:

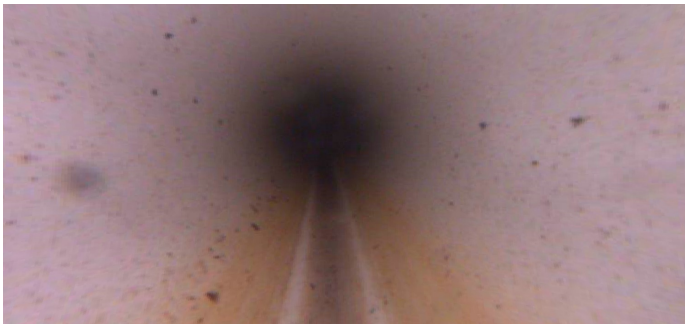
Code:	MSA
Description:	Abandoned Survey

Distance (ft):	149.4
Structural Grade:	0
O&M Grade:	0
Clock Start/From:	
Clock To:	
1st Value:	
2nd Value:	
Value Percent:	
Continuous Index:	
Within 8" of Joint:	NO
Remarks:	camera underwater
